ARROYO DE LA LAGUNA REACH-BASED GEOMORPHIC EVALUATION

NOVEMBER 2023

PREPARED BY
San Francisco Estuary Institute

IN PARTNERSHIP WITH
Alameda County Flood Control and
Water Conservation District, Zone 7

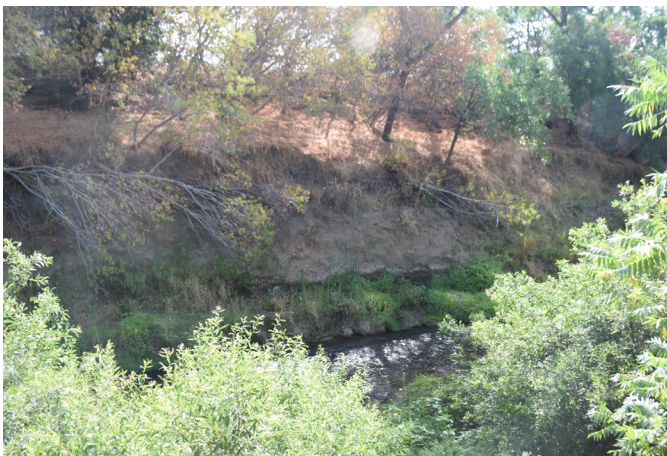
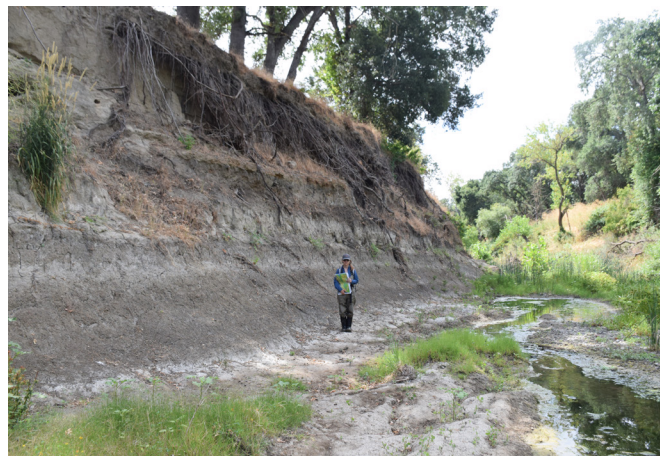
Figure 5. Example reaches with near vertical banks.

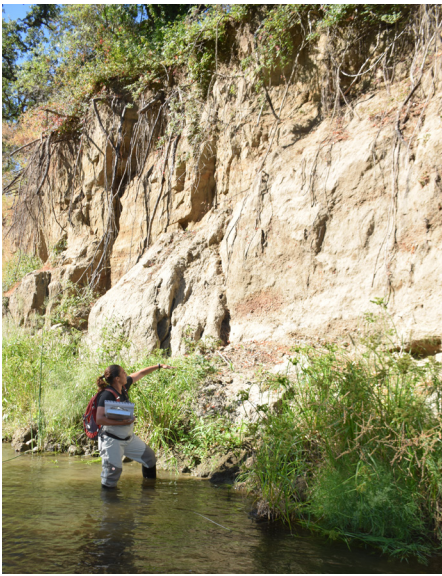
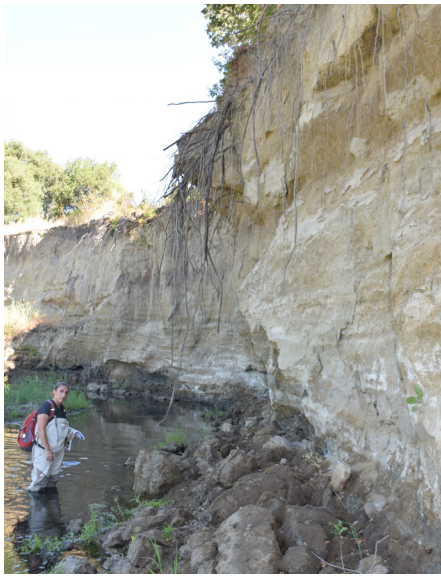
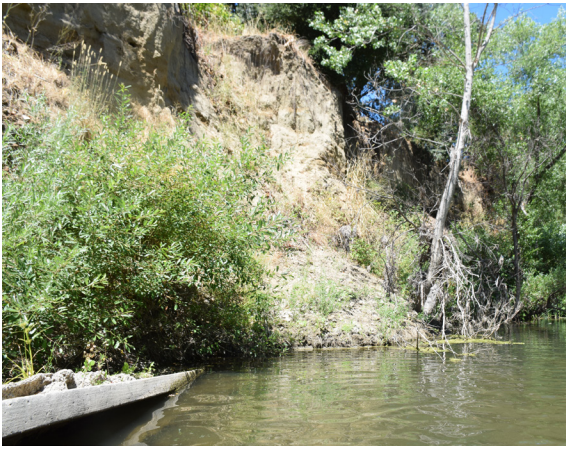
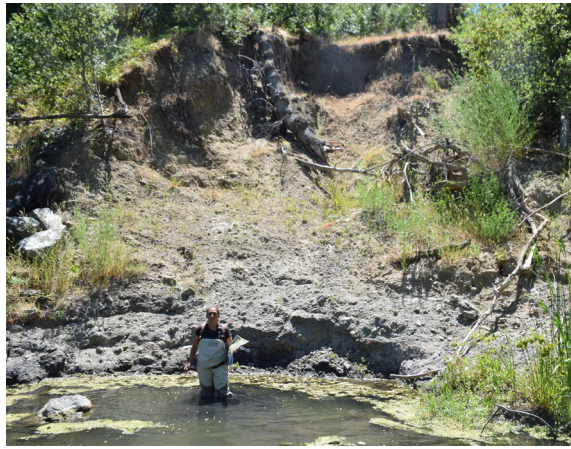
Figure 6. Examples illustrating block style failure; dry ravel style failure; bank slump failure.

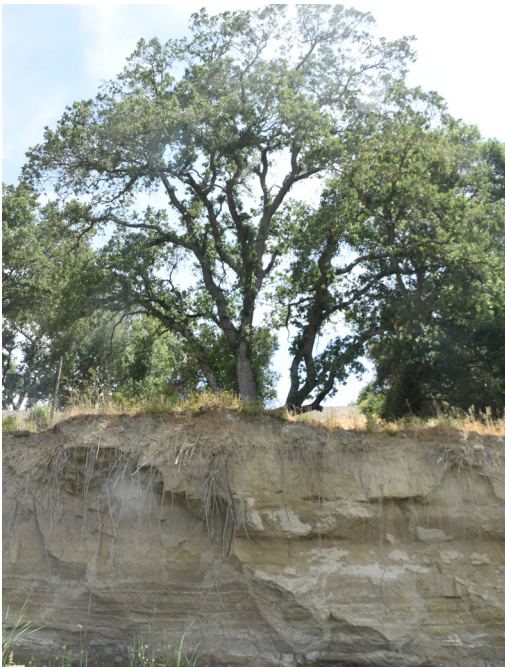
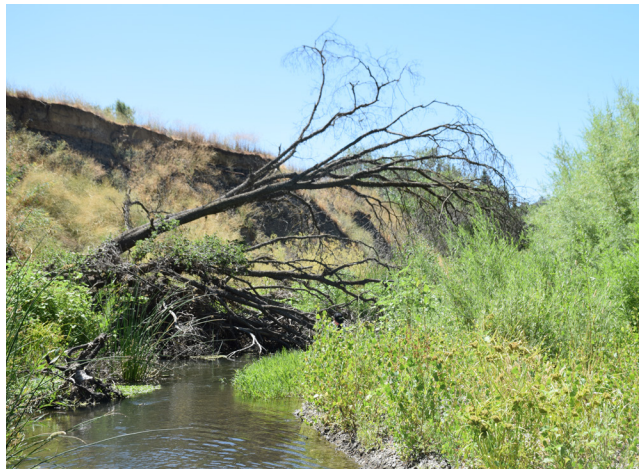
Figure 7. Oak tree in danger with exposed roots and undercut bank; tree recently recruited into channel.

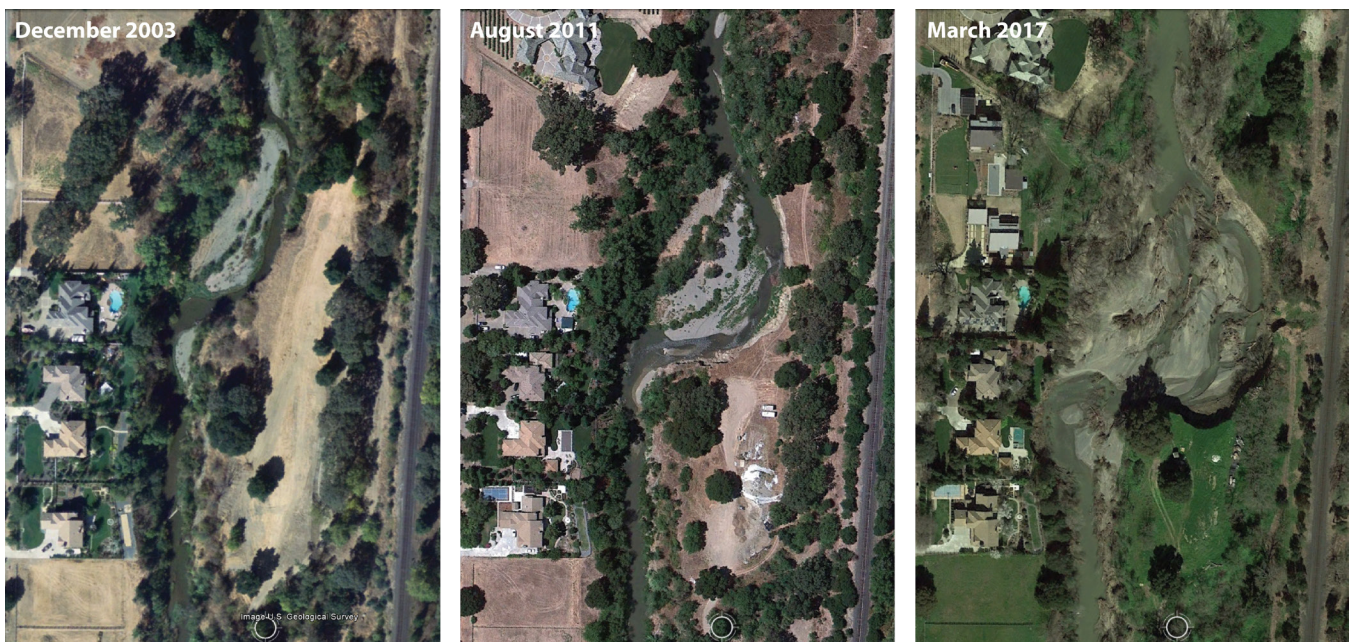
The S-curve meander bends represent nodes of widening and inset floodplain building. As the channel enters these nodes, it changes from single thread to multi-thread, and often becomes coarser, supporting long riffle lengths. These areas of the channel have vertical or near vertical outer banks that fail both as block failures and as dry-ravel failures. The channel meander bend is actively migrating, compressing in a downstream direction. Comparison of a time series of aerial photographs clearly illustrates the changes that have occurred (Figure 12), indicating that the brunt of the erosional pressure has been directed at the downstream outer bend, where a house and a swimming pool are close to the top of bank. Because of Zone's 7's 2017 restoration and bank set-back project at 3 Verona, the downstream portion of the downstream S-curve location has been reconstructed, stabilized by willow and other riparian plantings, and has been holding sediment at the toe of the slope providing some protection. Because it is likely not economical to lay back the banks in locations with high-value real estate near to the stream, measures that focus upon providing stability at the toe of slopes (e.g. protection from scour during high flows, and protection from constant wetting/drying) should be considered. The outer banks are generally 7-9m high (with some locations 12 m high), so that when they fail, a significant amount of sediment is delivered directly into the channel. Field surveys by Zone 7 have been estimated that approximately 27,000 yds³ of sediment has been contributed from bank retreat at two properties in the downstream S-curve alone between 2005 and 2010. In addition, failures

Figure 12. Time series of aerial photographs illustrating the migration of the channel meander at the downstream S-curve.

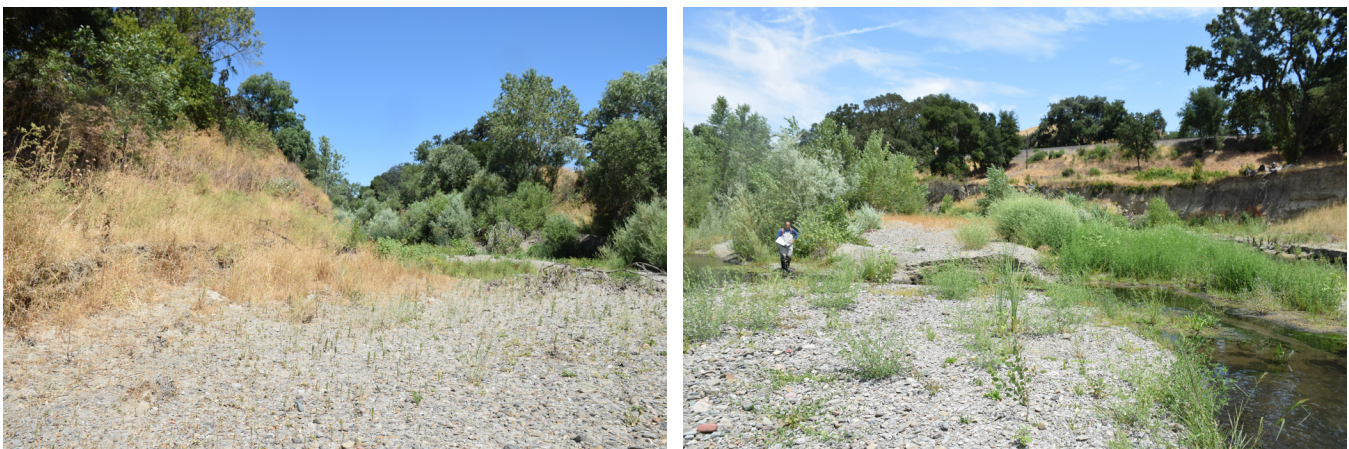
Figure 13. Examples illustrating active inset floodplain building.

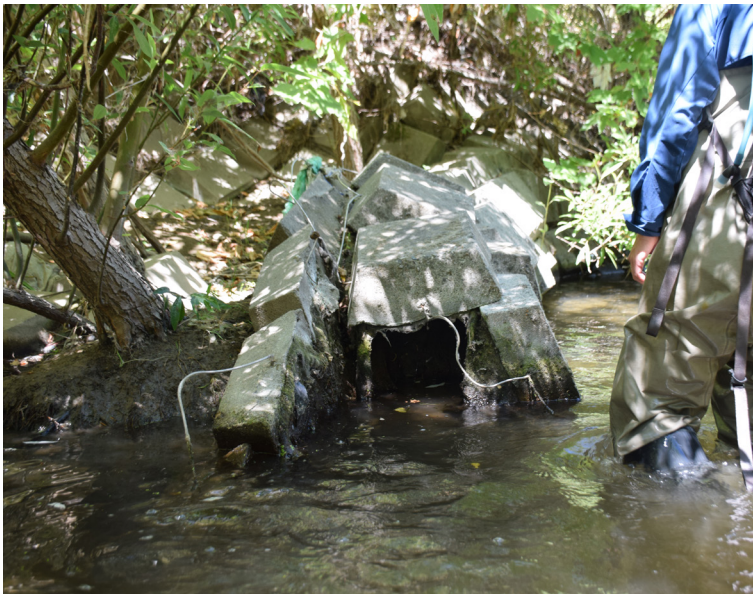
The relatively straight reaches adjacent to the two S-curve nodes have tall vertical banks that are actively failing, and threatening many properties. A number of land owners in this reach have placed riprap, articulated concrete mats, or filter fabric to help stabilize the toe of the slope, with varying success (Figure 15). Limited indicators of downcutting were observed underneath the concrete mats. These straight reaches have a more shallow gradient than the adjacent S-curve reaches, and have a well defined pool-riffle sequence, with many low bar deposits. In addition, discontinuous remnant 1950s flood deposits are observed, which are coarse packages of fluvial material forming a surface approximately 2-4 m above the current channel bed. In places, a wider floodplain surface is developing, which is fairly ecologically complex, with a number of swales and young woody vegetation (e.g. cottonwoods and willows).

Figure 15. Failing articulated concrete mat.

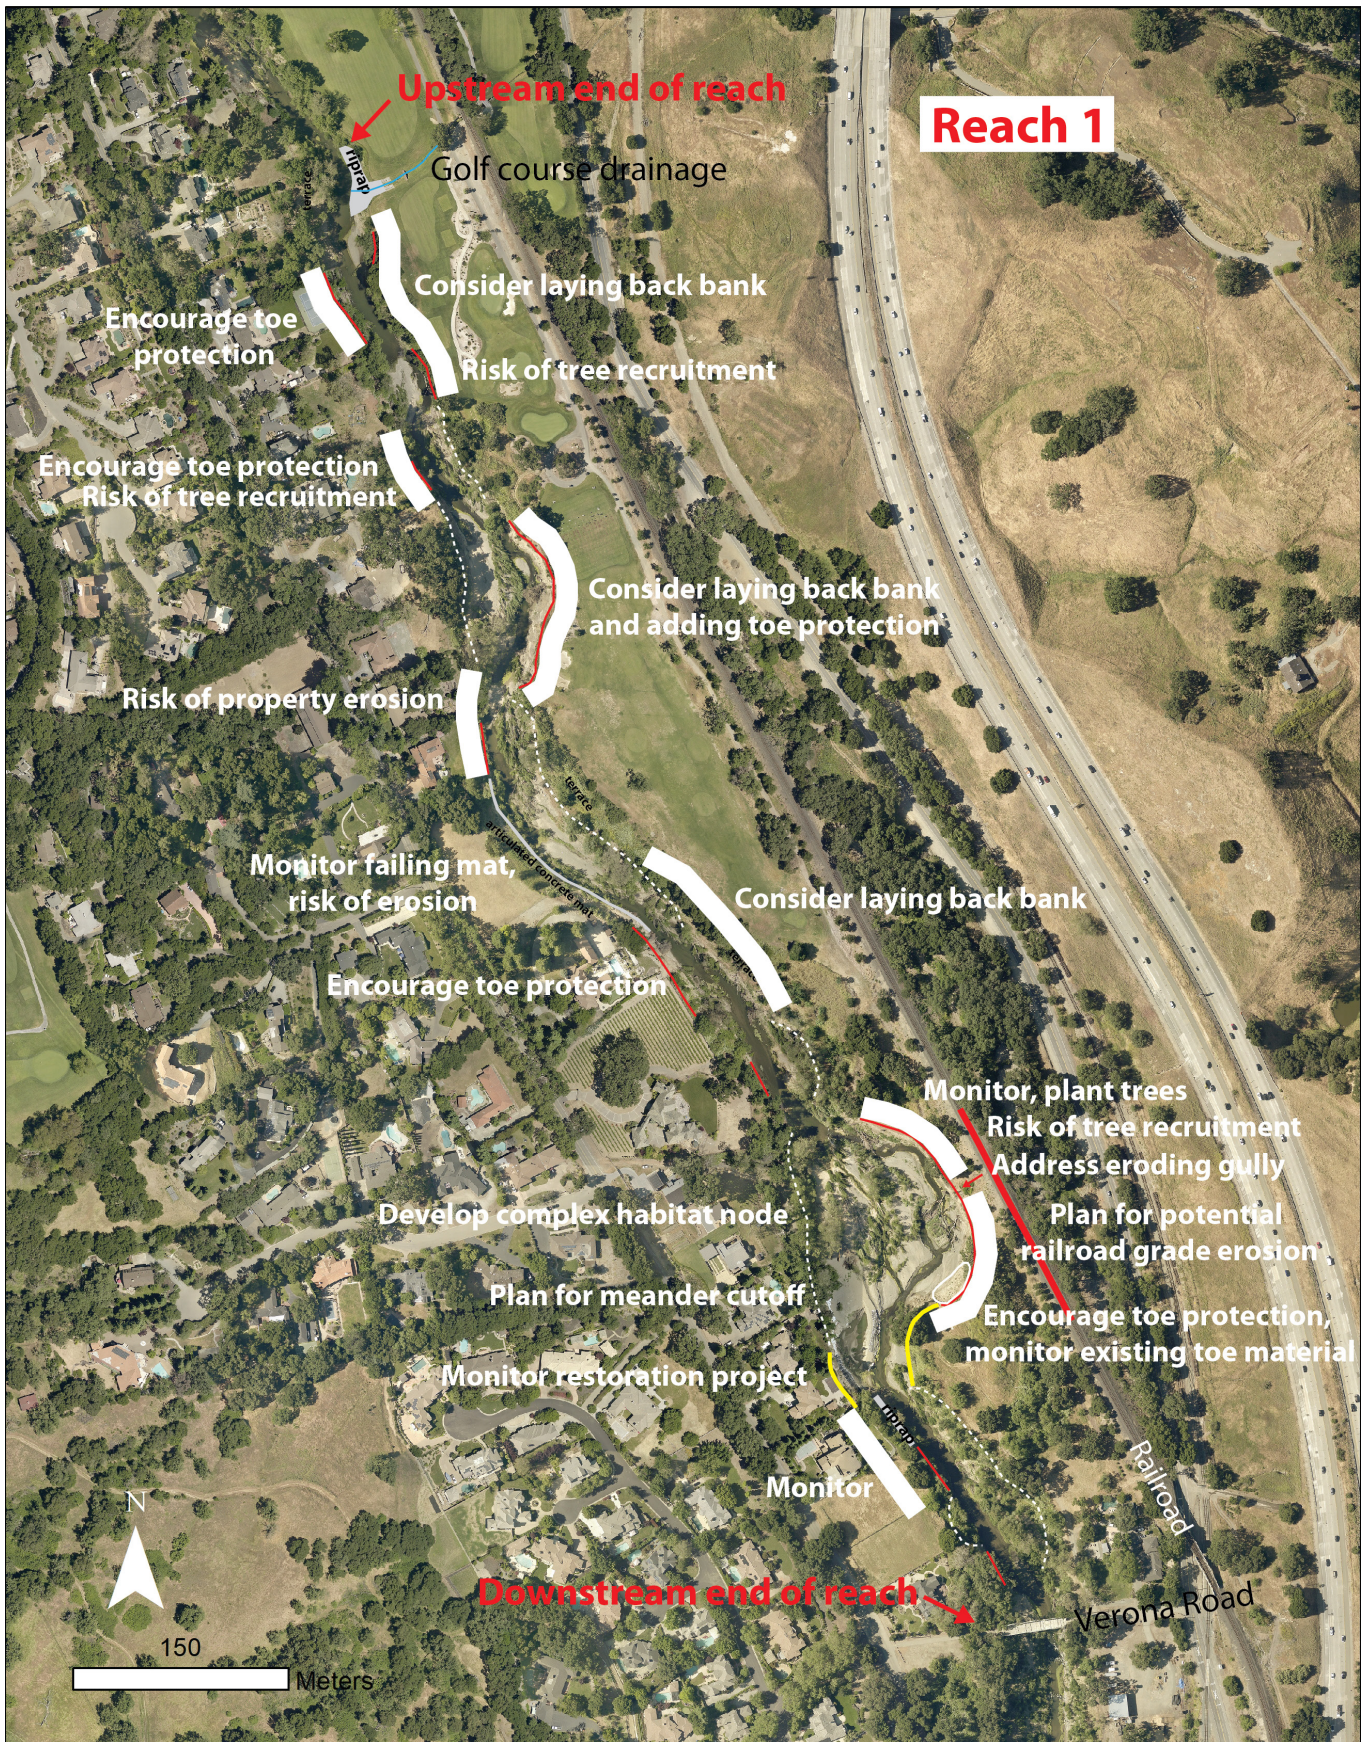
Figure 20. Risks and opportunities within Reach 1. Existing conditions created by the 3 Verona bank reconstruction project are highlighted by the yellow lines.

To summarize our findings by reach, we identified notable risks, opportunities, and potential management actions applicable to this reach in the near term (Figure 20). Risks include: the continued failure of outer banks that may ultimately damage property or structures, increased recruitment of large riparian trees into the channel as widening and deepening continue, the continued faster-paced migration of the downstream S-curve and slower-paced migration of the upstream S-curve, eventual undermining of the railroad trestle at the downstream S-curve, the potential reworking (e.g., channel migration, bank erosion, sediment deposition) of existing restoration/stabilization projects, and the potential headward migration of the steeper gradient associated with the two S-curves. And at a larger scale, continued development of the upstream urban areas without a focus upon the timing and volume of runoff produced will likely increase the volume of water delivered to ADLL during storms, thus increasing the stream power and the likelihood that the channel will continue to erode and incise.

However, this reach holds opportunities especially given the potential for large-scale restoration projects that are able to slow/halt the erosion of the outer banks and protect the adjacent properties. We recommend focusing on the opportunity presented by the left bank being composed primarily of Zone 7 and Castlewood Country Club property, and under-utilized open space to work with the expected future evolution. In particular, providing the channel additional width at the S-curve locations could lead to the development of a large, functioning node(s) of floodplain, and the creation of complex habitat areas, critical for ecological function and improved wildlife habitat. Specific locations where small drainages are routed into the channel can be addressed so that they do not exacerbate local bank erosion. And finally, the 3 Verona project should be monitored, with lessons learned applied to other areas in this reach.

Because of these risks, we recommend many actions for this reach. Locations where the channel might be widened proactively should be identified. Locations where the toe of slope has deposited material can be focused upon to stabilize that material and reduce the future erosional stress on the toe. Tree planting can focus on the top of banks, behind the current trees that are in danger of being recruited, allowing for some shading and root strength when/if the existing trees are recruited. We recommend addressing key data gaps in order to anticipate locations of future bank failures, and create an “anticipatory management plan” (Beagle et al., 2016) that focuses upon the threat to the railroad so that bank failures can be planned for over the long term.

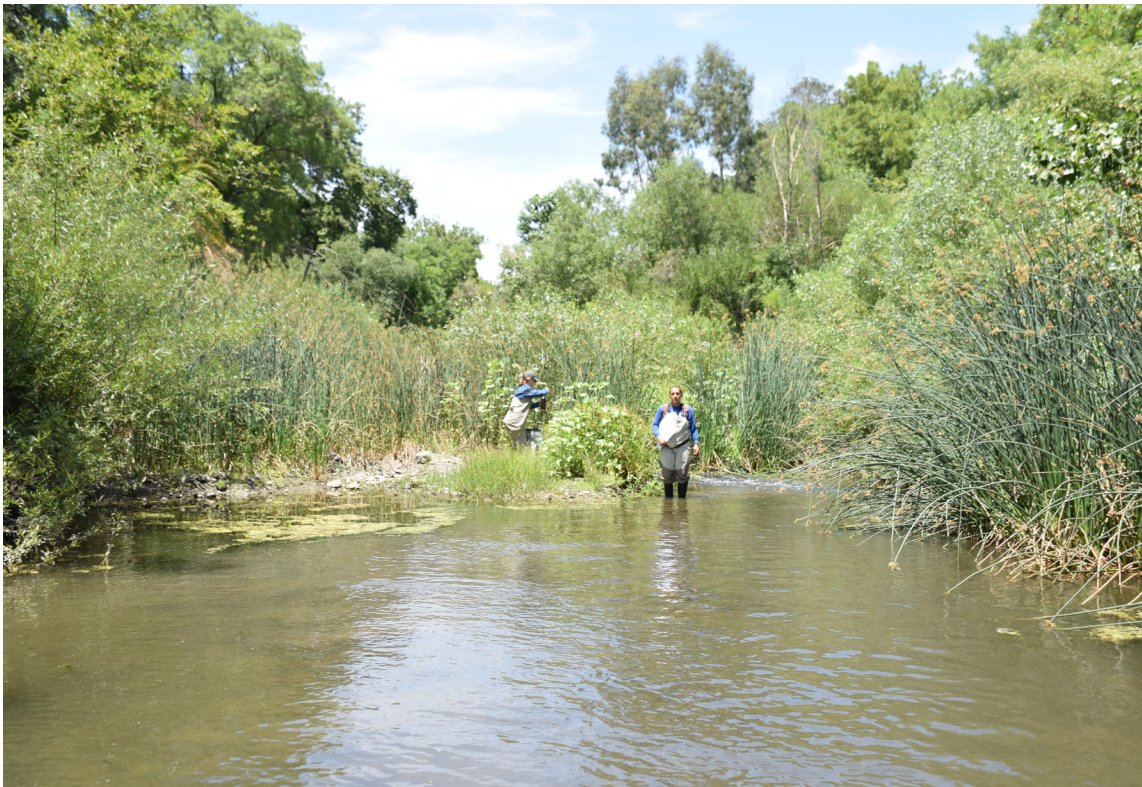
Figure 22. Photograph looking upstream at the downstream end of the steep riffle, and surrounding willow trees on the bar surfaces.

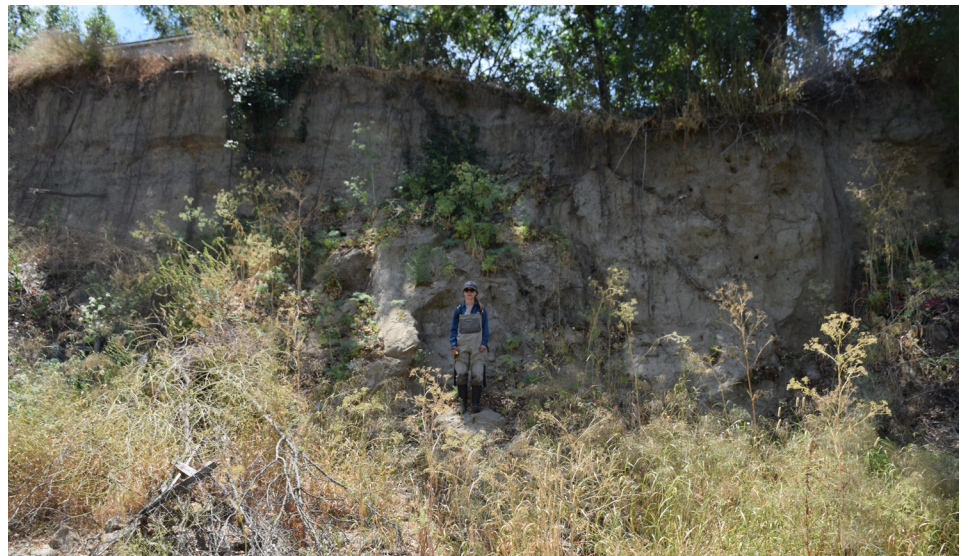
(right) Figure 24. Right bank at cross section showing near vertical bank and failed material at the base.

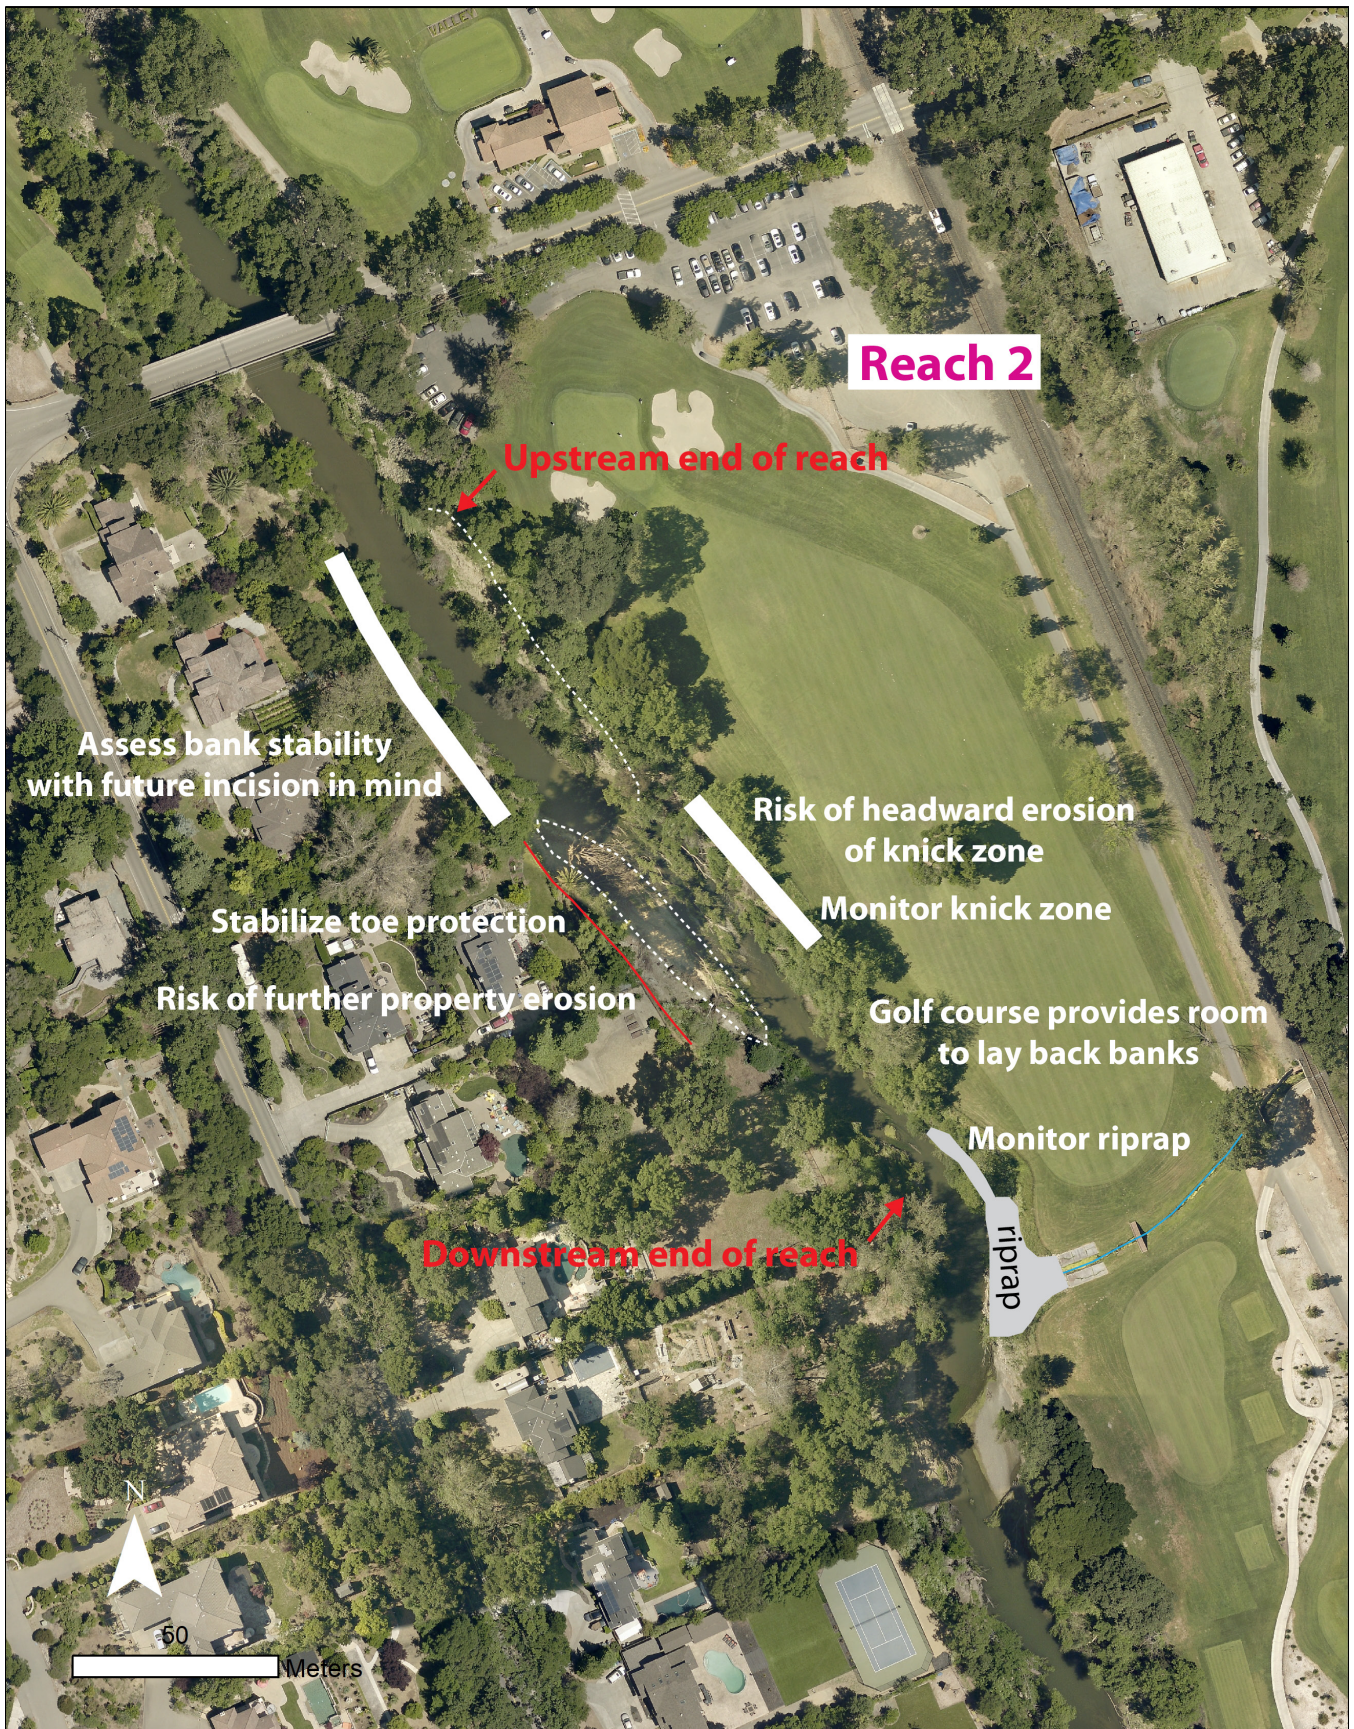
Figure 26. Risks and opportunities within Reach 2.

In this reach, the right bank is nearly vertical and failing via dry-ravel failure, and continued or increasing bank failure actively threatens residential backyard property and out-buildings (Figure 26). An aerial photograph analysis reveals 1 primary residence within 80 ft (2.5x the bank height) of the top of bank in this reach. A refined understanding of bank erosion rates will help inform risk management scenarios, however, the channel will likely deepen and widen after the knickpoint moves through, which will further destabilizing the banks, increase rates of bank erosion, and lead to loss of property.

However, because the left bank is golf course property, there are opportunities for proactive management. On the left bank, there is approximately 20 m of space between the top of bank and the fairway. This reach (and upstream of this reach) could be a location where the bank is laid back, with minimal impacts to golf course function, thus widening the channel width. The golf course is currently planning to proactively set back a 150m length segment of the left bank, with placement at the toe of the right bank. The project is being done in collaboration with Zone 7 during the Summer of 2019. This will hopefully be a pilot that could be repeated as needed, and should be designed with potential future incision in mind. The right bank currently has developed a bar from failed material at the toe of the bank. Additional measures to stabilize these features will provide continued protection for the outer bank. Knowledge of the potential incision will allow for appropriate monitoring to occur, potentially identifying the issue and allowing for proactive management including bank setbacks, and anticipating the need to move non-essential structures away from the top of bank.

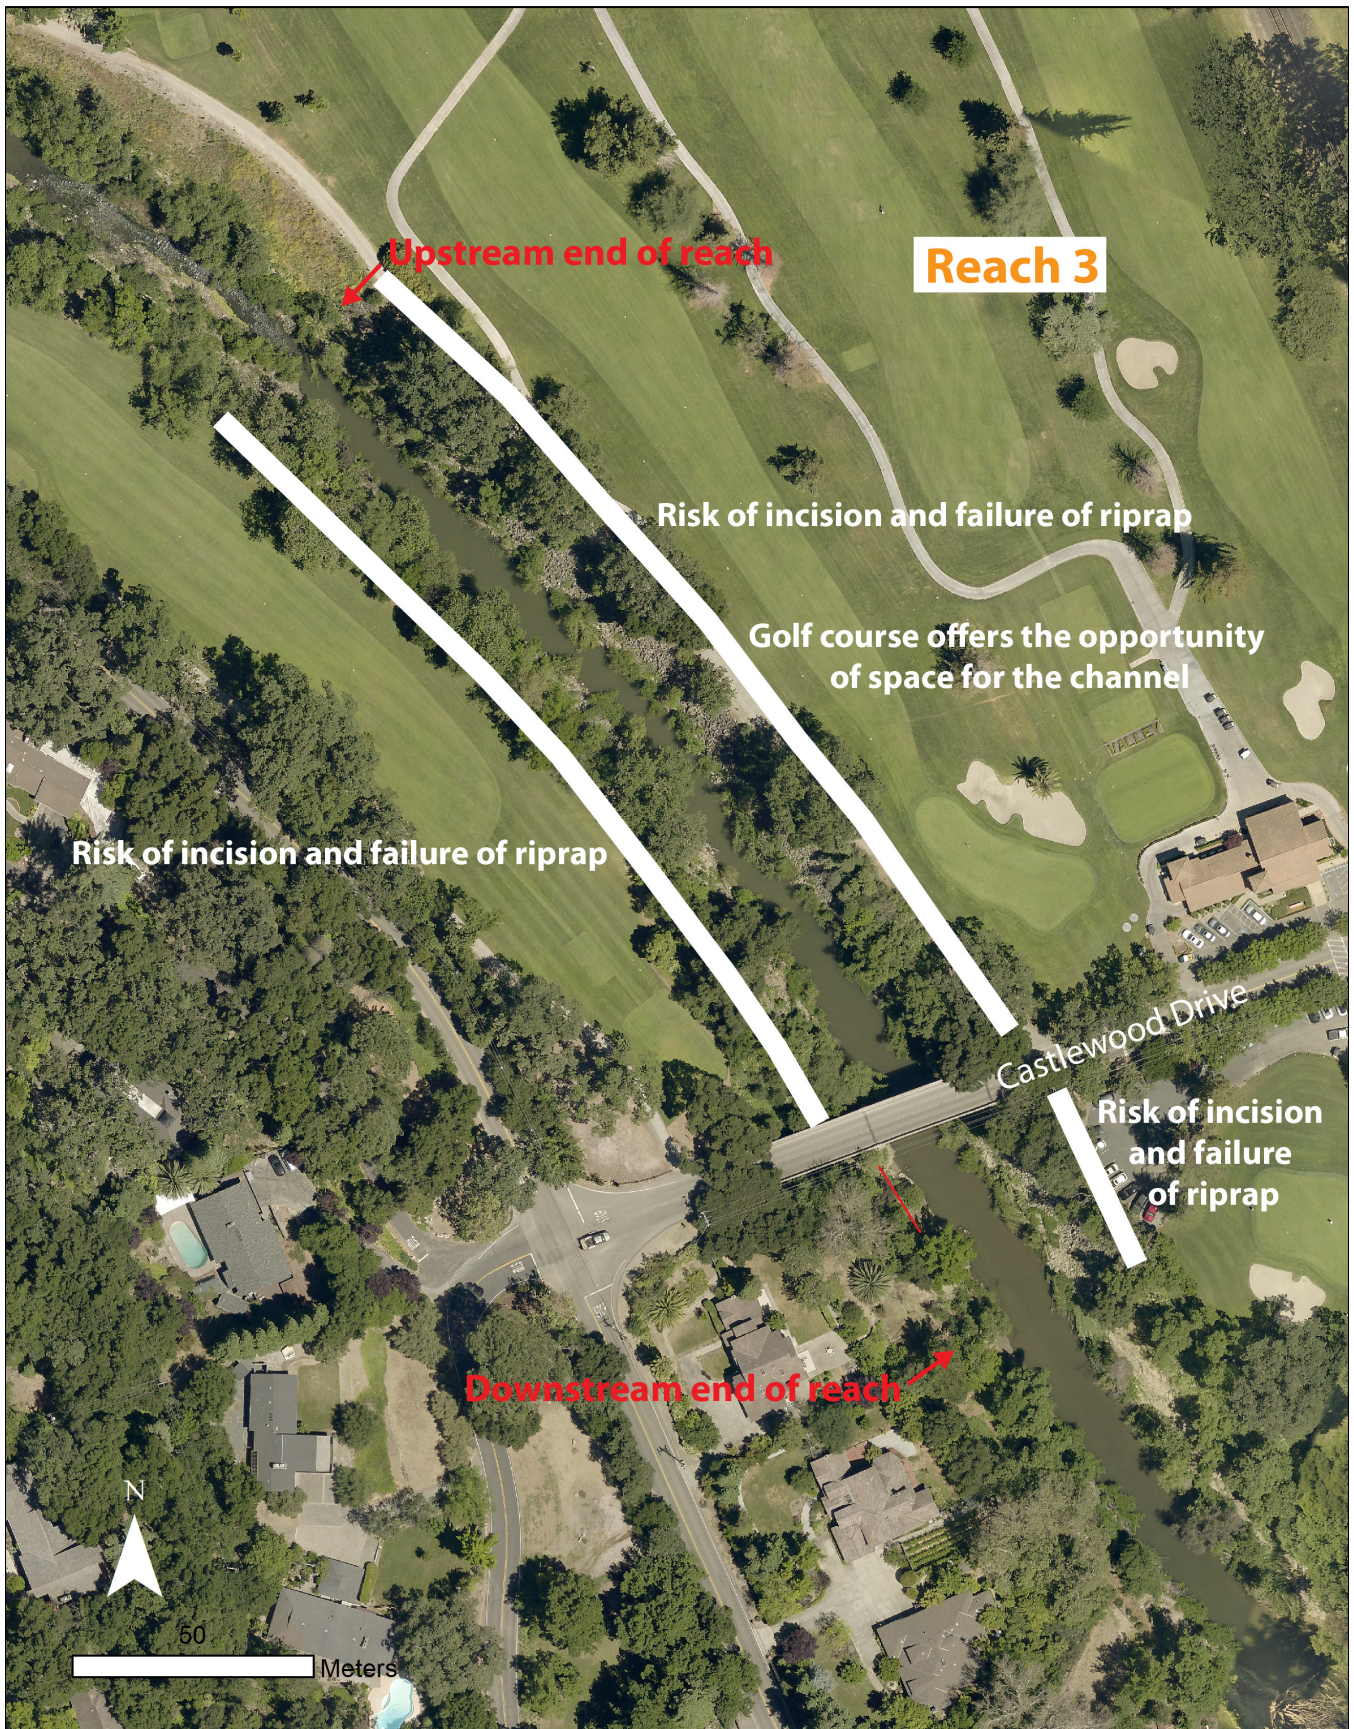
Figure 29. Risks and opportunities for Reach 3.

While the riprap has prevented recent bank erosion, causing the reach to appear relatively stable today, there is risk of incision of the reach due to future headward migration of the knick zone, which could undermine the toe of the banks, leading to rapid failure of the riprap, and increased instability of the channel banks (Figure 29).

However, opportunities for proactive management exist because both banks are currently Country Club property. The reach is currently overgrown with non-native and highly invasive English Ivy (*Hedera helix*); vegetation management efforts could remove this invasive and increase habitat value by replacing with a palette of more structurally complex native plant species. And, if there was support to conduct a large-scale channel and bank restoration project in this reach, the project would occur with a single landowner, and in an area without any permanent structures, removing two common hurdles experienced by many other projects.

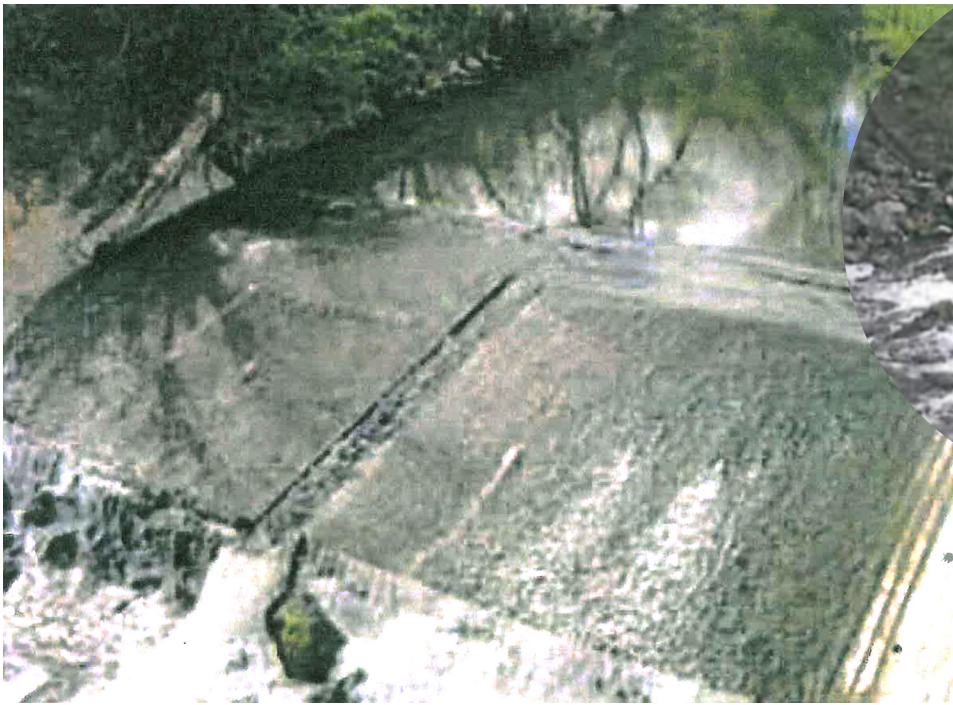
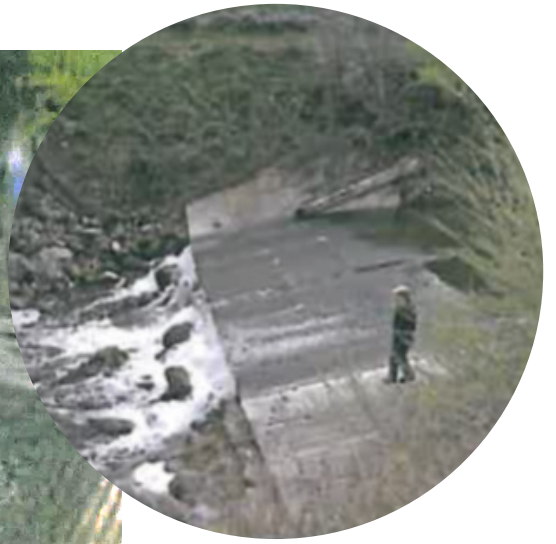
• Figure 31. Two 2007 photos showing the previous condition of the concrete weir before it was undermined and collapsed (courtesy of Zone 7, and Mahacek, 2007).

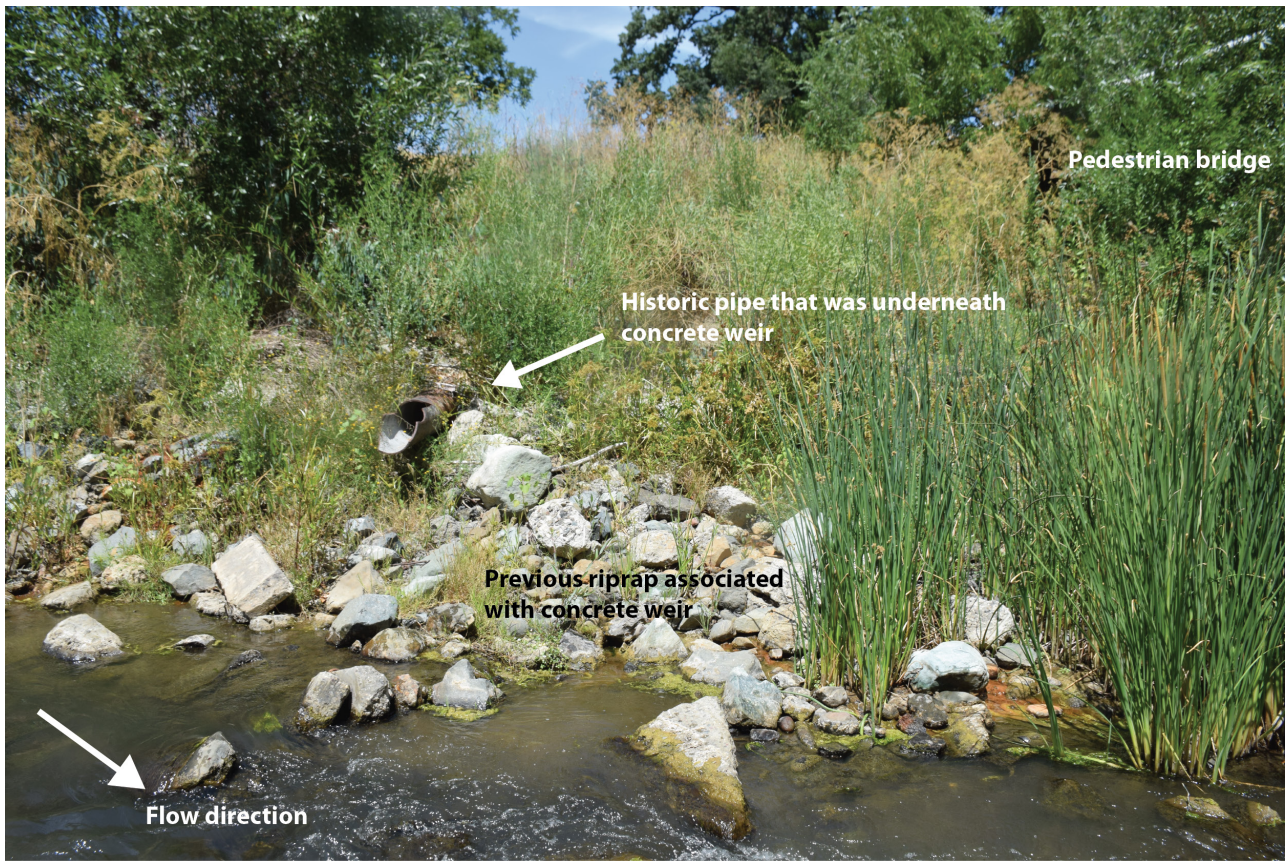
Figure 32. Field photograph of the left bank and an historical pipe that was underneath the concrete weir before it failed and was removed. Pipe is now approximately 1 m above the current bed elevation.

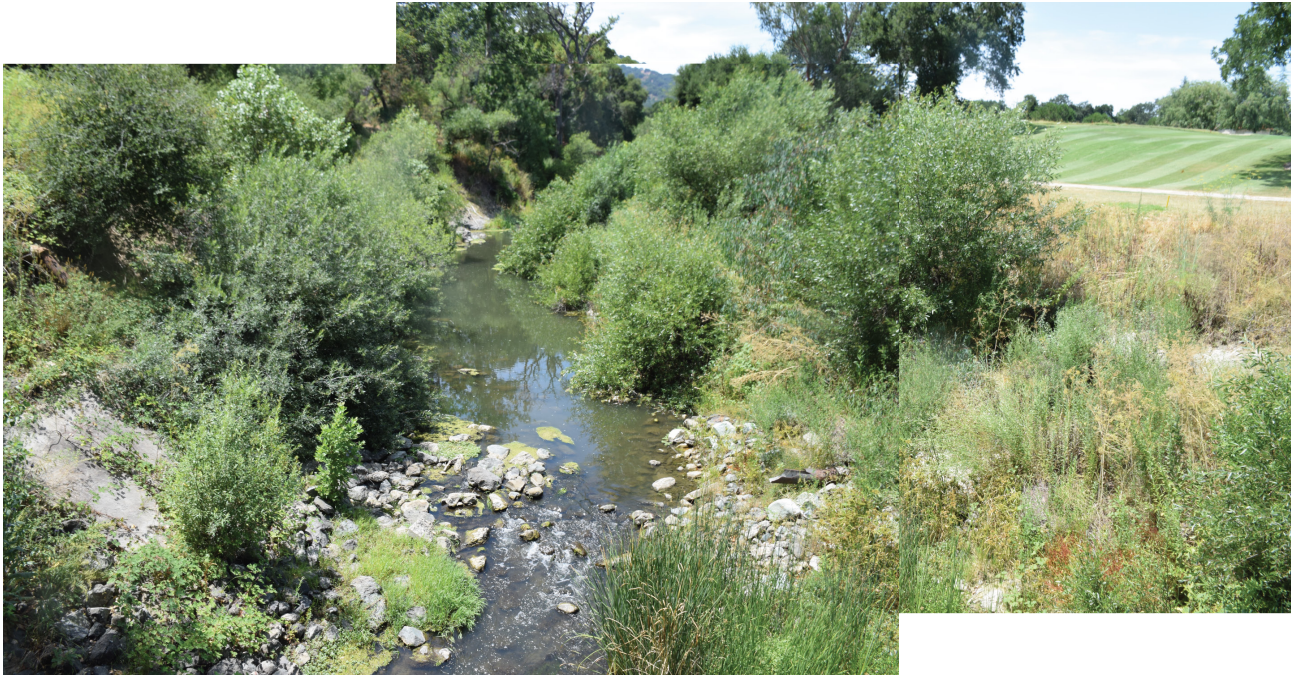
Figure 33. Current view of weir location, looking upstream from the pedestrian bridge.

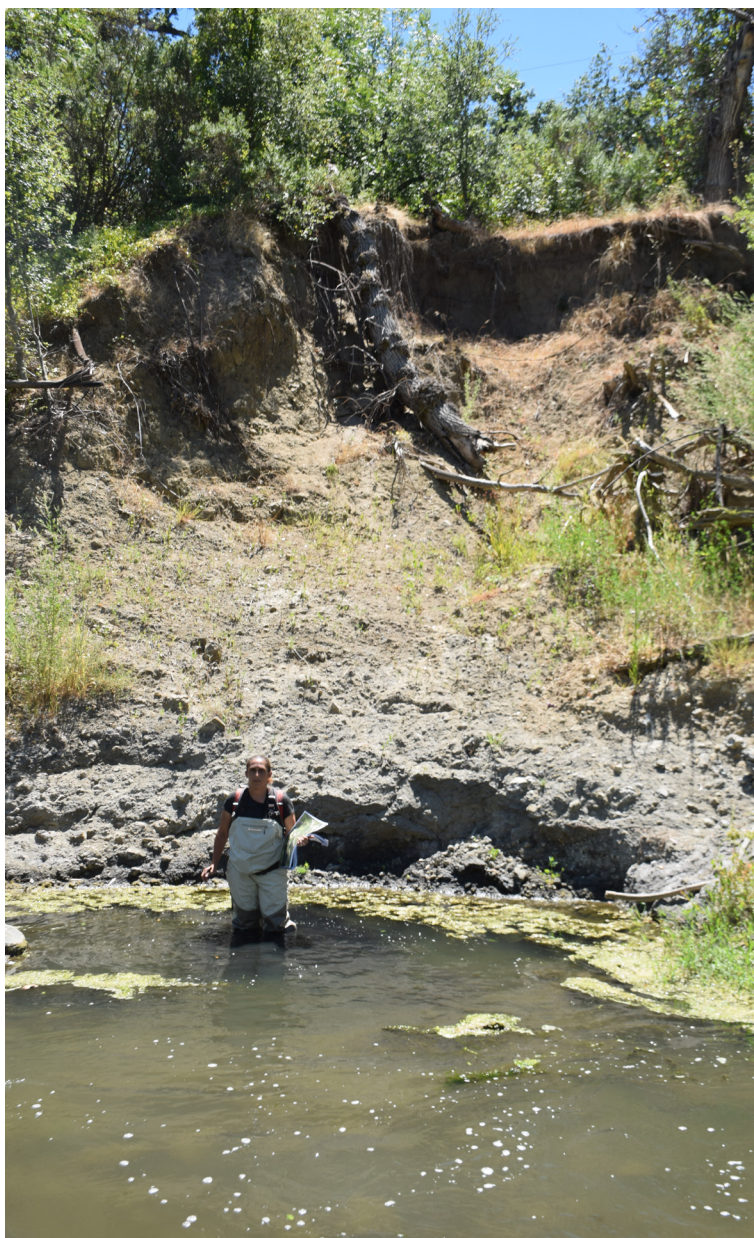
Figure 35. Bank slump location in Reach 4 that is contributing a mix of grain sizes to the channel.

More closely inspect the banks, mapping locations of slump-block style failures of the banks using a combination of LiDAR and field observation to identify potential risks to structures at the top of the banks.

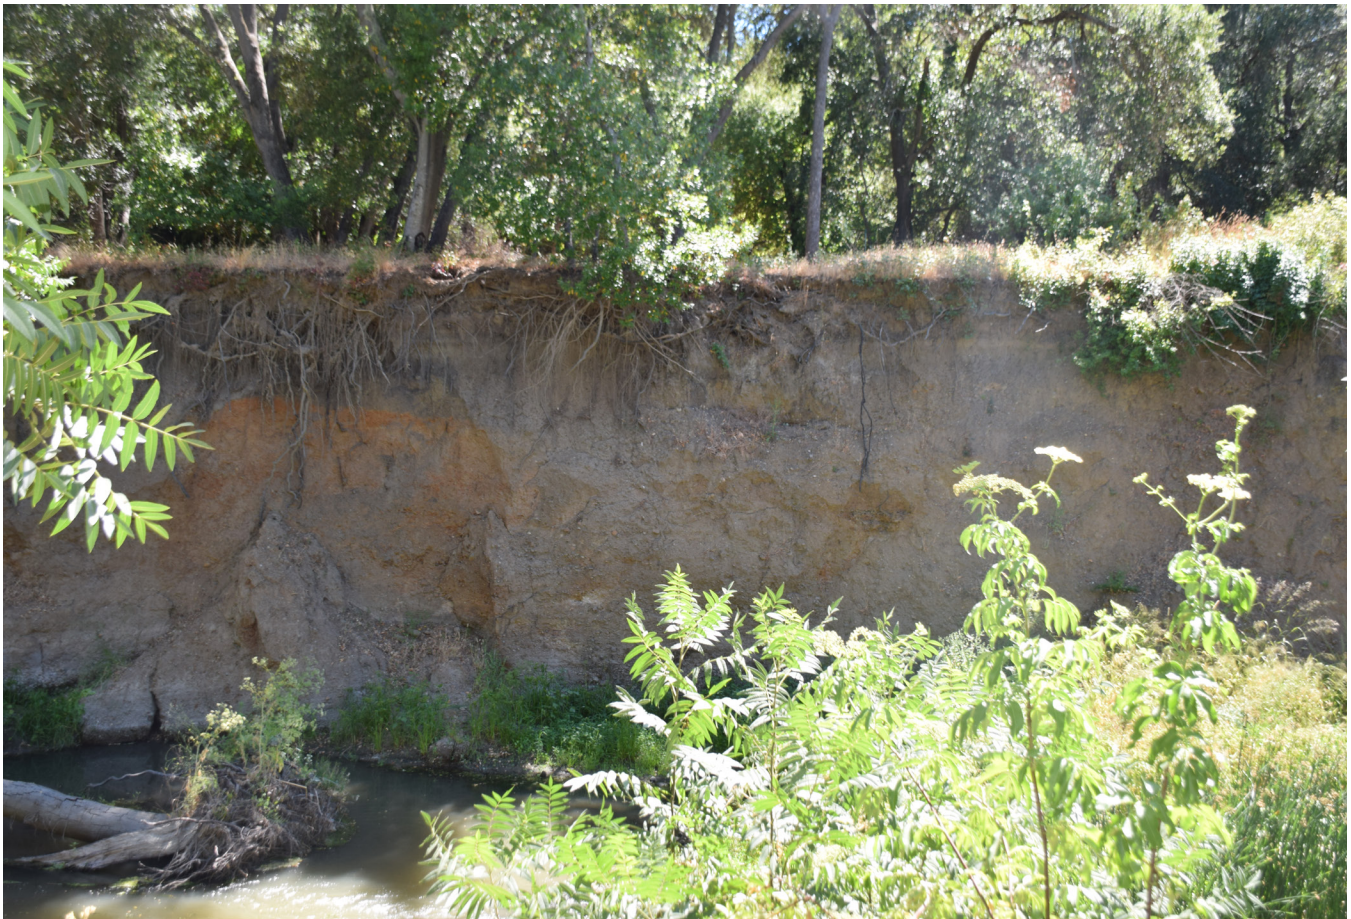
Figure 40. Vertical outer bank and adjacent flat terrace surface (with riparian trees) in Reach 5.

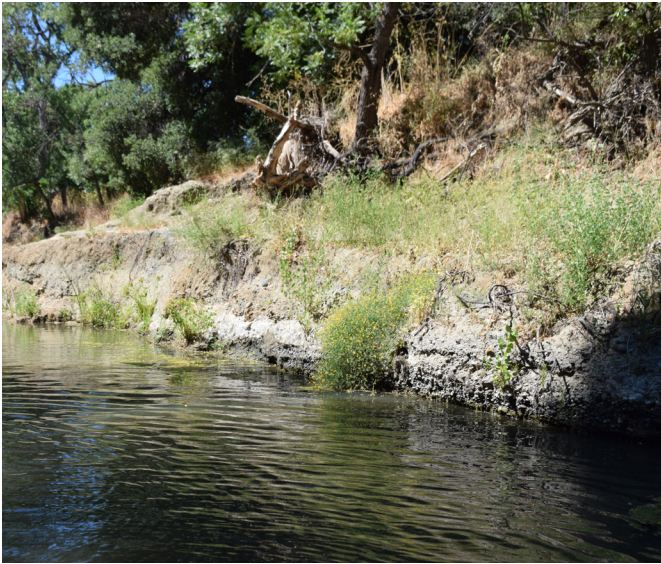
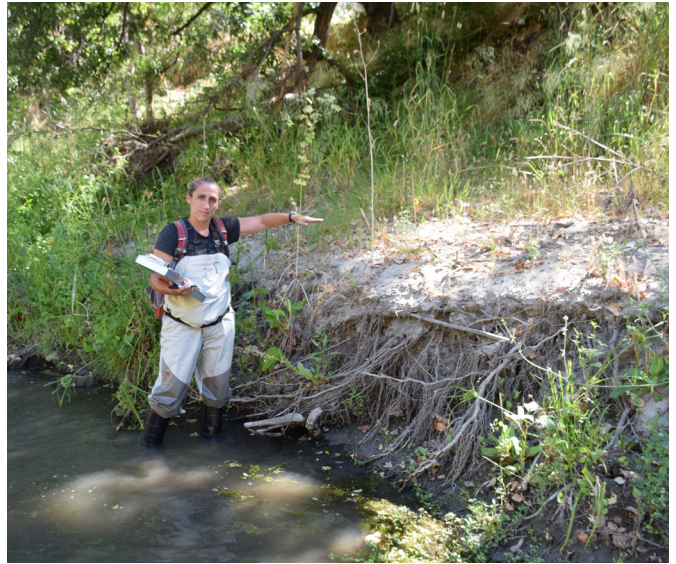
Figure 42. Hardpan exposed above the channel bed.

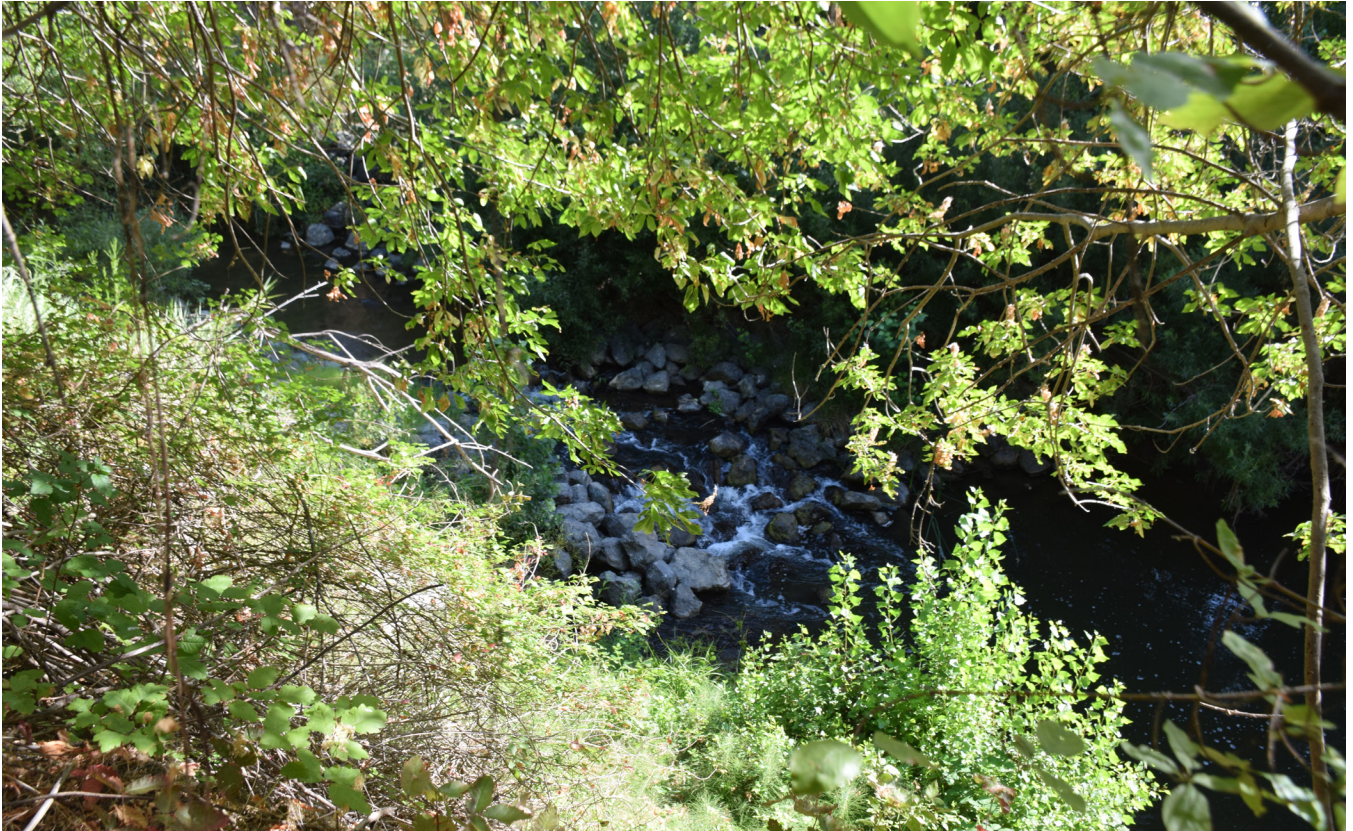
Figure 43. Riprap placed on bed at pump station.
