ARROYO DE LA LAGUNA REACH-BASED GEOMORPHIC EVALUATION

NOVEMBER 2023

PREPARED BY
San Francisco Estuary Institute

IN PARTNERSHIP WITH
Alameda County Flood Control and
Water Conservation District, Zone 7

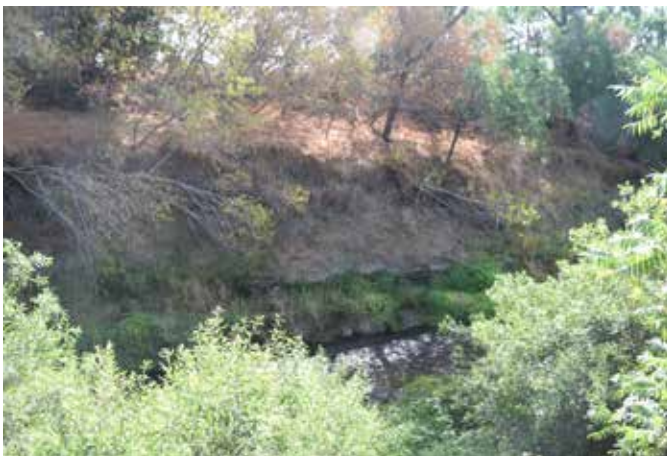
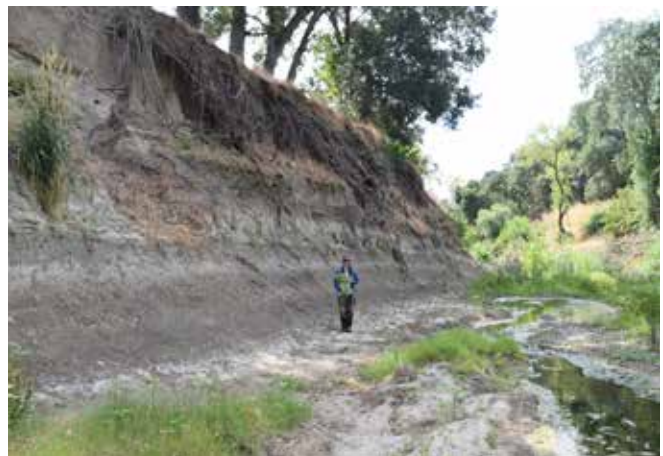
Figure 5. Example reaches with near vertical banks.

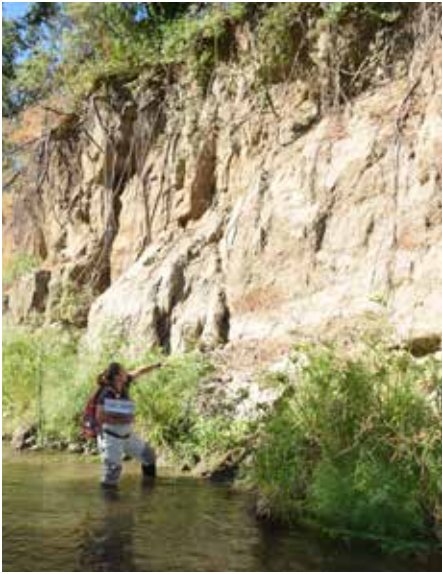
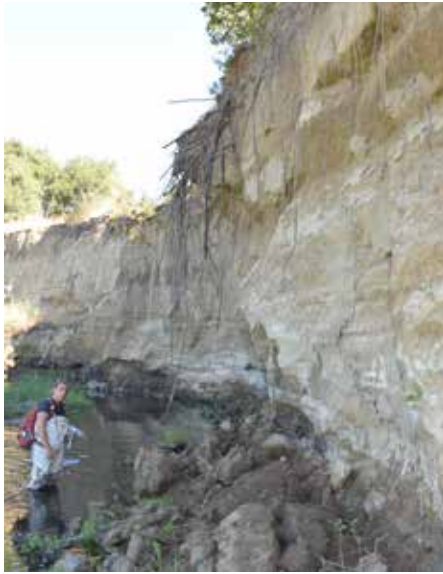
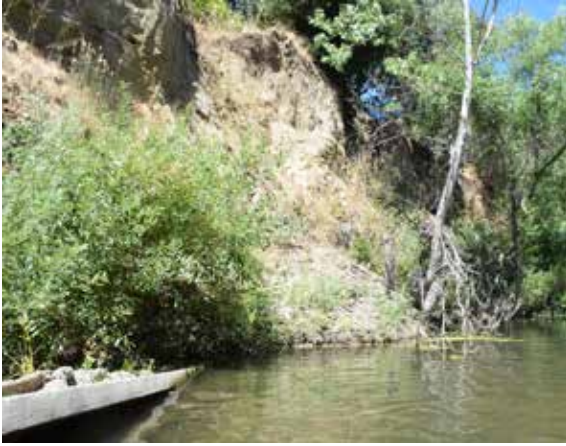
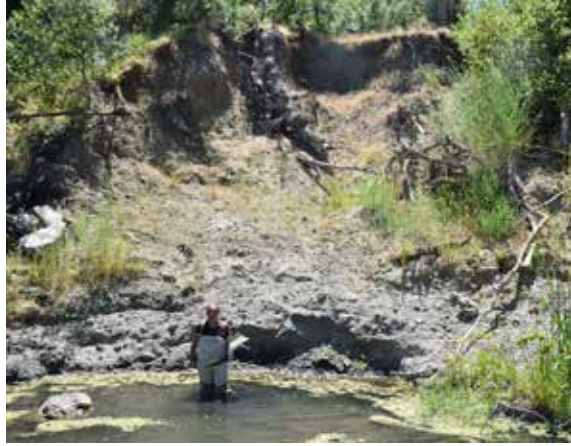
Figure 6. Examples illustrating block style failure; dry ravel style failure; bank slump failure.

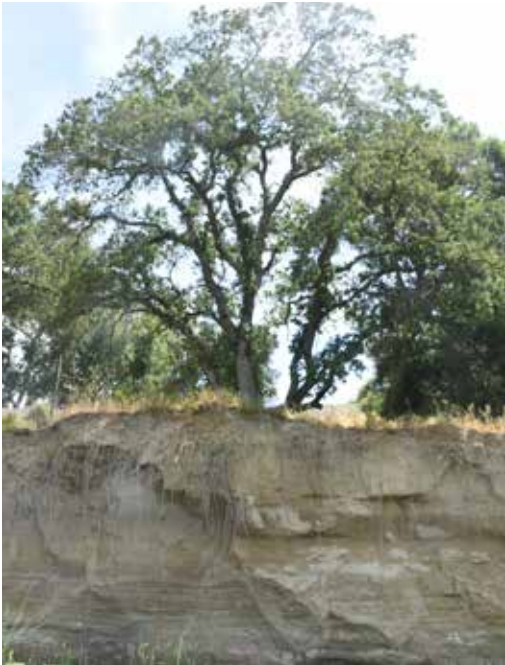
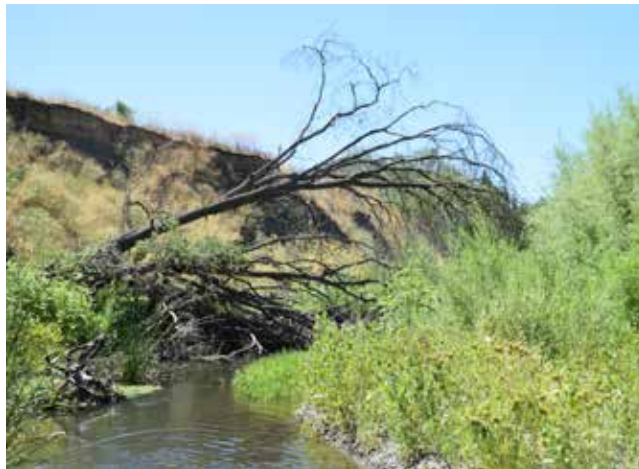
Figure 7. Oak tree in danger with exposed roots and undercut bank; tree recently recruited into channel.

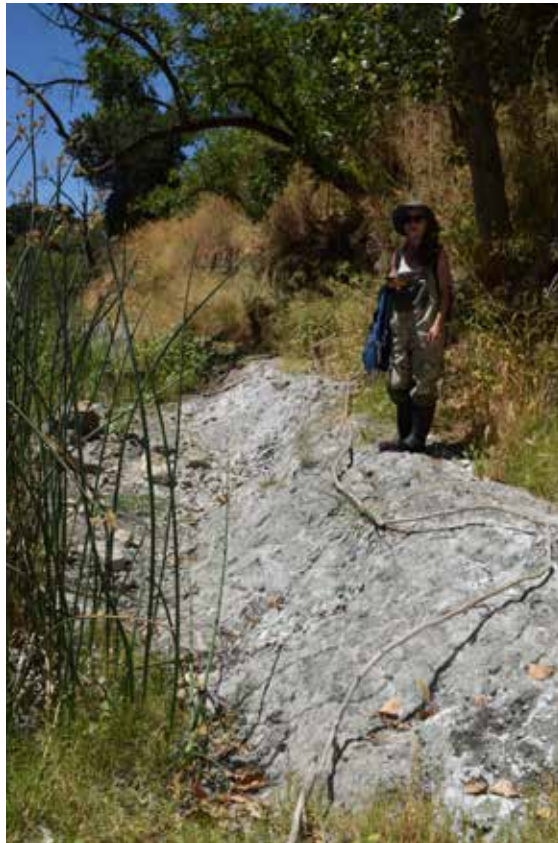
(left) Figure 8.
Exposed hardpan
(Reach 4).

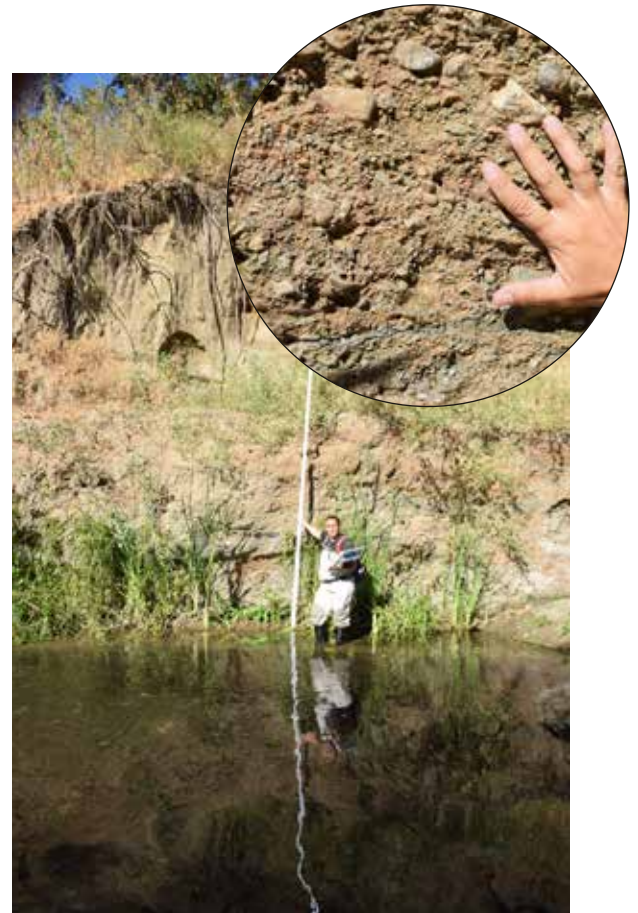
(right) Figure
9. Depositional
feature, likely
the 1950s flood
package, and
detail of the
deposit.

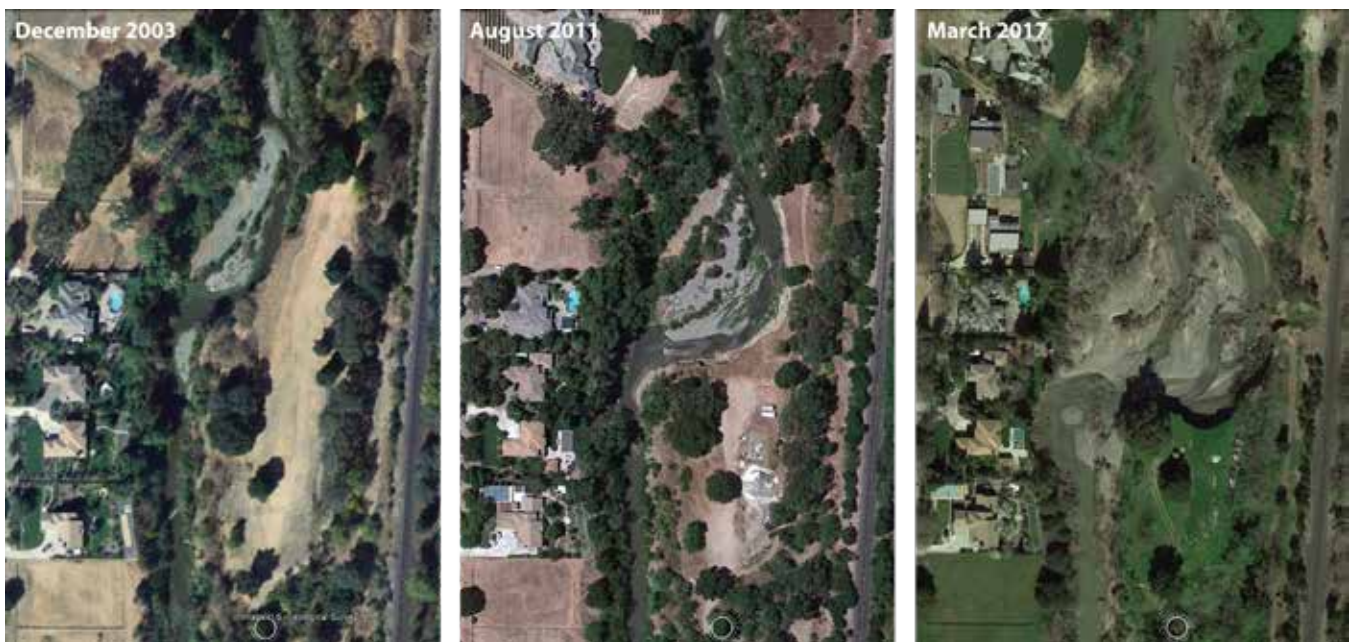
The S-curve meander bends represent nodes of widening and inset floodplain building. As the channel enters these nodes, it changes from single thread to multi-thread, and often becomes coarser, supporting long riffle lengths. These areas of the channel have vertical or near vertical outer banks that fail both as block failures and as dry-ravel failures. The channel meander bend is actively migrating, compressing in a downstream direction. Comparison of a time series of aerial photographs clearly illustrates the changes that have occurred (Figure 12), indicating that the brunt of the erosional pressure has been directed at the downstream outer bend, where a house and a swimming pool are close to the top of bank. Because of Zone's 7's 2017 restoration and bank set-back project at 3 Verona, the downstream portion of the downstream S-curve location has been reconstructed, stabilized by willow and other riparian plantings, and has been holding sediment at the toe of the slope providing some protection. Because it is likely not economical to lay back the banks in locations with high-value real estate near to the stream, measures that focus upon providing stability at the toe of slopes (e.g. protection from scour during high flows, and protection from constant wetting/drying) should be considered. The outer banks are generally 7-9m high (with some locations 12 m high), so that when they fail, a significant amount of sediment is delivered directly into the channel. Field surveys by Zone 7 have been estimated that approximately 27,000 yds³ of sediment has been contributed from bank retreat at two properties in the downstream S-curve alone between 2005 and 2010. In addition, failures

Figure 12. Time series of aerial photographs illustrating the migration of the channel meander at the downstream S-curve.

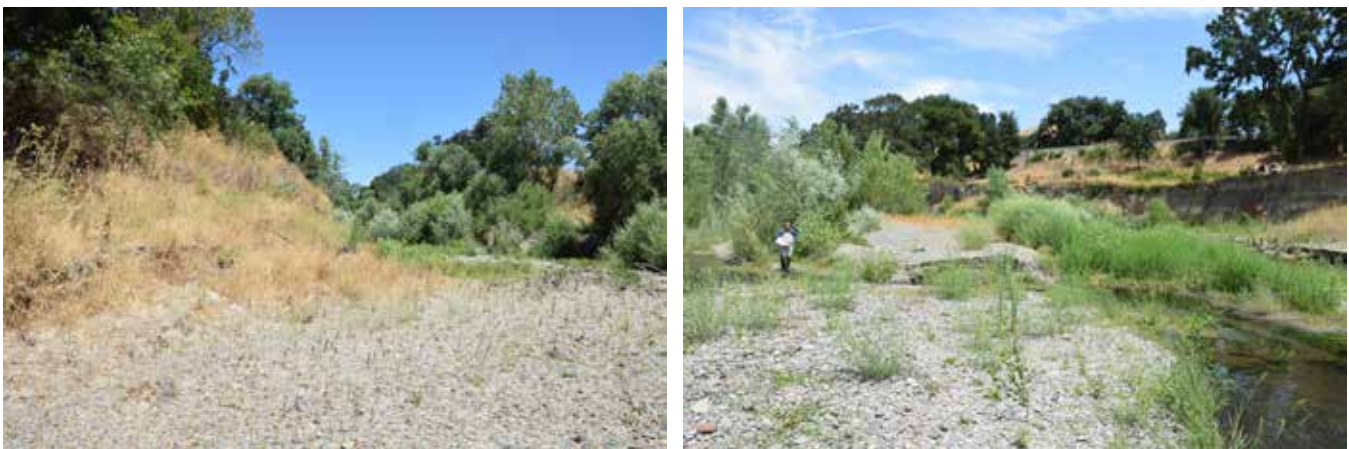
Figure 13. Examples illustrating active inset floodplain building.

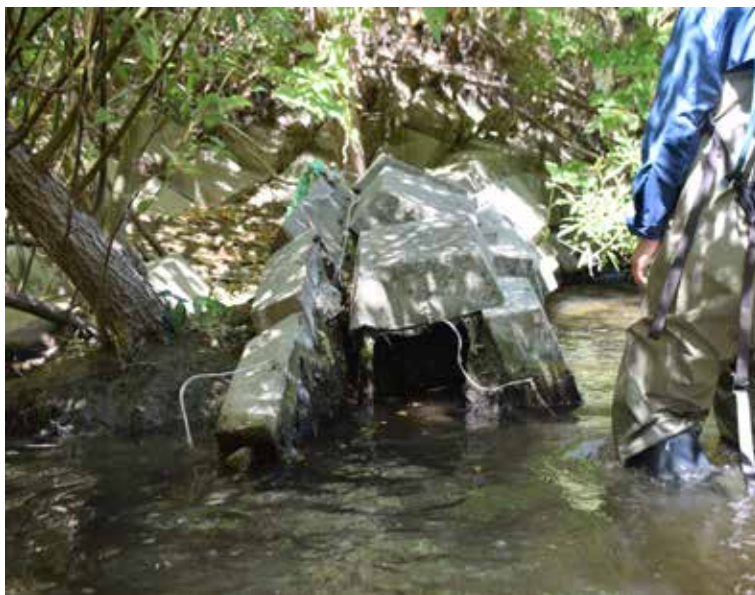
The relatively straight reaches adjacent to the two S-curve nodes have tall vertical banks that are actively failing, and threatening many properties. A number of land owners in this reach have placed riprap, articulated concrete mats, or filter fabric to help stabilize the toe of the slope, with varying success (Figure 15). Limited indicators of downcutting were observed underneath the concrete mats. These straight reaches have a more shallow gradient than the adjacent S-curve reaches, and have a well defined pool-riffle sequence, with many low bar deposits. In addition, discontinuous remnant 1950s flood deposits are observed, which are coarse packages of fluvial material forming a surface approximately 2-4 m above the current channel bed. In places, a wider floodplain surface is developing, which is fairly ecologically complex, with a number of swales and young woody vegetation (e.g. cottonwoods and willows).

Figure 15. Failing articulated concrete mat.

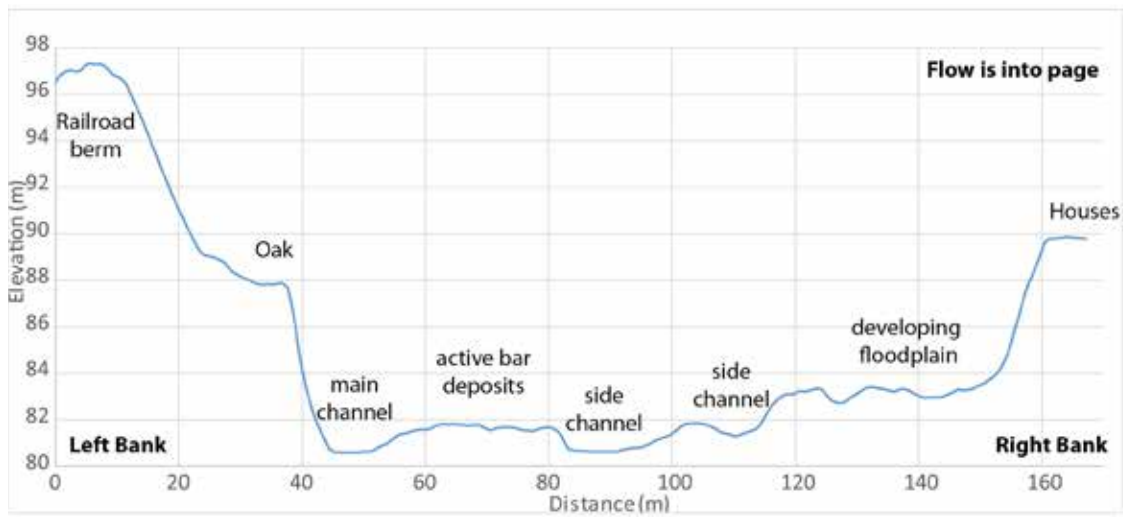
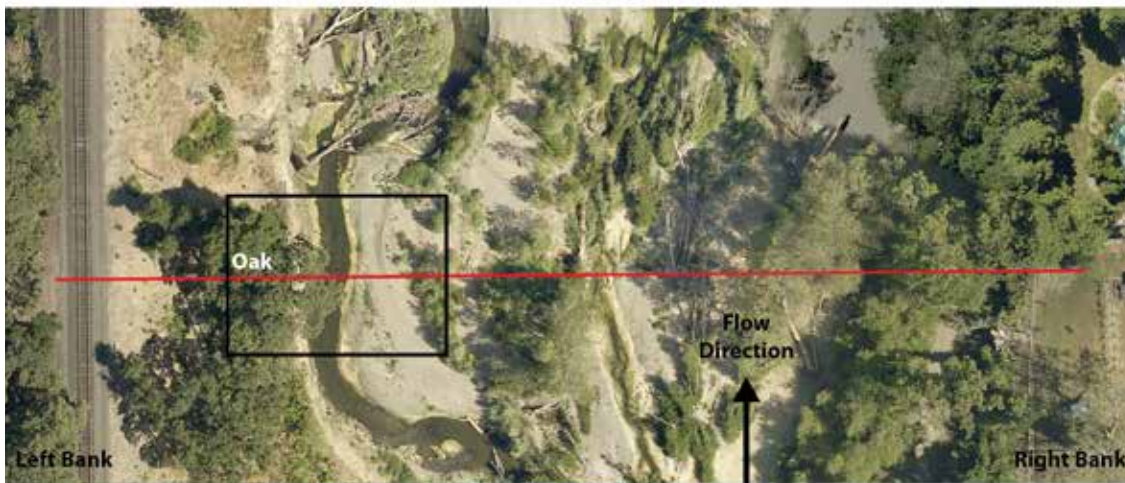
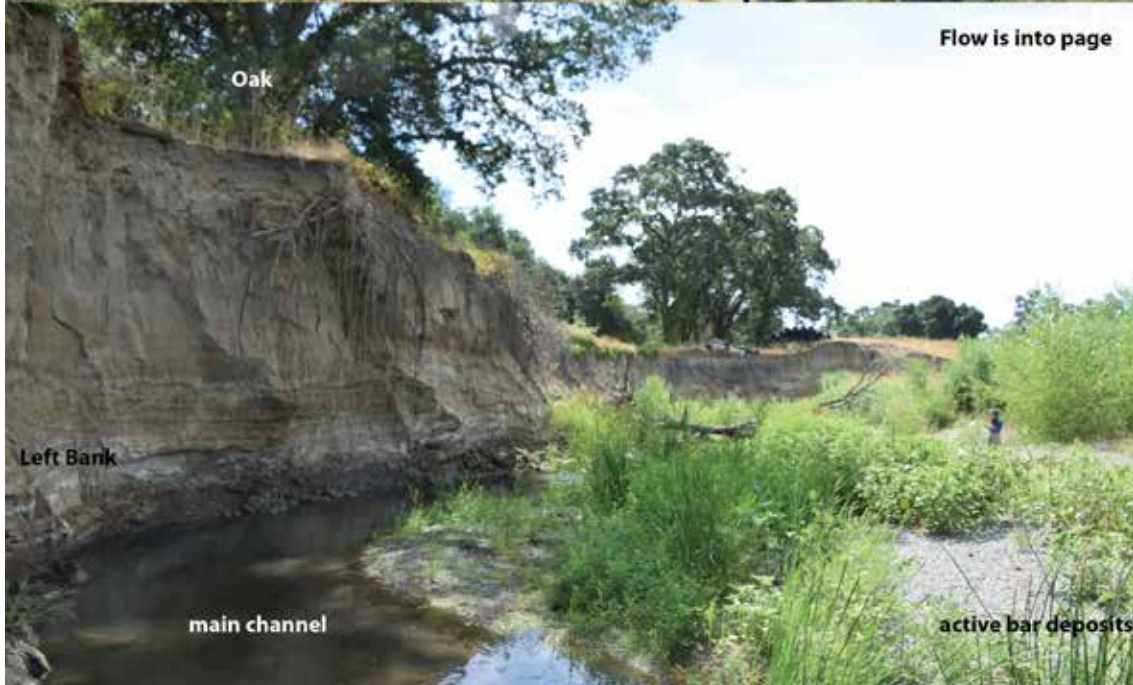
Two representative channel cross sections show the S-curve meander bend and the relatively straight reach morphology. Figure 17 illustrates an S-curve meander bend, with tall vertical banks with blocks of failed material at the toe, a main channel, and multiple other smaller channels. The developing bars and floodplains are visible at distinct elevations relating to various recurrence intervals of flows. Figure 18 illustrates a representative straight reach morphology between S-curves.

Figure 17. Representative channel cross section at an S-curve meander bend, looking downstream. The red line on the aerial photo indicates the location of the cross section. The black rectangle shows the area shown in the field photograph (looking downstream).

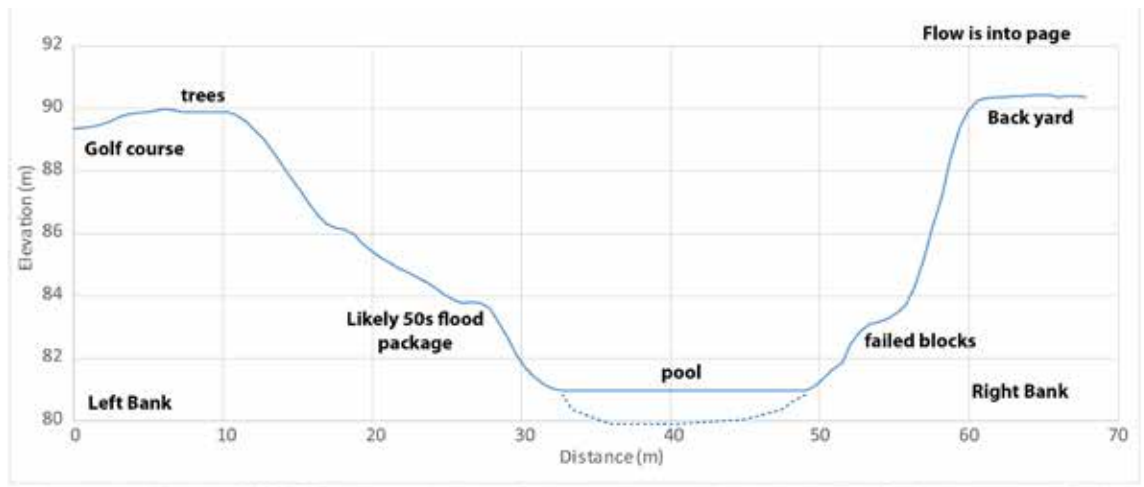
Figure 18. Representative channel cross section for the relatively straight reaches between S-curve locations (looking downstream). Solid line shows elevations directly from LiDAR, while the dashed line shows approximate elevations from field observation. The black rectangle shows the area shown in the field photograph (looking downstream).

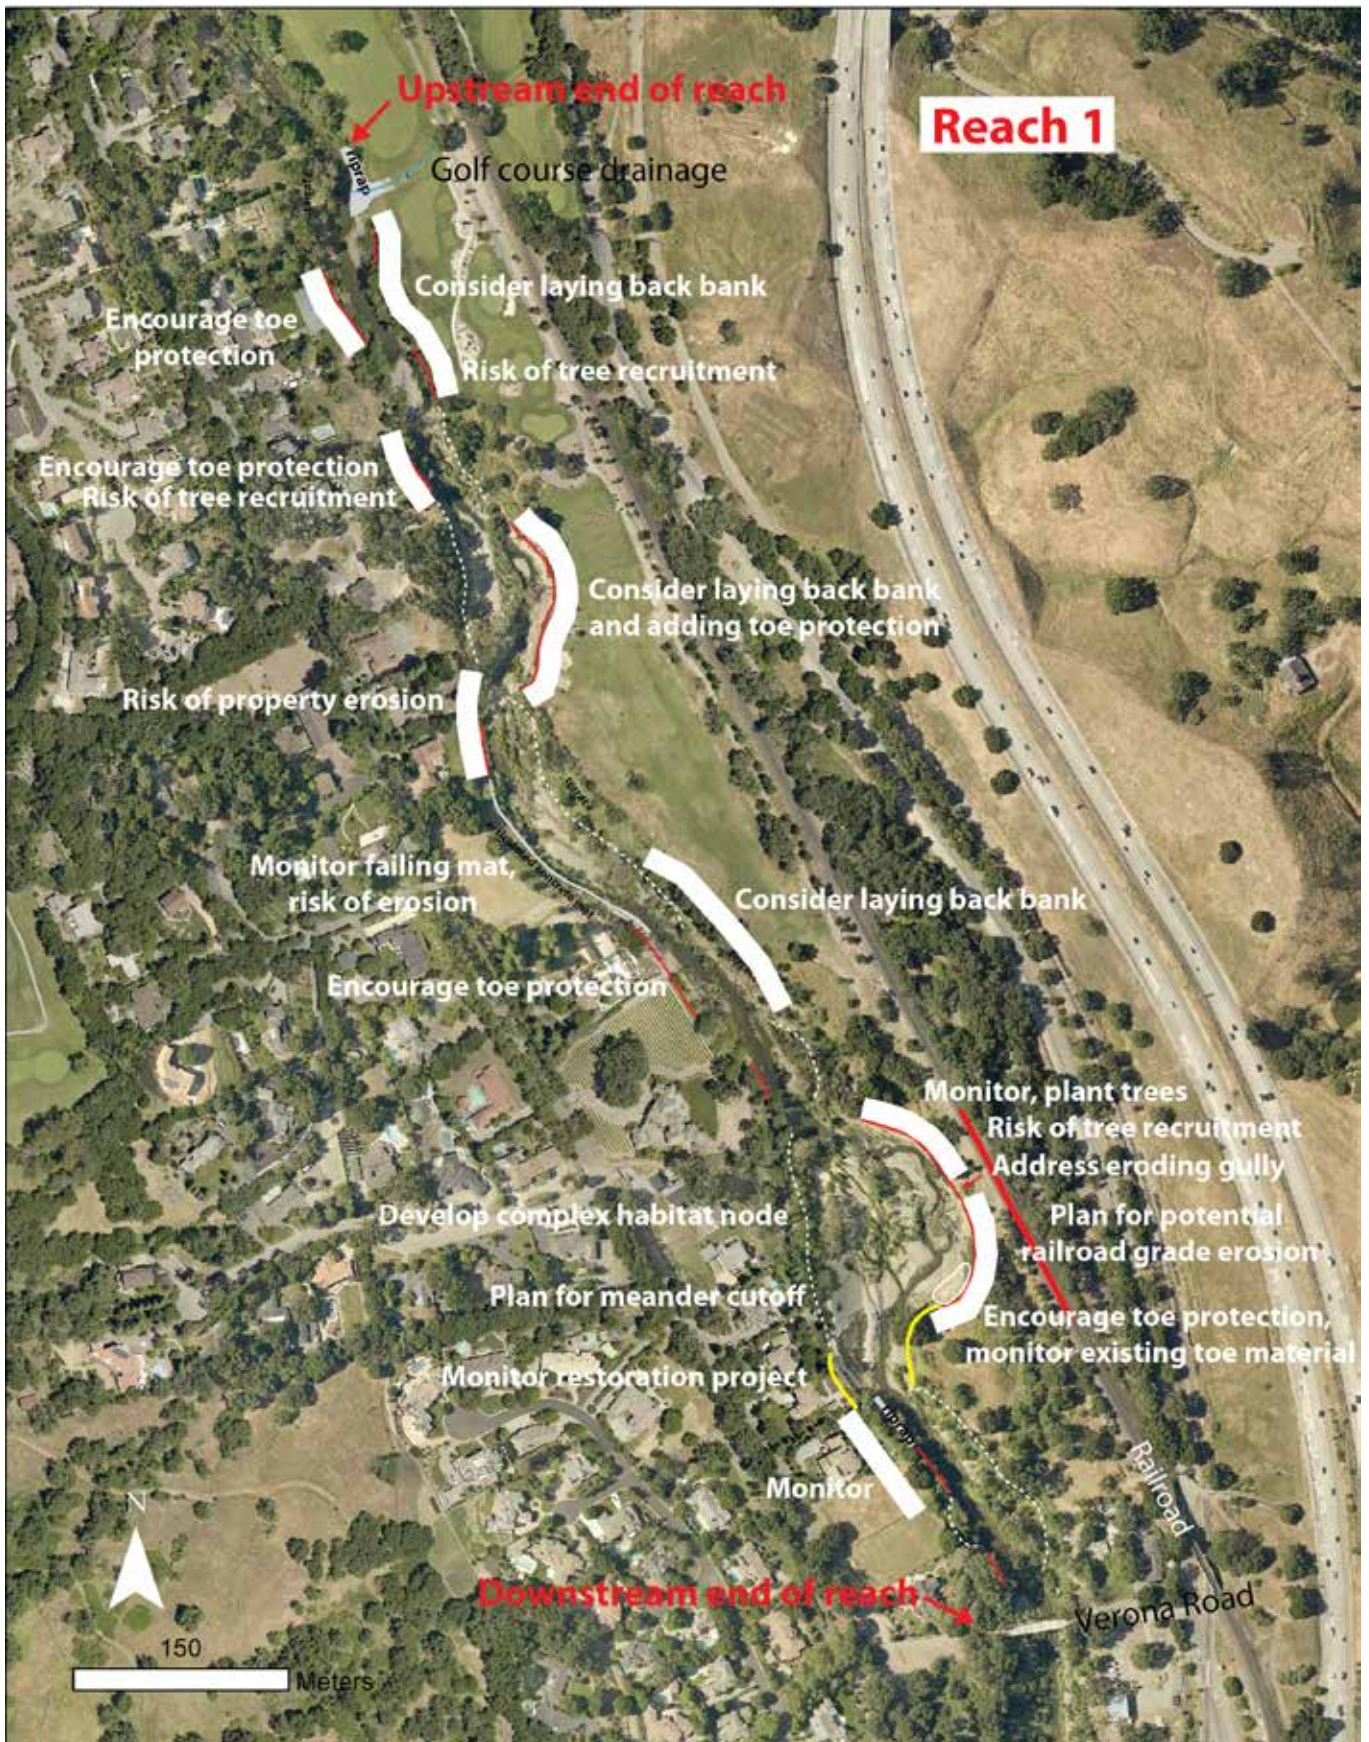
Figure 20. Risks and opportunities within Reach 1. Existing conditions created by the 3 Verona bank reconstruction project are highlighted by the yellow lines.

To summarize our findings by reach, we identified notable risks, opportunities, and potential management actions applicable to this reach in the near term (Figure 20). Risks include: the continued failure of outer banks that may ultimately damage property or structures, increased recruitment of large riparian trees into the channel as widening and deepening continue, the continued faster-paced migration of the downstream S-curve and slower-paced migration of the upstream S-curve, eventual undermining of the railroad trestle at the downstream S-curve, the potential reworking (e.g., channel migration, bank erosion, sediment deposition) of existing restoration/stabilization projects, and the potential headward migration of the steeper gradient associated with the two S-curves. And at a larger scale, continued development of the upstream urban areas without a focus upon the timing and volume of runoff produced will likely increase the volume of water delivered to ADLL during storms, thus increasing the stream power and the likelihood that the channel will continue to erode and incise.

However, this reach holds opportunities especially given the potential for large-scale restoration projects that are able to slow/halt the erosion of the outer banks and protect the adjacent properties. We recommend focusing on the opportunity presented by the left bank being composed primarily of Zone 7 and Castlewood Country Club property, and under-utilized open space to work with the expected future evolution. In particular, providing the channel additional width at the S-curve locations could lead to the development of a large, functioning node(s) of floodplain, and the creation of complex habitat areas, critical for ecological function and improved wildlife habitat. Specific locations where small drainages are routed into the channel can be addressed so that they do not exacerbate local bank erosion. And finally, the 3 Verona project should be monitored, with lessons learned applied to other areas in this reach.

Because of these risks, we recommend many actions for this reach. Locations where the channel might be widened proactively should be identified. Locations where the toe of slope has deposited material can be focused upon to stabilize that material and reduce the future erosional stress on the toe. Tree planting can focus on the top of banks, behind the current trees that are in danger of being recruited, allowing for some shading and root strength when/if the existing trees are recruited. We recommend addressing key data gaps in order to anticipate locations of future bank failures, and create an “anticipatory management plan” (Beagle et al., 2016) that focuses upon the threat to the railroad so that bank failures can be planned for over the long term.

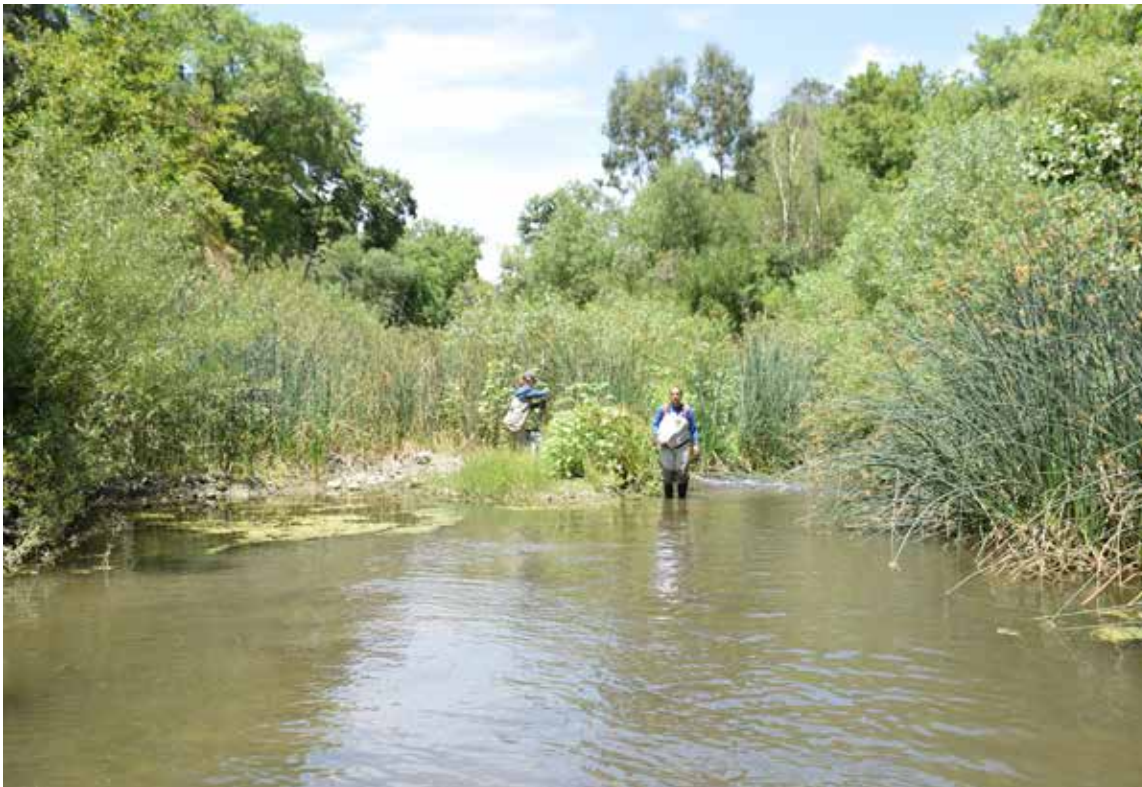
Figure 22. Photograph looking upstream at the downstream end of the steep riffle, and surrounding willow trees on the bar surfaces.

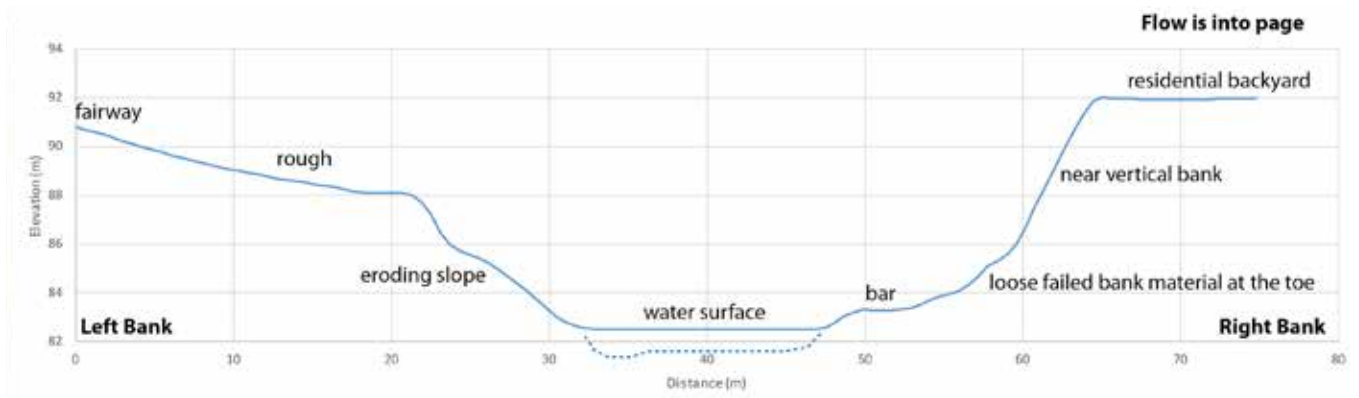
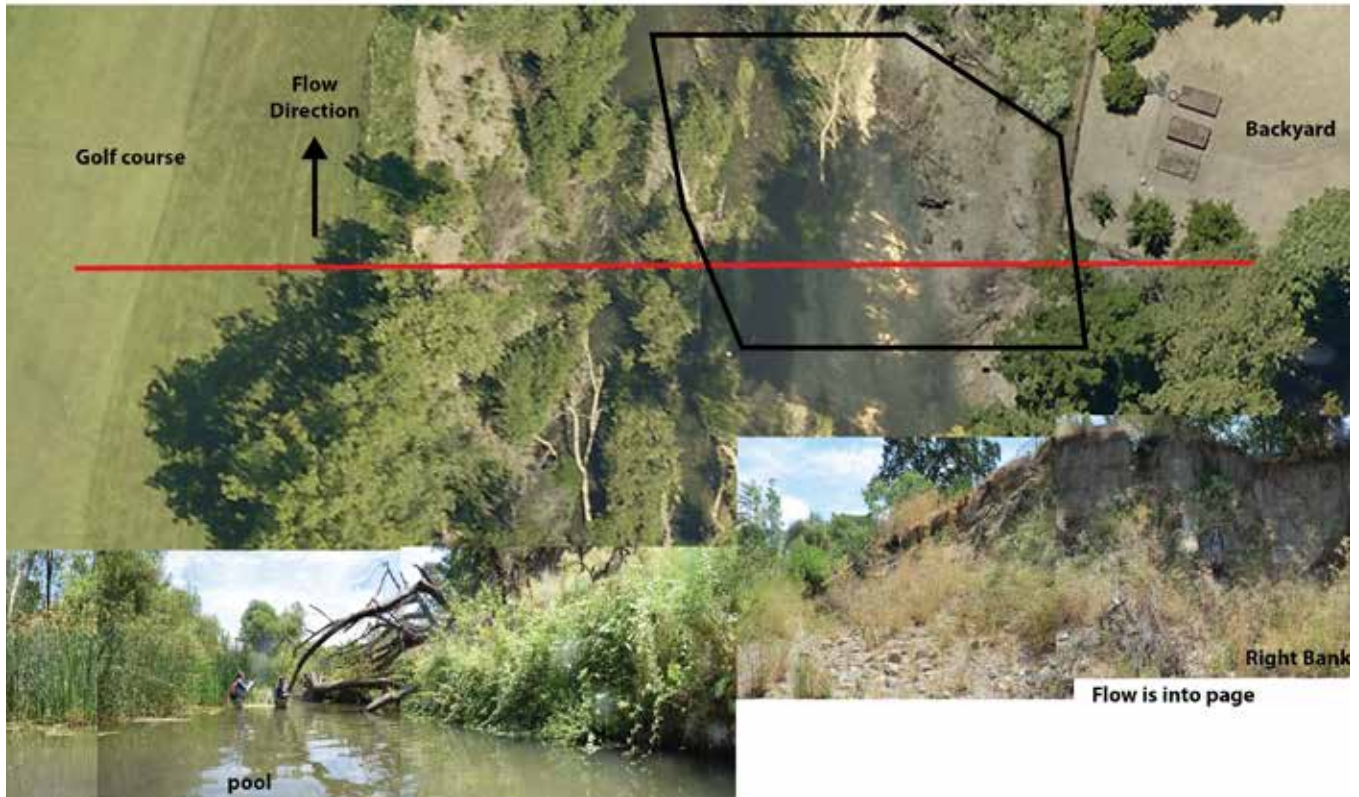
The representative cross section for this reach shows the near vertical outer bank on the right bank side, with the at-risk residential property at the top (Figure 23). It also shows the loose failed bank material piled up at the toe of the slope, and the low bar that has deposited (Figure 24). The left bank shows the slope that is failing more as a rotational-style failure, and the lower terrace surface that now has the fairway rough of the golf course. Unfortunately the detail of the channel (mid-channel bars) do not come across in the LiDAR data.

(above) Figure 23. Channel cross section cut from the LiDAR data and annotated with field notes, and the matching field photograph. Solid line shows elevations directly from LiDAR, while the dashed line shows approximate elevations from field observation. The black polygon shows the area shown in the field photograph (looking downstream).

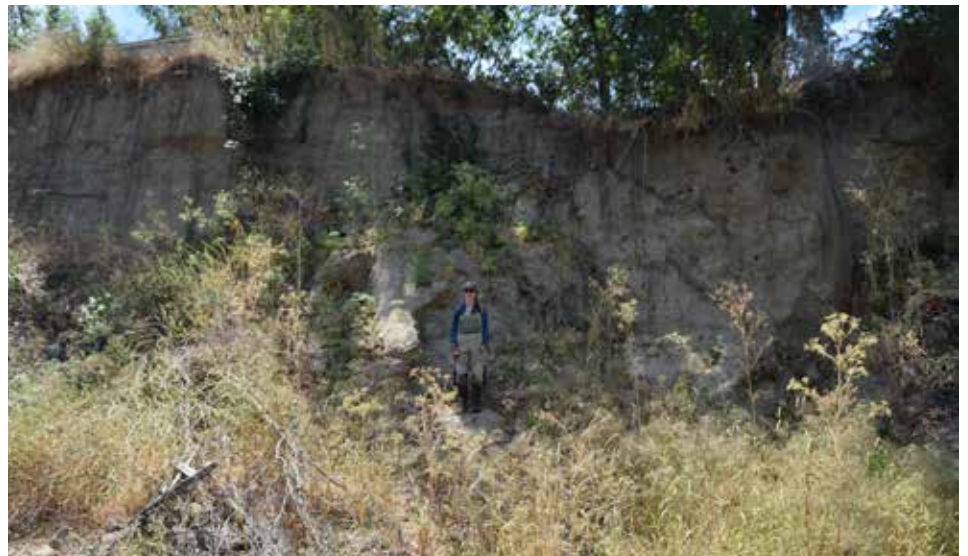
(right) Figure 24. Right bank at cross section showing near vertical bank and failed material at the base.

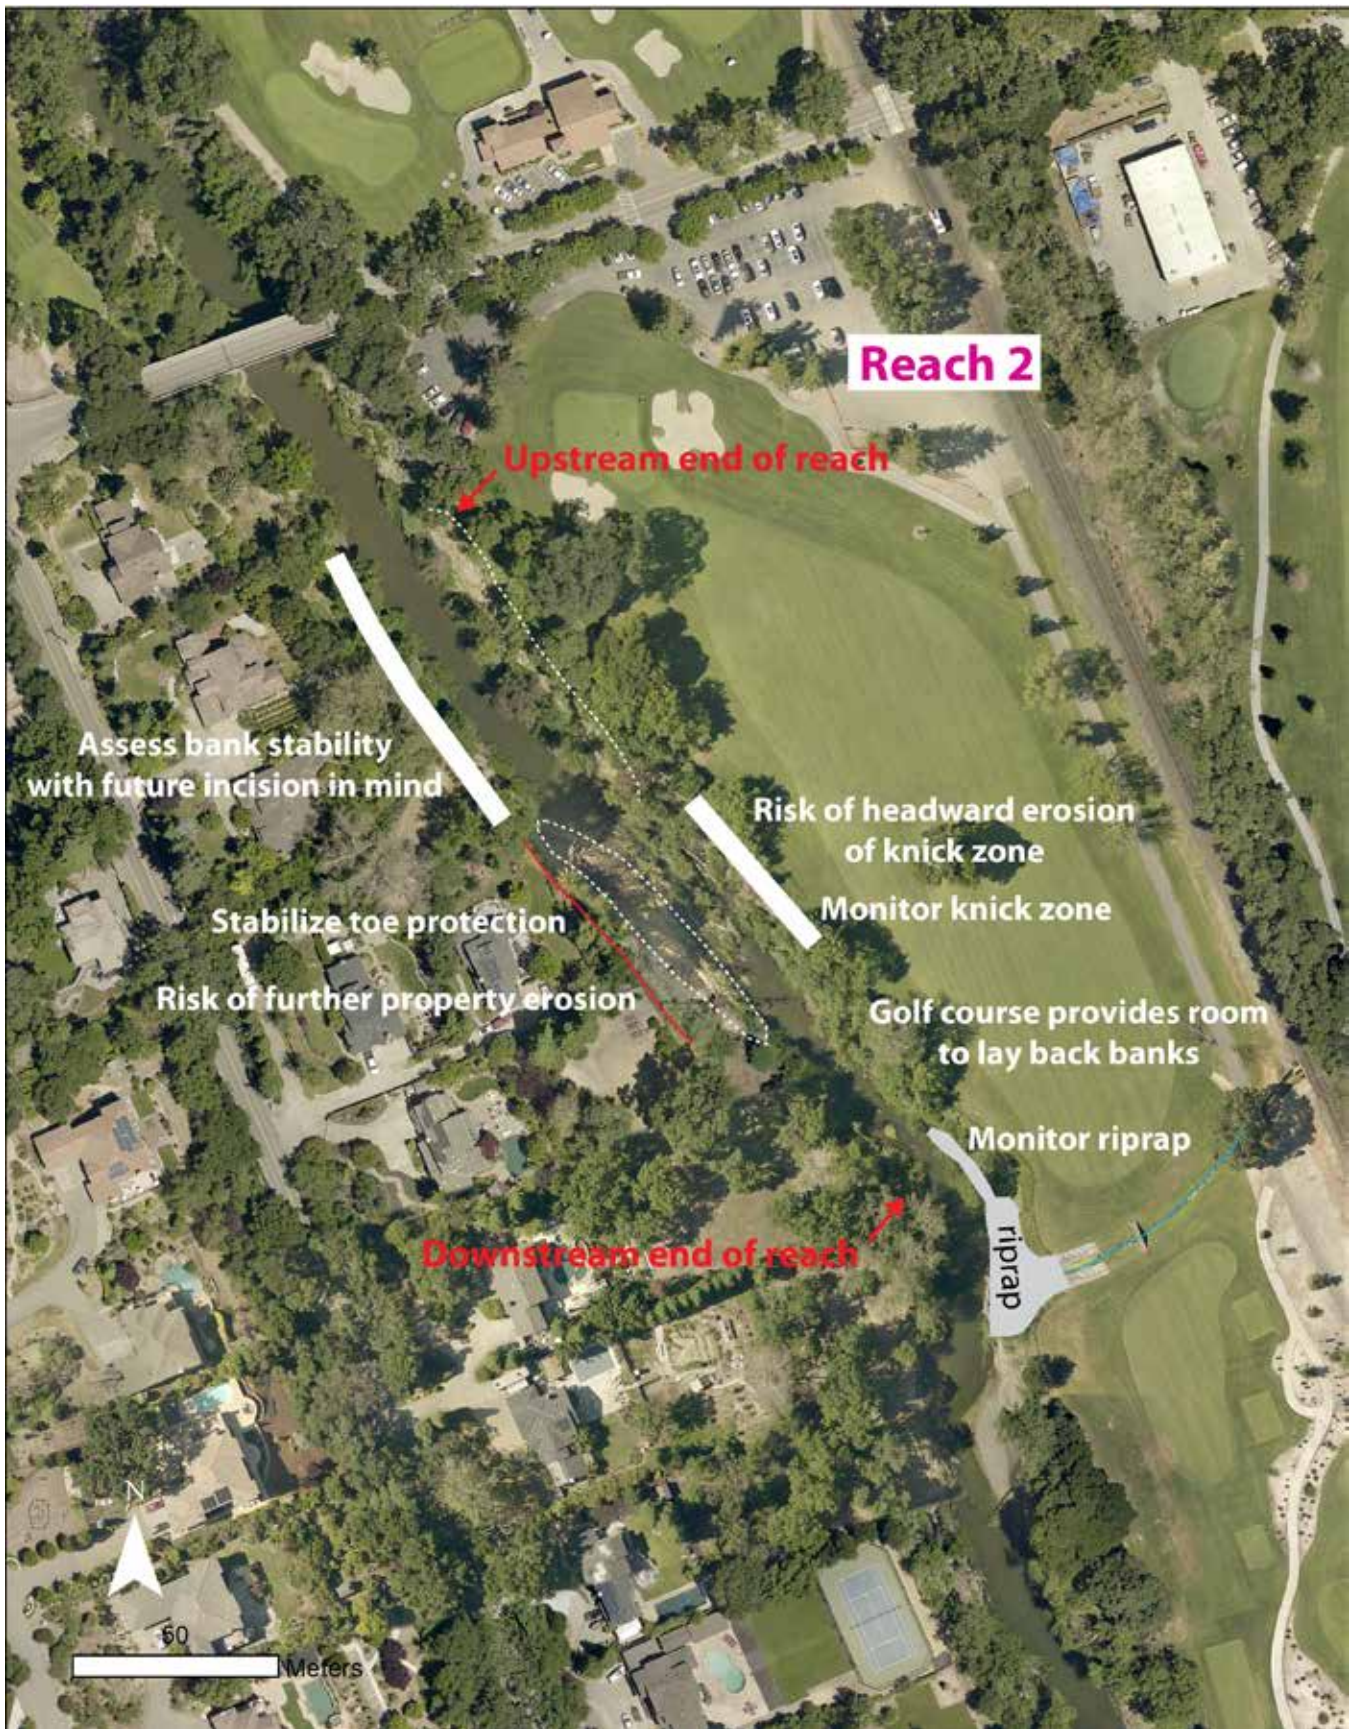
Figure 26. Risks and opportunities within Reach 2.

In this reach, the right bank is nearly vertical and failing via dry-ravel failure, and continued or increasing bank failure actively threatens residential backyard property and out-buildings (Figure 26). An aerial photograph analysis reveals 1 primary residence within 80 ft (2.5x the bank height) of the top of bank in this reach. A refined understanding of bank erosion rates will help inform risk management scenarios, however, the channel will likely deepen and widen after the knickpoint moves through, which will further destabilizing the banks, increase rates of bank erosion, and lead to loss of property.

However, because the left bank is golf course property, there are opportunities for proactive management. On the left bank, there is approximately 20 m of space between the top of bank and the fairway. This reach (and upstream of this reach) could be a location where the bank is laid back, with minimal impacts to golf course function, thus widening the channel width. The golf course is currently planning to proactively set back a 150m length segment of the left bank, with placement at the toe of the right bank. The project is being done in collaboration with Zone 7 during the Summer of 2019. This will hopefully be a pilot that could be repeated as needed, and should be designed with potential future incision in mind. The right bank currently has developed a bar from failed material at the toe of the bank. Additional measures to stabilize these features will provide continued protection for the outer bank. Knowledge of the potential incision will allow for appropriate monitoring to occur, potentially identifying the issue and allowing for proactive management including bank setbacks, and anticipating the need to move non-essential structures away from the top of bank.

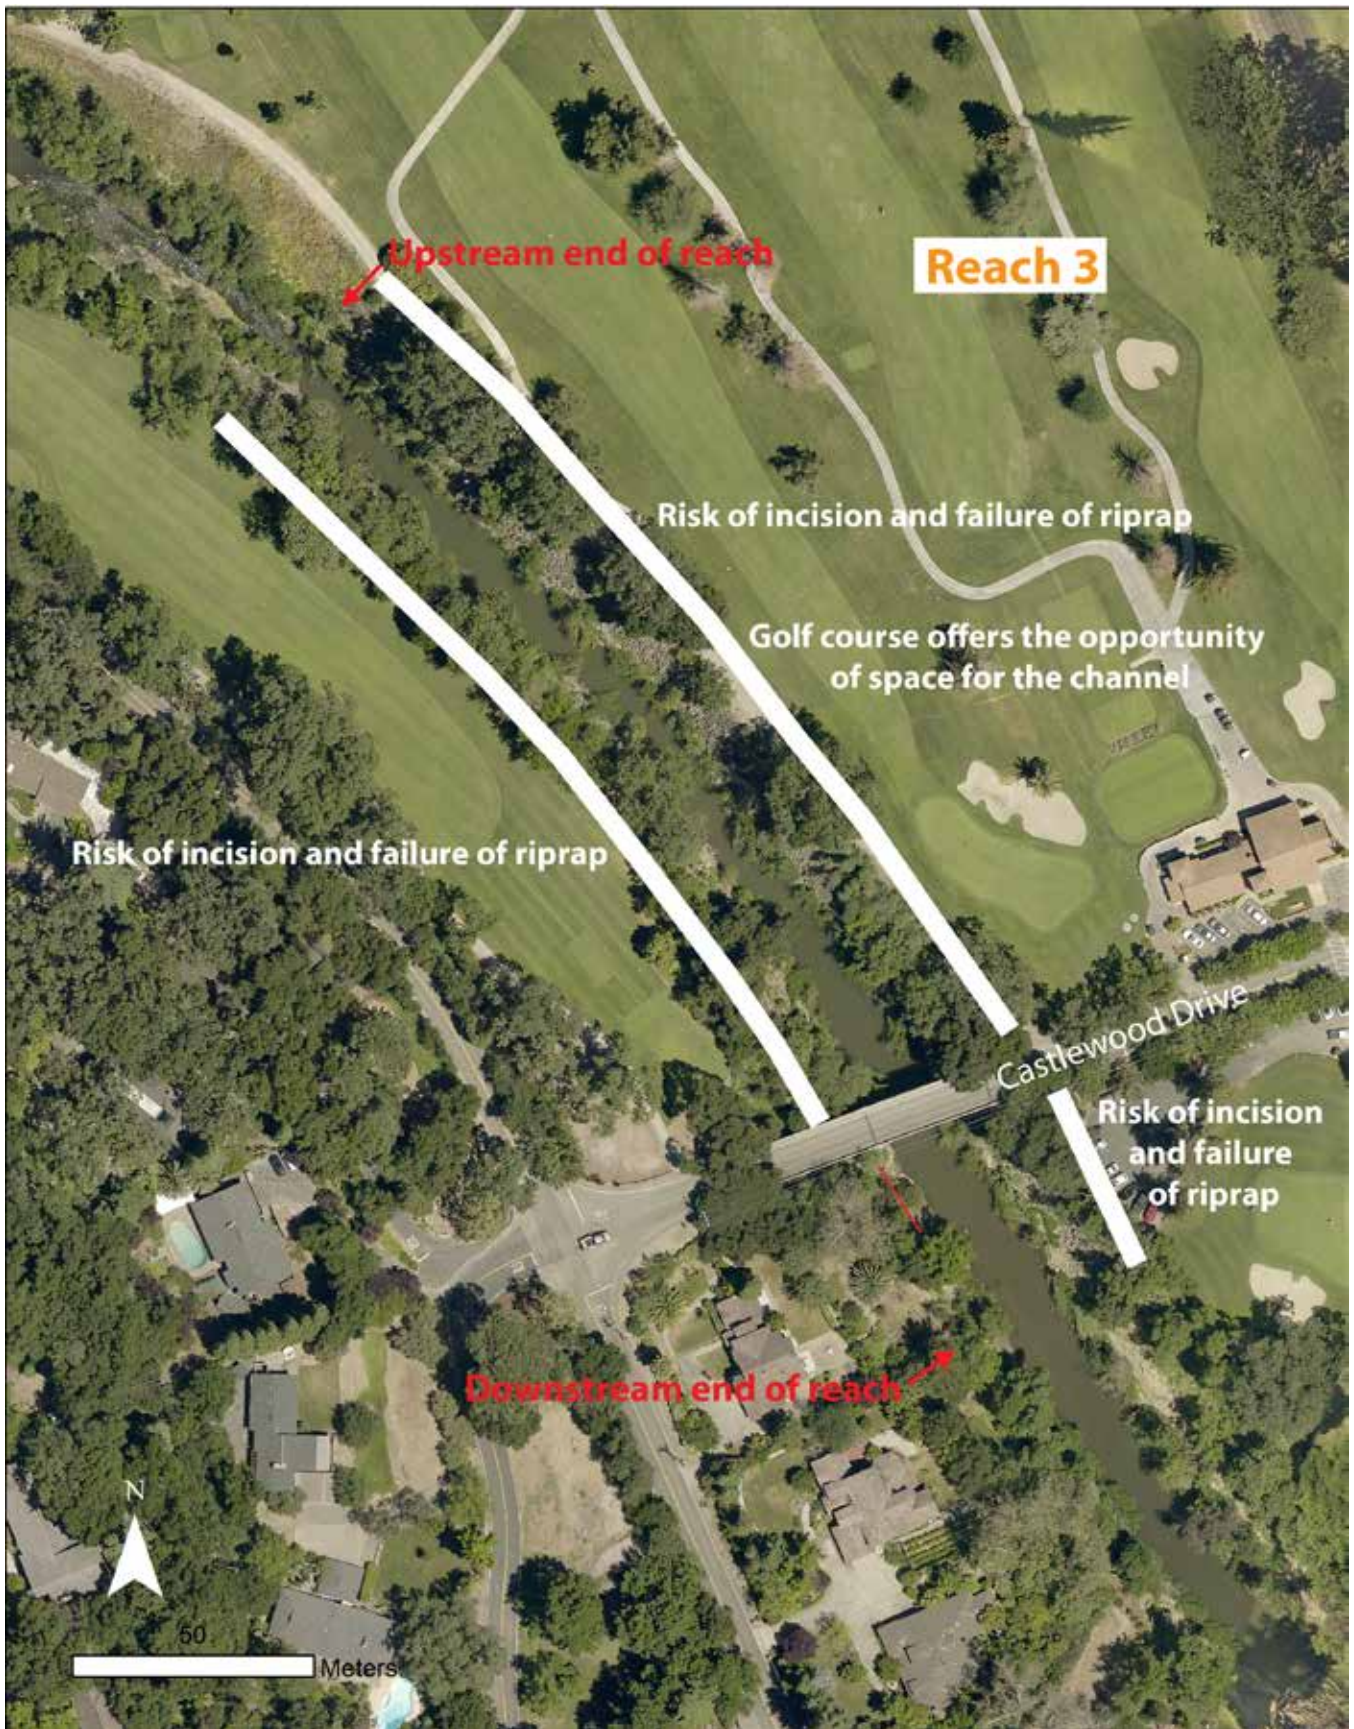
Figure 29. Risks and opportunities for Reach 3.

While the riprap has prevented recent bank erosion, causing the reach to appear relatively stable today, there is risk of incision of the reach due to future headward migration of the knick zone, which could undermine the toe of the banks, leading to rapid failure of the riprap, and increased instability of the channel banks (Figure 29).

However, opportunities for proactive management exist because both banks are currently Country Club property. The reach is currently overgrown with non-native and highly invasive English Ivy (*Hedera helix*); vegetation management efforts could remove this invasive and increase habitat value by replacing with a palette of more structurally complex native plant species. And, if there was support to conduct a large-scale channel and bank restoration project in this reach, the project would occur with a single landowner, and in an area without any permanent structures, removing two common hurdles experienced by many other projects.

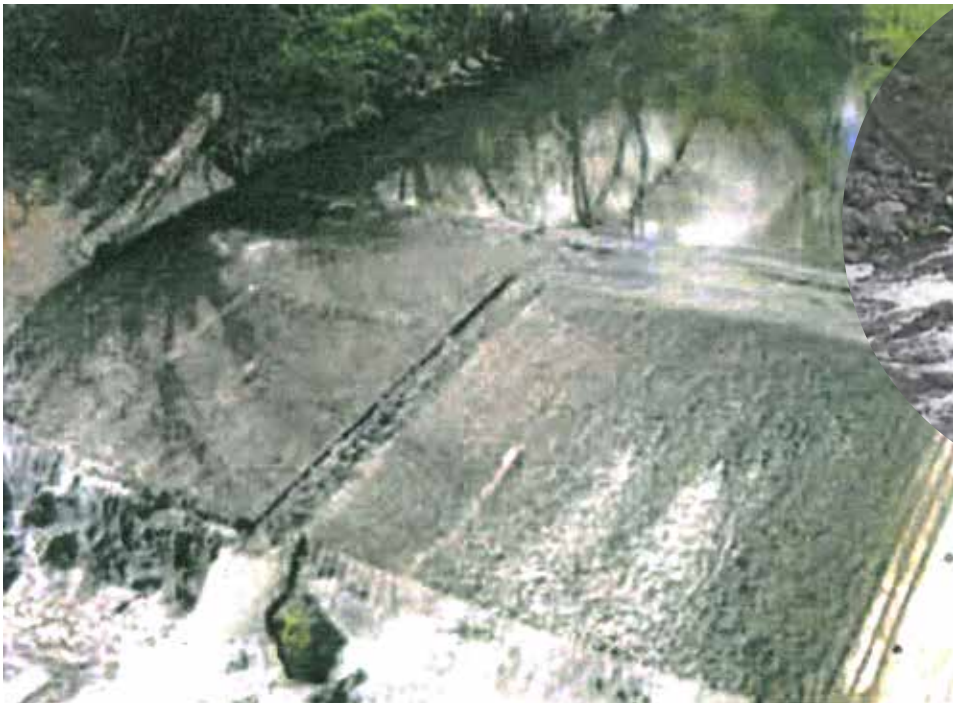
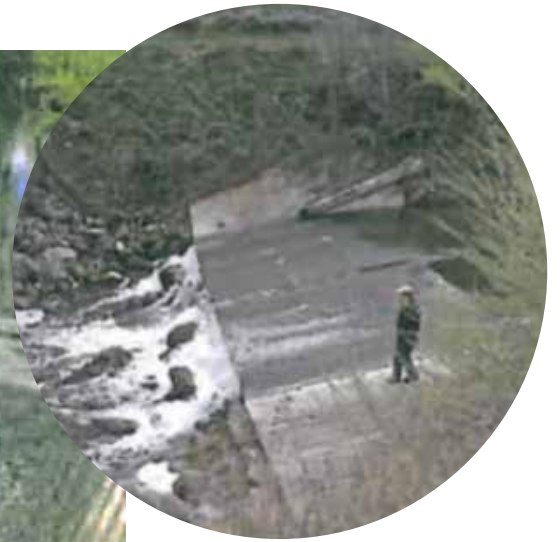
• Figure 31. Two 2007 photos showing the previous condition of the concrete weir before it was undermined and collapsed (courtesy of Zone 7, and Mahacek, 2007).
