ARROYO DE LA LAGUNA REACH-BASED GEOMORPHIC EVALUATION

NOVEMBER 2023

PREPARED BY
San Francisco Estuary Institute

IN PARTNERSHIP WITH
Alameda County Flood Control and
Water Conservation District, Zone 7

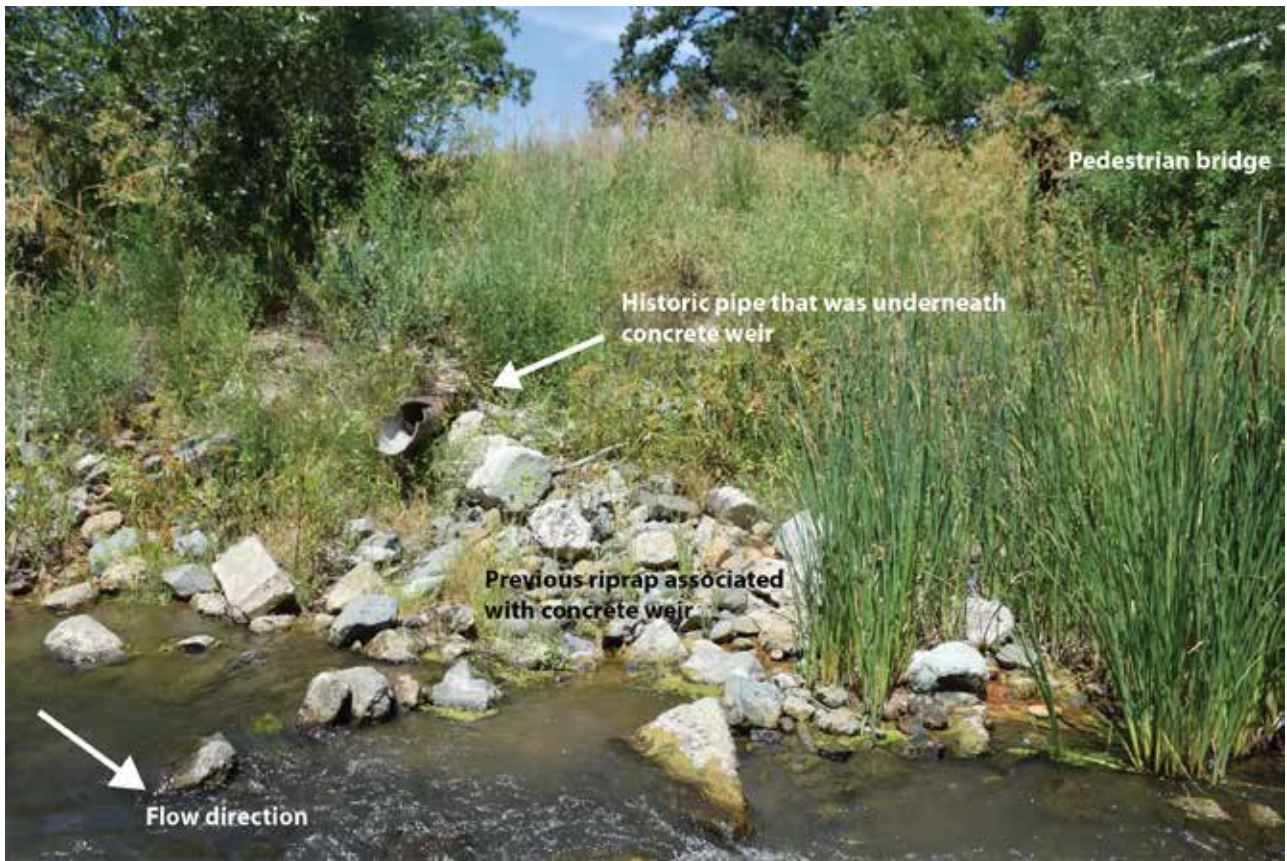
Figure 32. Field photograph of the left bank and an historical pipe that was underneath the concrete weir before it failed and was removed. Pipe is now approximately 1 m above the current bed elevation.

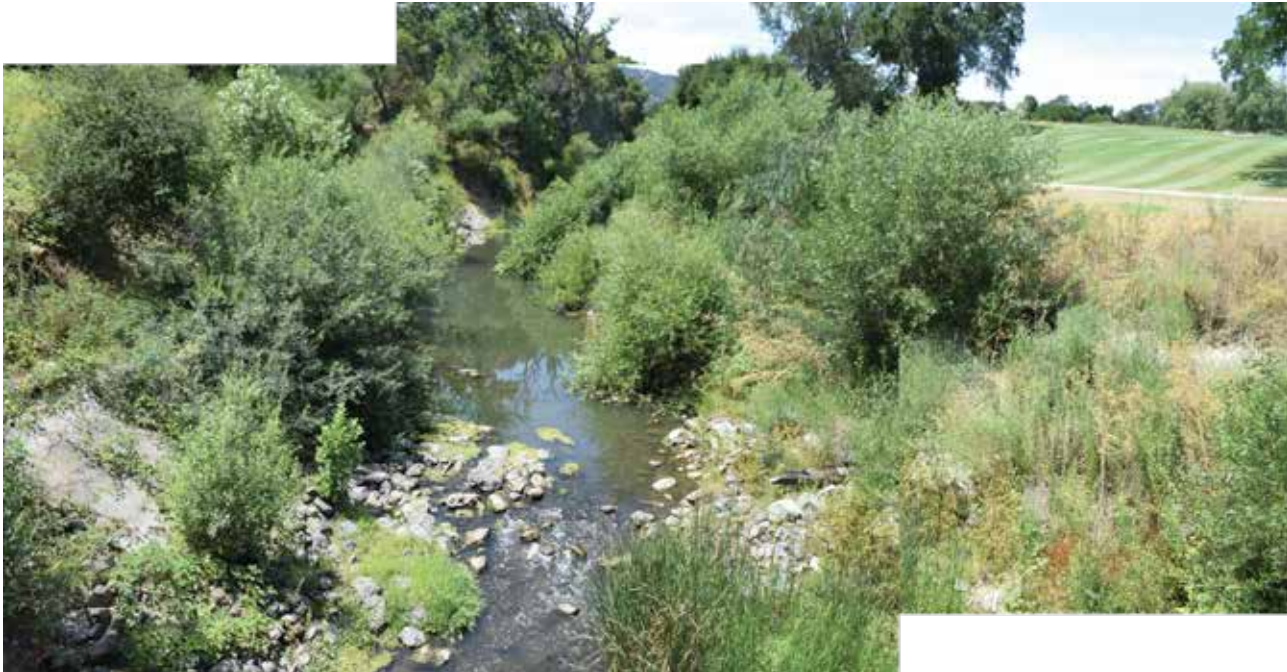
Figure 33. Current view of weir location, looking upstream from the pedestrian bridge.

Although the Country Club need not be fully responsible for restoring Arroyo de la Laguna, in this reach there are opportunities for laying back the banks on the left side, on Country Club property. This would limit the erosive force against Foothill Road. There are several areas with limited riparian vegetation in this reach, and planting an additional row of trees behind the current trees located at the top of bank would increase habitat, shade, bank stability, as well as other benefits. Stream managers should examine the functioning of the Line B.2.1 structure, and installing an energy dissipator at the bottom to reduce scour from inflows. In addition, managers should discourage any new riprap intended as bank stabilization in this reach, and create an anticipatory management plan with landowners (Beagle et al., 2016), especially the Country Club, to carefully plan out potential future responses if incision does begin to occur. This plan should also explore if any new opportunities exist because the weir is no longer present.

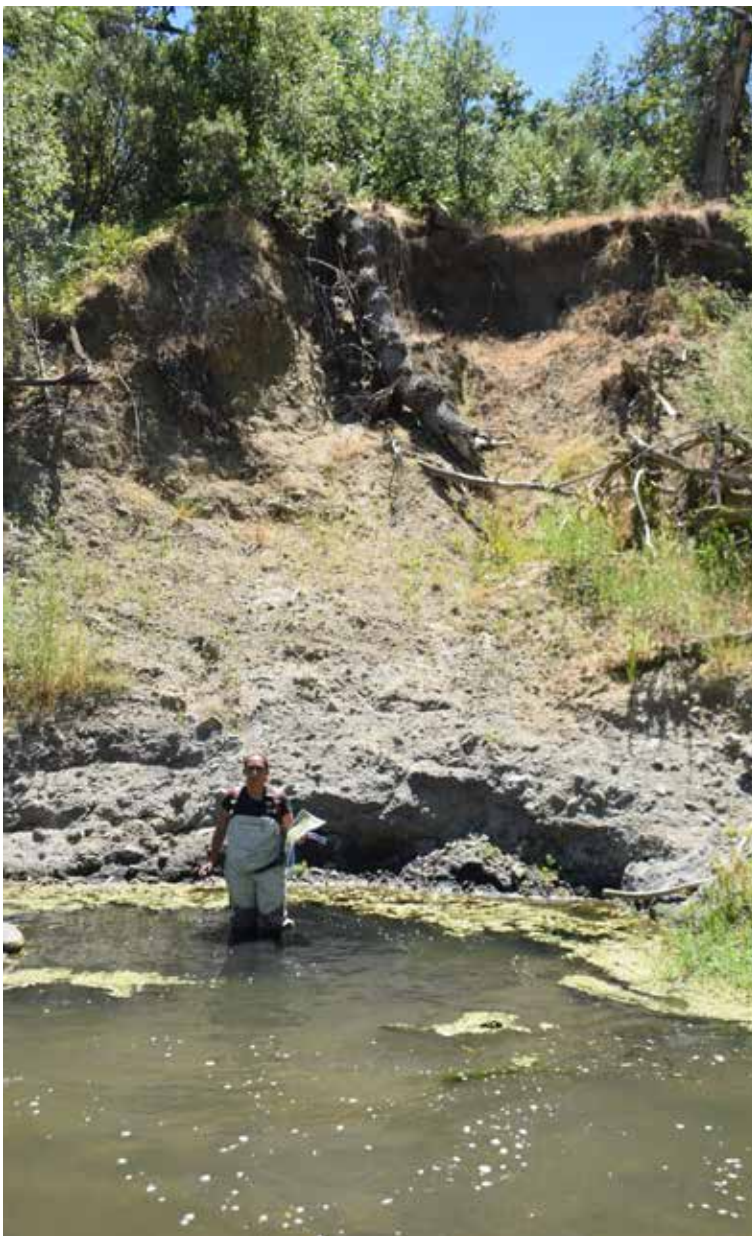
Figure 35. Bank slump location in Reach 4 that is contributing a mix of grain sizes to the channel.

More closely inspect the banks, mapping locations of slump-block style failures of the banks using a combination of LiDAR and field observation to identify potential risks to structures at the top of the banks.

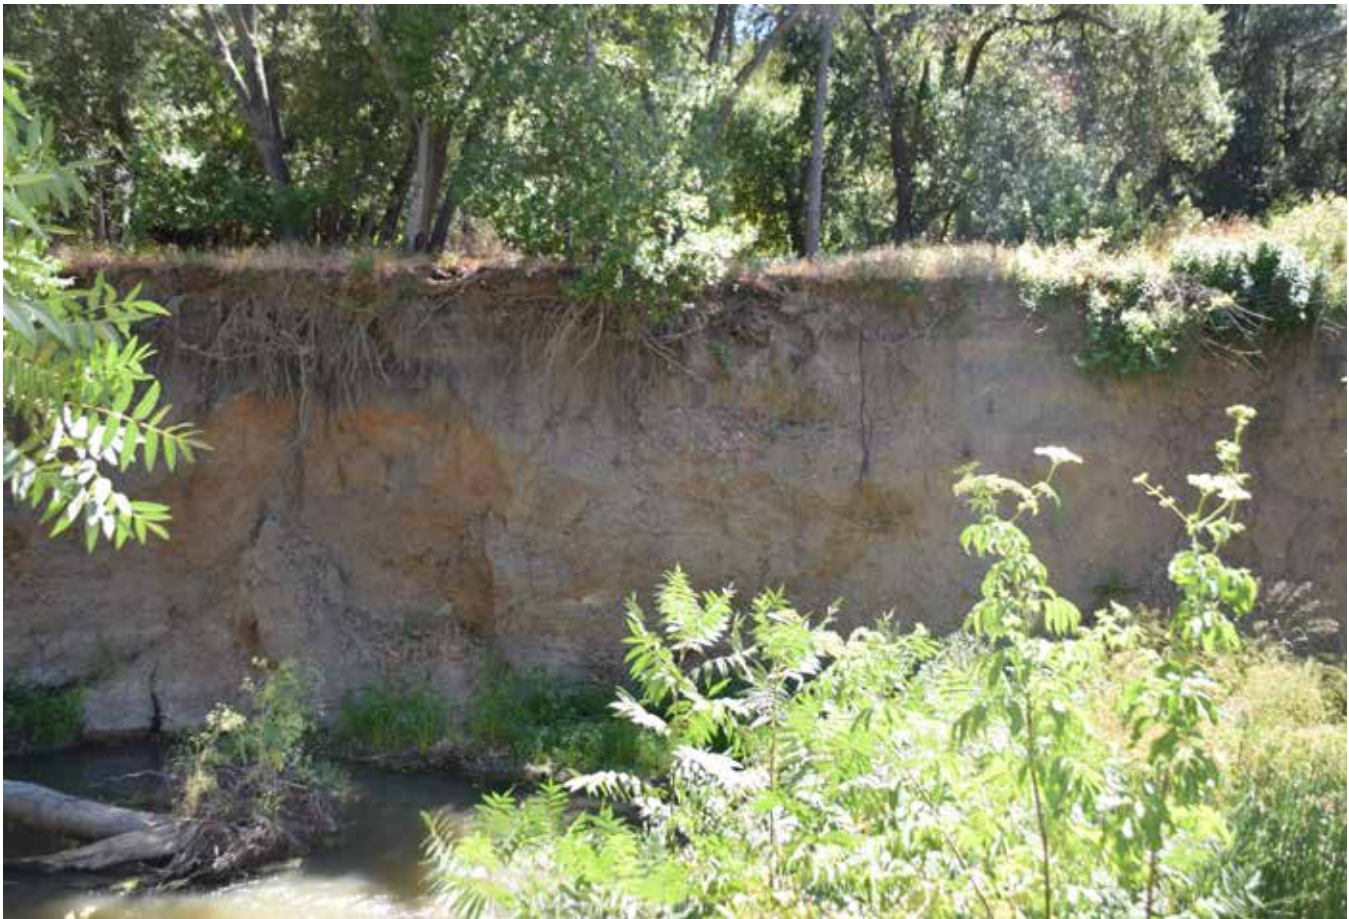
Figure 40. Vertical outer bank and adjacent flat terrace surface (with riparian trees) in Reach 5.

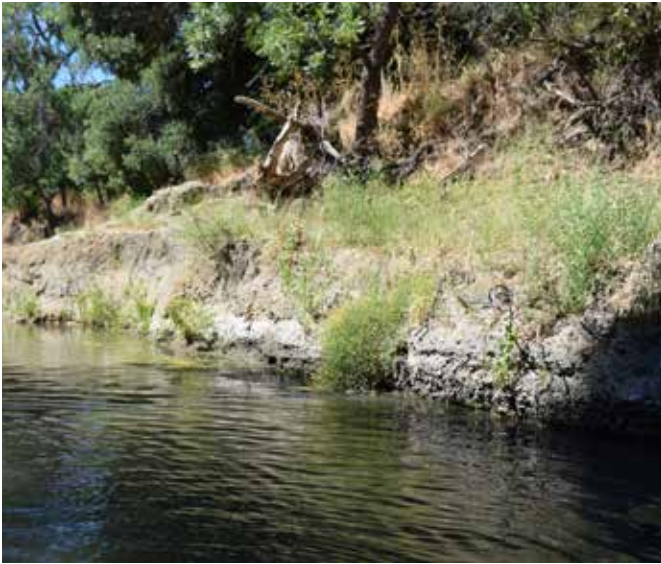
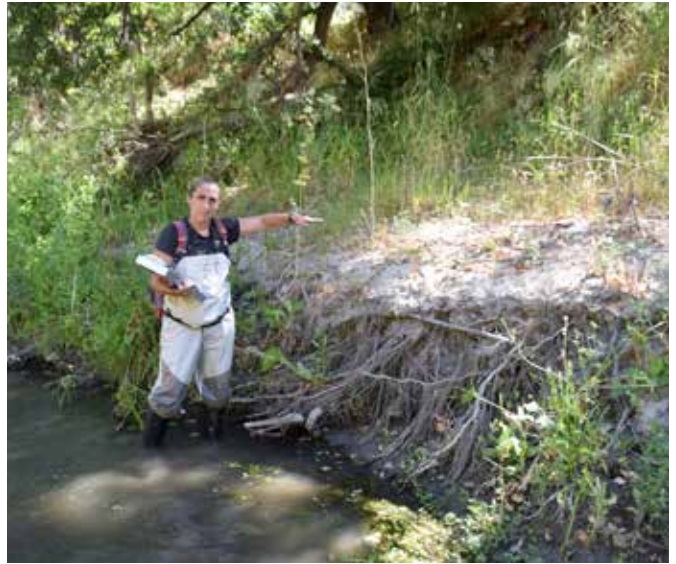
The channel has many elements indicating previous and ongoing incision. The channel incised to expose the hardpan, and has now cut through the hardpan, leaving it exposed above the bed (Figure 42). A culvert was observed to be hanging approximately 1.5 m above the current bed elevation. Near the middle of the reach, the field team observed an approximately 100 year old cottonwood tree rooted on the slope down to the historical channel bed, which is 2 m higher than the current bed elevation. We hypothesize that it rooted when the channel was at that location and receiving groundwater support. At several locations, riprap had been placed at the toe of the bank as protection from additional erosion. At the City of Pleasanton pump station, riprap was placed in 2000 on the pipe that traverses the bed when it became exposed due to incision (Figure 43). This riprap is likely currently serving as a small grade control. In general, the heights of the terrace above the current channel bed increase from the downstream (5-6 m) to the upstream (8-9 m) portion of the reach. This is counter-intuitive as systems that are incising generally have a greater distance between terrace surface and bed elevation further downstream, as the downstream reaches have had a longer duration of incision. However, we hypothesize

Figure 42. Hardpan exposed above the channel bed.

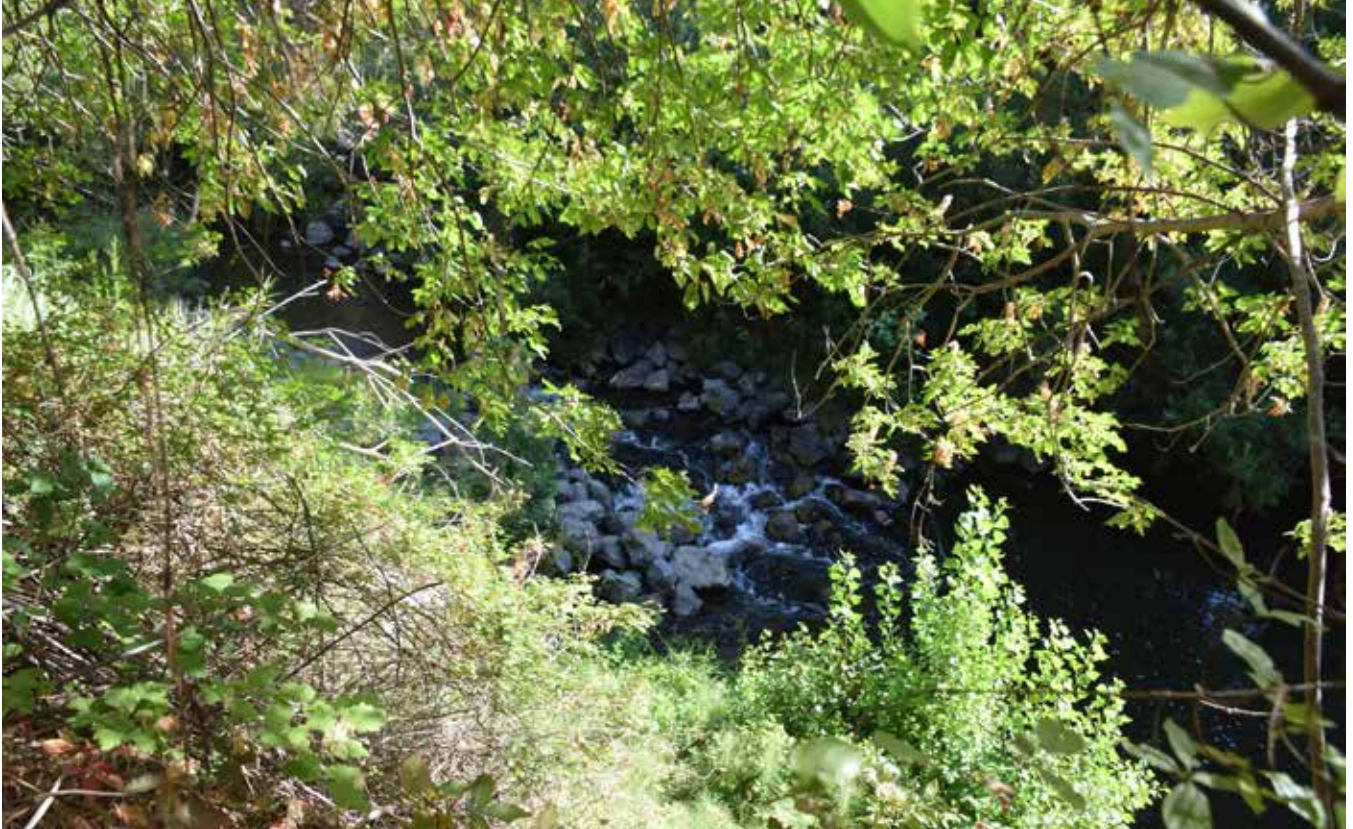
Figure 43. Riprap placed on bed at pump station.

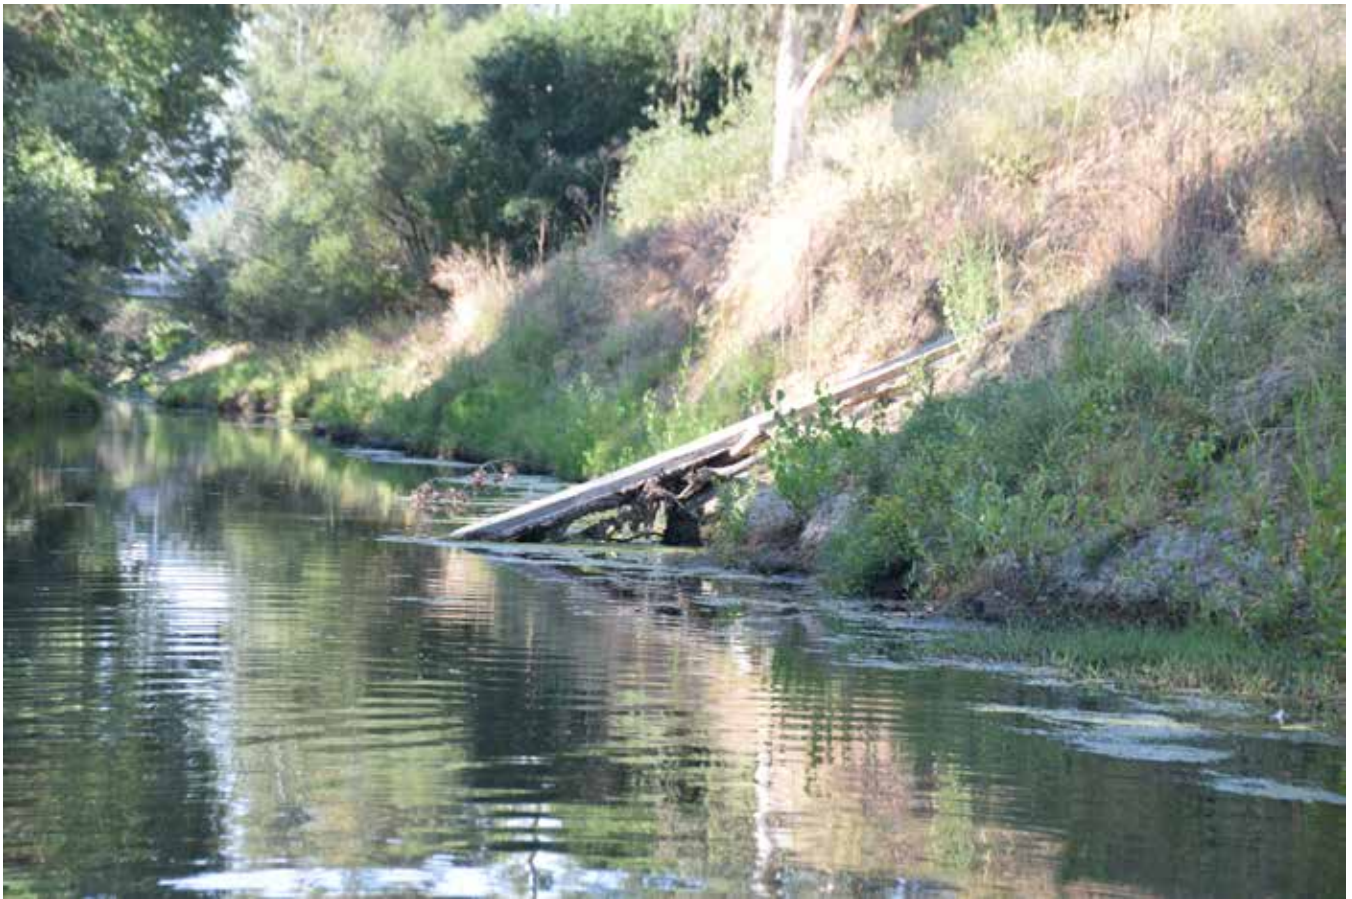
Figure 48. Concrete drain with void space indicating erosion.
