Robertson Park and Medeiros Parkway sUAS Surveys for the Sycamore Pilot Implementation Project

June 2024

Prepared By:
San Francisco Estuary Institute

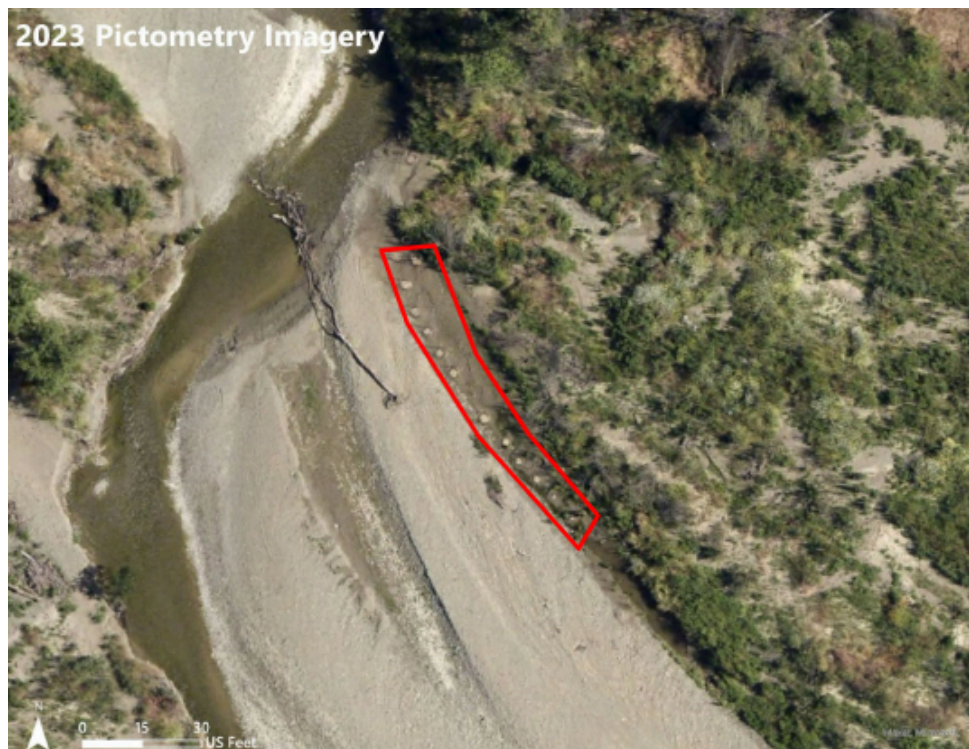
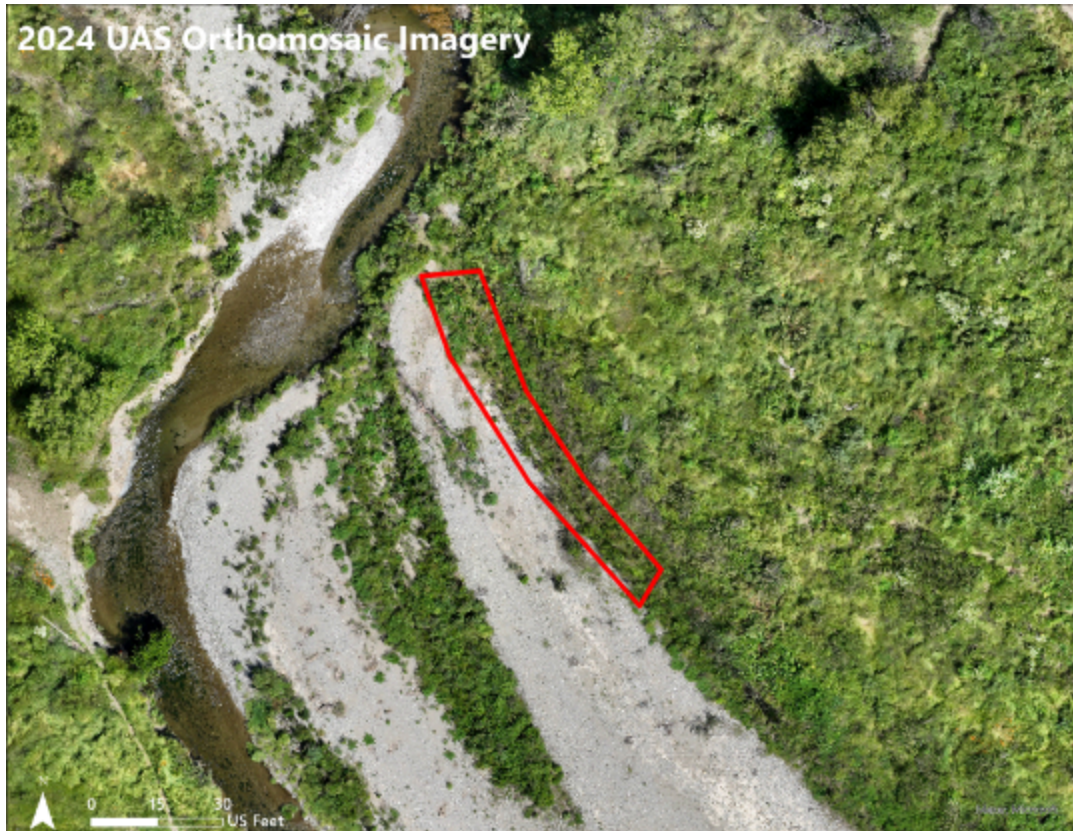
Figure 4. Pictometry imagery from 2023 at Medeiros Parkway with plantings outlined in red.

Figure 5. UAS orthomosaic imagery from April 2024 SFEI survey at Medeiros Parkway

As seen in the figures above, Pictometry imagery from 2023 (Pictometry International Corp. 2023) shows a string of Year 1 plantings along the edge of the inner floodplain of Arroyo Mocho at Medeiros Parkway (Figure 4). The same area photographed by SFEI's sUAS in April 2024 shows the absence of those plantings (Figure 5). Additionally, one can see changes in gravel bars, the absence of a fallen tree, and new vegetative growth on either side of the open water channel. The imagery provides evidence of high flows from winter storms altering the restoration site and potentially burying or sweeping away a significant portion of Year 1 plantings from 2023. The sUAS imagery collected in April 2024 offers high-resolution imagery to assess the site. Satellite imagery such as from Sentinel-2 and Landsat would not capture all the complexities of the site changes due to their much coarser resolution.

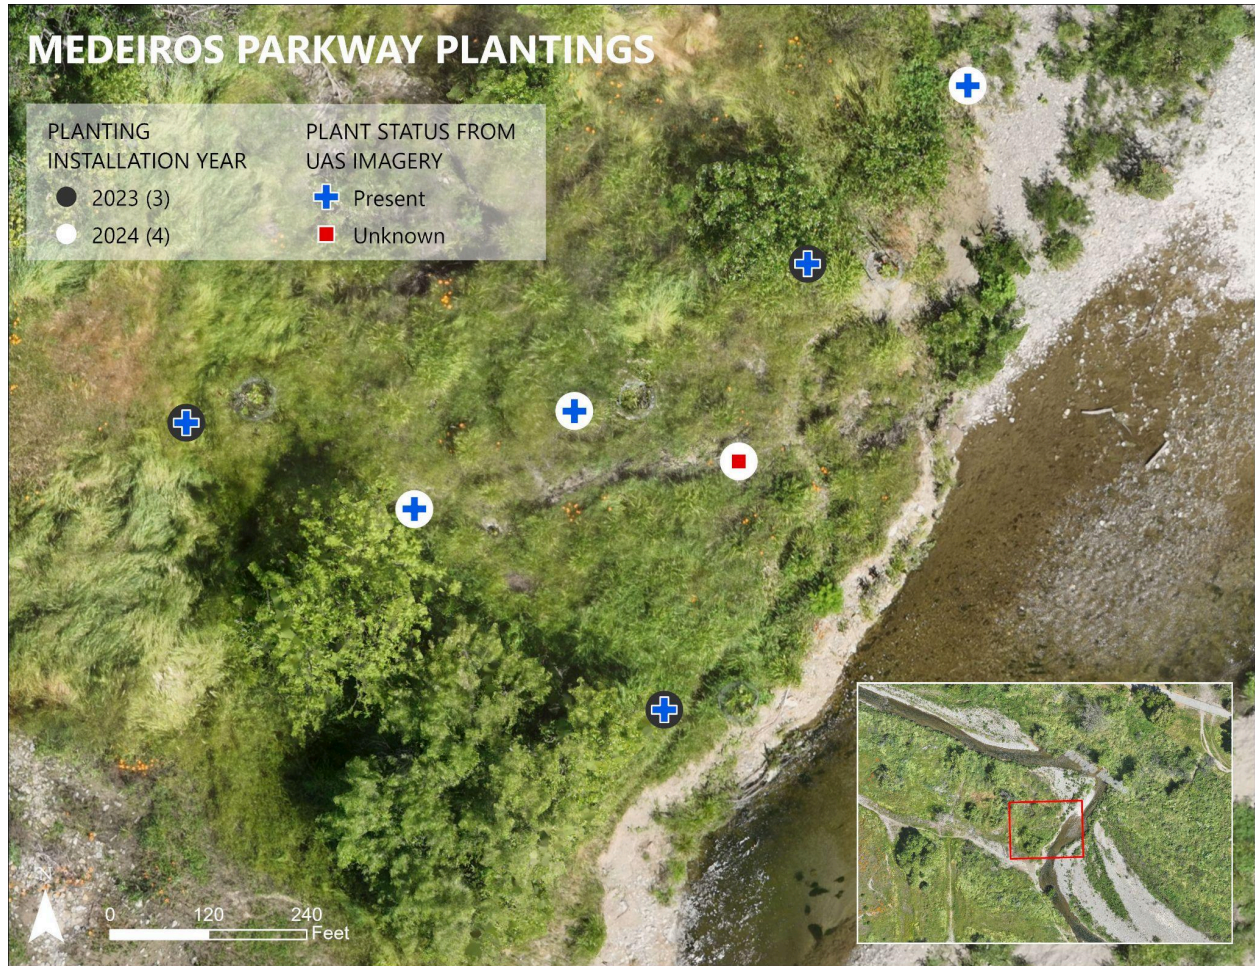
In Figure 6 below, seven planting locations are shown with their status as determined by assessing the sUAS imagery. In this example, all but one planting could be determined as present and surviving.

Figure 6. Examples of Medeiros Parkway planting locations and status. In this example, all but one planting was able to be determined as present and surviving.

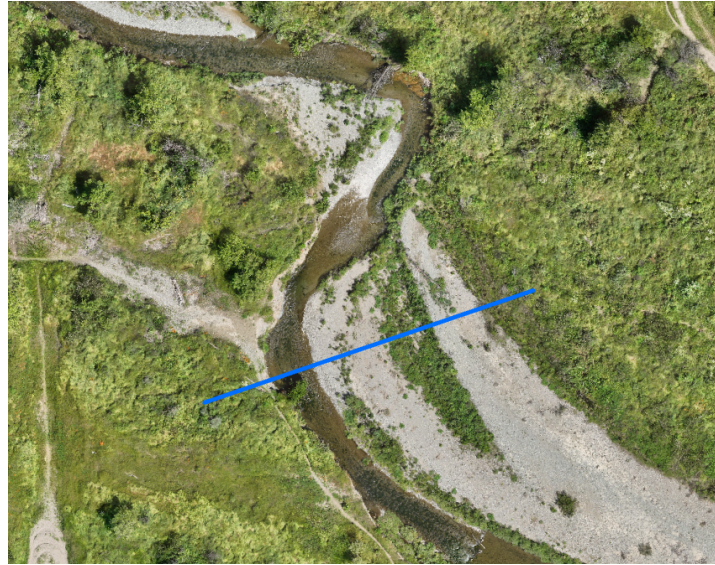
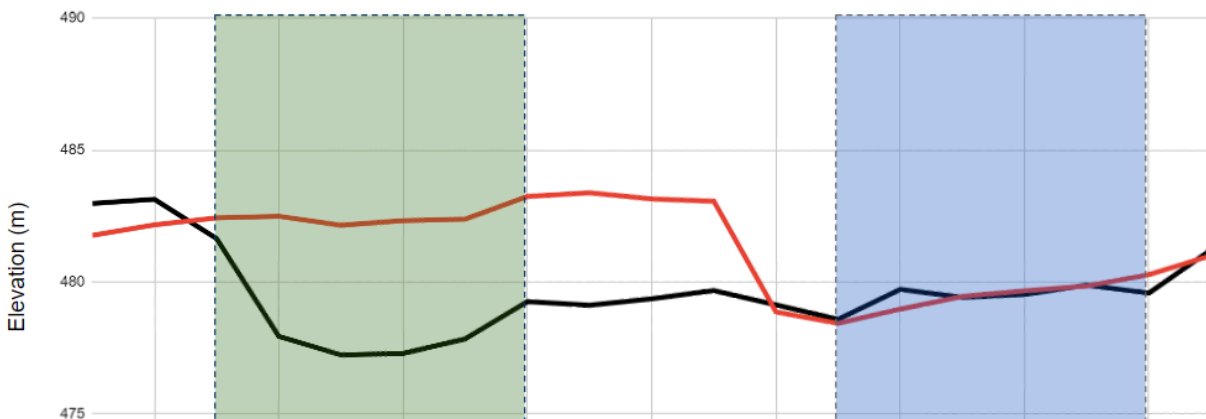
these changes is through virtual cross sections. Cross sections of elevation data over time can help demonstrate the changes that can be assessed by using data products from the sUAS surveys, as seen below in Figure 11. Figure 11 uses an elevation cross section over two years of elevation data, 2021 and 2024, to illustrate a significant change in the channel topography along a cross section of Arroyo Mocho in Medeiros Park.

Figure 11. Elevation cross-sections of the USGS 2021 Alameda County LiDAR (red) compared to the SFEI 2024 sUAS-derived DTM (black). The blue rectangle represents the Active Channel zone previously delineated, and the green rectangle shows the active channel as it appears in the 2024 sUAS imagery and DTM.

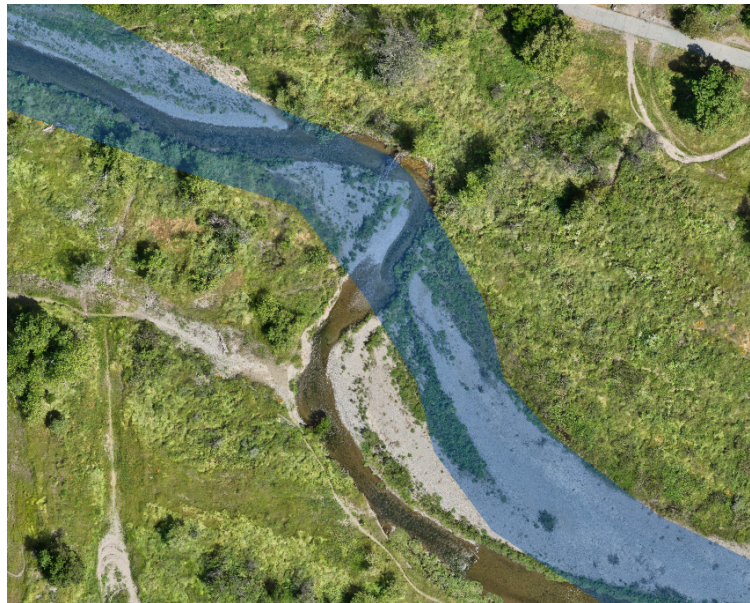
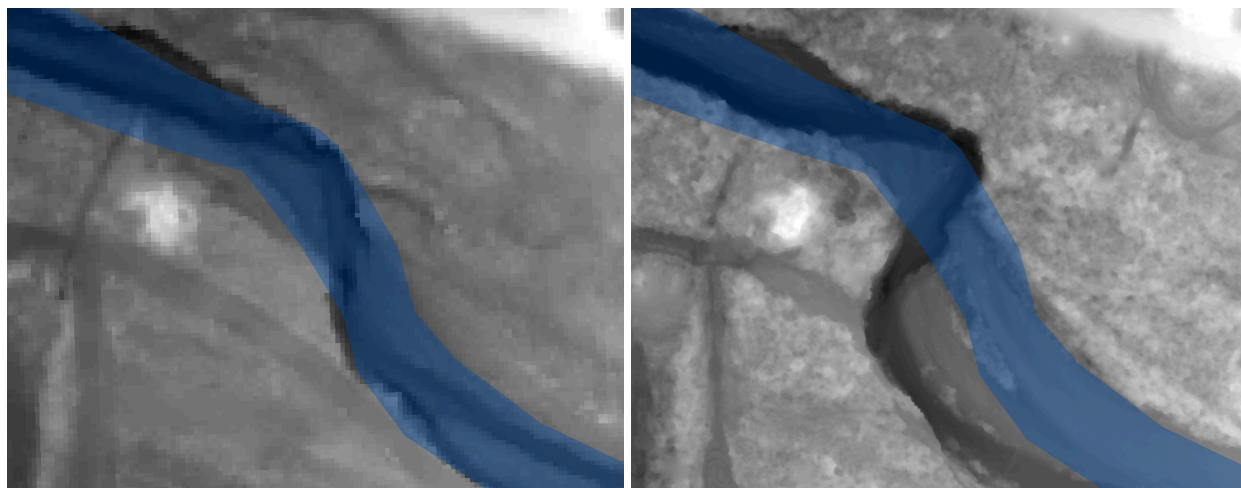
Furthermore, sUAS elevation data can be used to delineate and update hydromorphic zone boundaries so that they retain accuracy throughout a restoration project. For this study, zones were delineated by hand in 2020 and confirmed through field work. The digitization was done using NAIP imagery from 2016. At the time of the plantings, which took place in 2023 and 2024, the zones had been digitized on imagery that was eight years old and confirmed by field work that had happened four years prior. Figure 12 underscores the importance of delineating important elevation-based boundaries using up-to-date elevation data. The low flow channel boundary, shown below in blue across Medeiros Park, no longer accurately reflects the channel

path, and planting decisions based on these outdated borders may impact the survival rate of each plant.

Figure 12. Medeiros Park. The Active Channel zone shown in blue, overlaid on the 2021 USGS Alameda County LiDAR (left) compared to the 2024 SFEI sUAS-derived photogrammetry based DSM (right) and the 2024 SFEI sUAS orthomosaic (top).
