ARROYO DE LA LAGUNA REACH-BASED GEOMORPHIC EVALUATION

NOVEMBER 2023

PREPARED BY
San Francisco Estuary Institute

IN PARTNERSHIP WITH
Alameda County Flood Control and
Water Conservation District, Zone 7

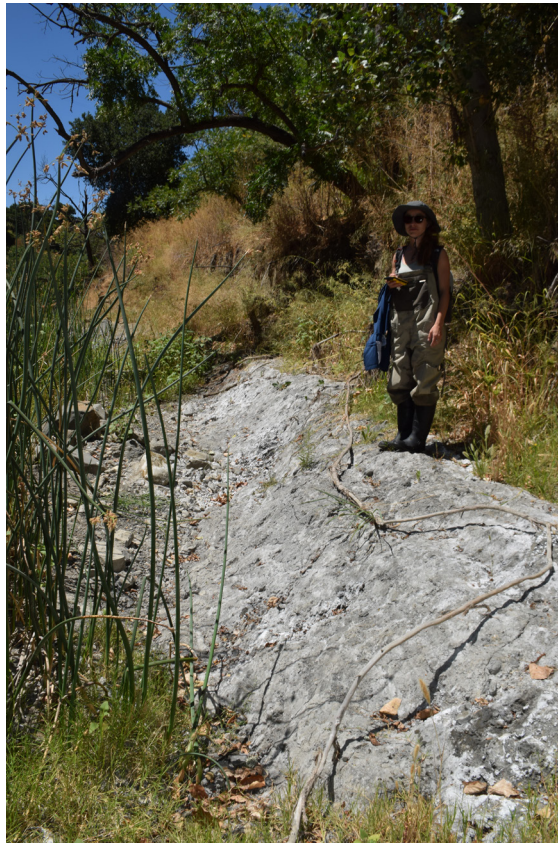
(left) Figure 8.
Exposed hardpan
(Reach 4).

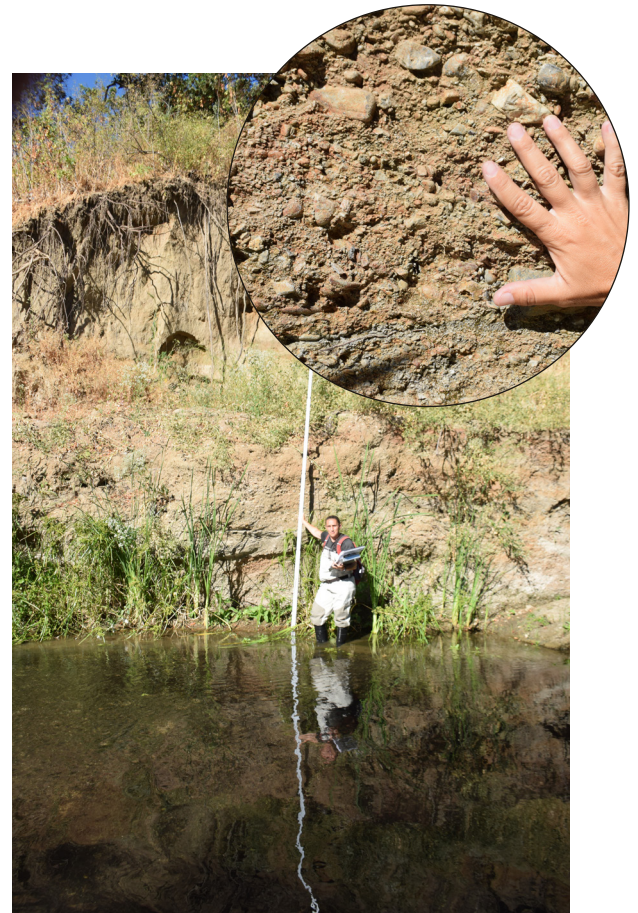
(right) Figure 9.
Depositional
feature, likely
the 1950s flood
package, and
detail of the
deposit.

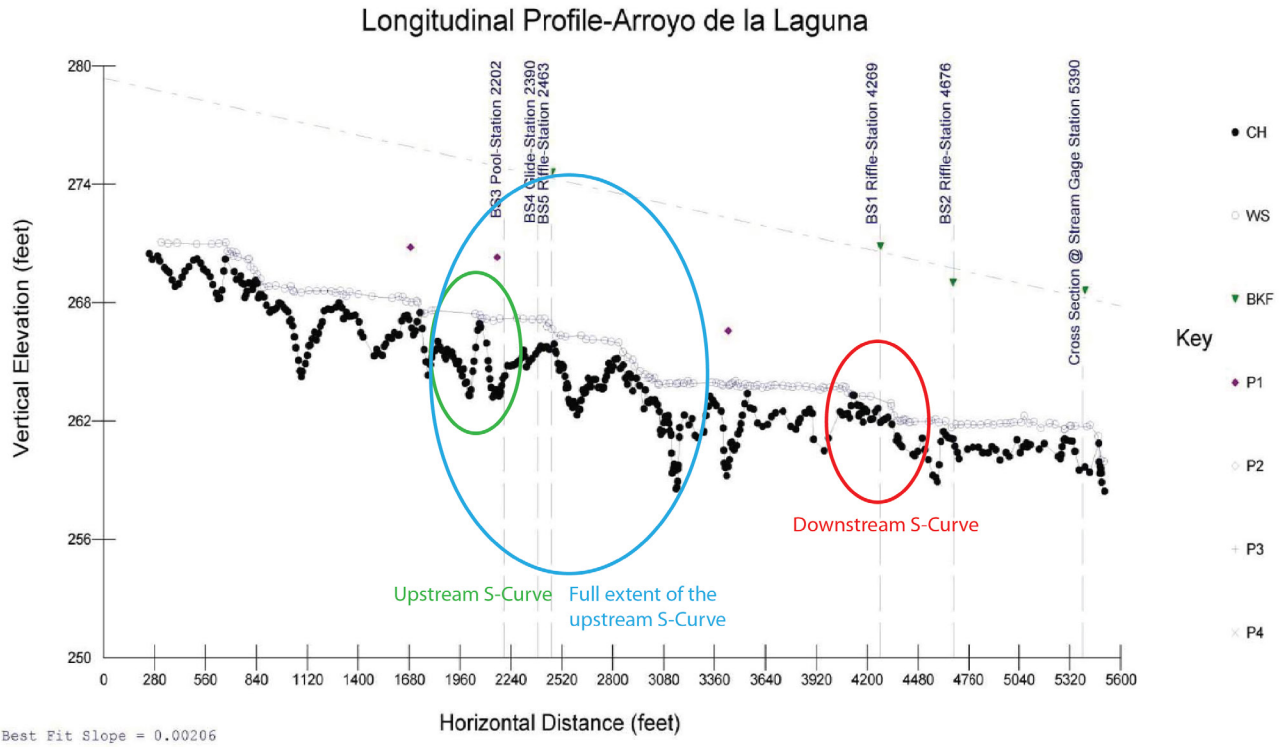
The channel bed riffles in this reach are visible on field-surveyed longitudinal profiles (Stantec, 2011) as steeper reaches, as compared to up and downstream reaches (Figure 14). It is not clear if the bed coarsening is due to deposition of transported bedload due to loss of stream power in the wider reach, or if the locally-sourced failed bank material is unable to be effectively transported, and thus acting as a “slug” of sediment.

Figure 14. Field surveyed longitudinal profile (Stantec, 2011) showing the steeper gradient in the downstream S-curve (red oval). The upstream S-curve is shown in the green oval, with the larger extent of the S-curve shown in the blue oval, also displaying a steeper gradient.

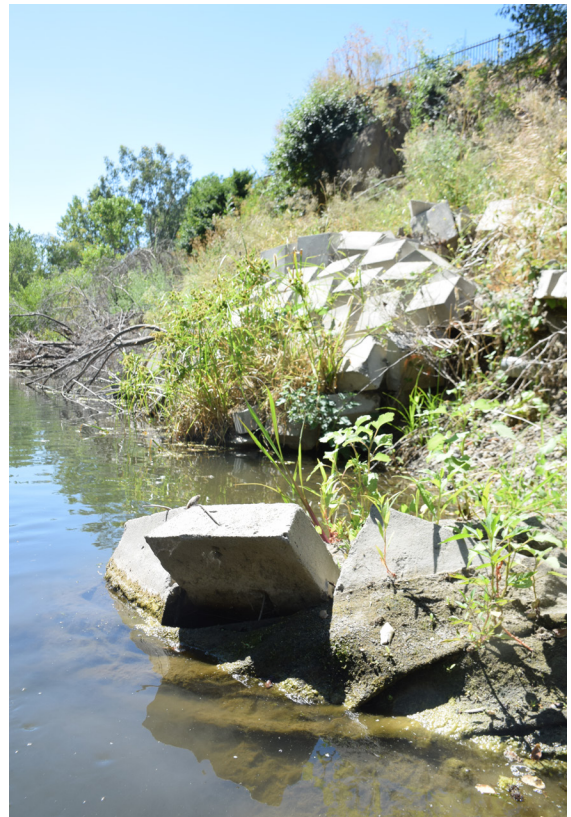
The relatively straight reaches adjacent to the two S-curve nodes have tall vertical banks that are actively failing, and threatening many properties. A number of land owners in this reach have placed riprap, articulated concrete mats, or filter fabric to help stabilize the toe of the slope, with varying success (Figure 15). Limited indicators of downcutting were observed underneath the concrete mats. These straight reaches have a more shallow gradient than the adjacent S-curve reaches, and have a well defined pool-riffle sequence, with many low bar deposits. In addition, discontinuous remnant 1950s flood deposits are observed, which are coarse packages of fluvial material forming a surface approximately 2-4 m above the current channel bed. In places, a wider floodplain surface is developing, which is fairly ecologically complex, with a number of swales and young woody vegetation (e.g. cottonwoods and willows).

Figure 15. Failing articulated concrete mat.

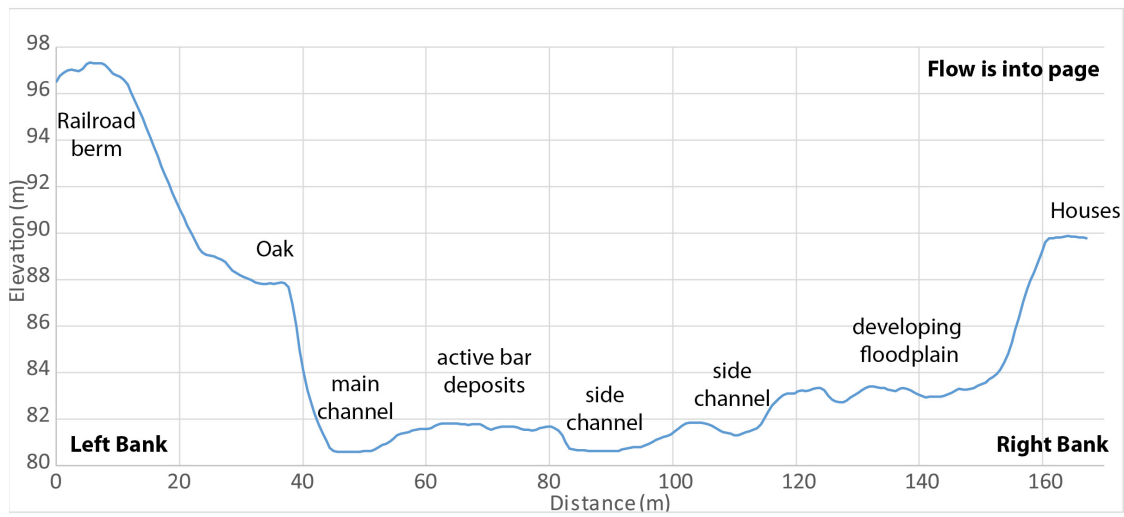
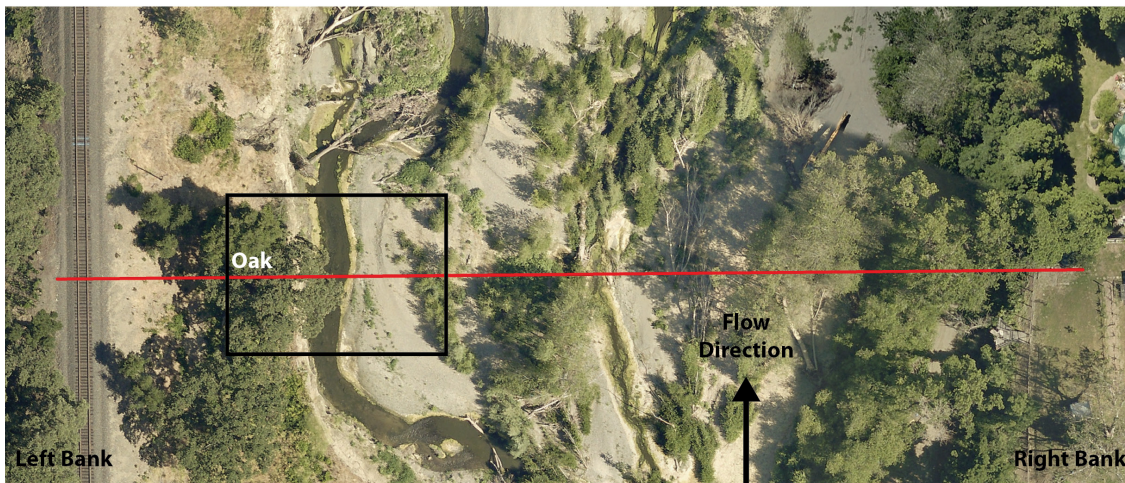
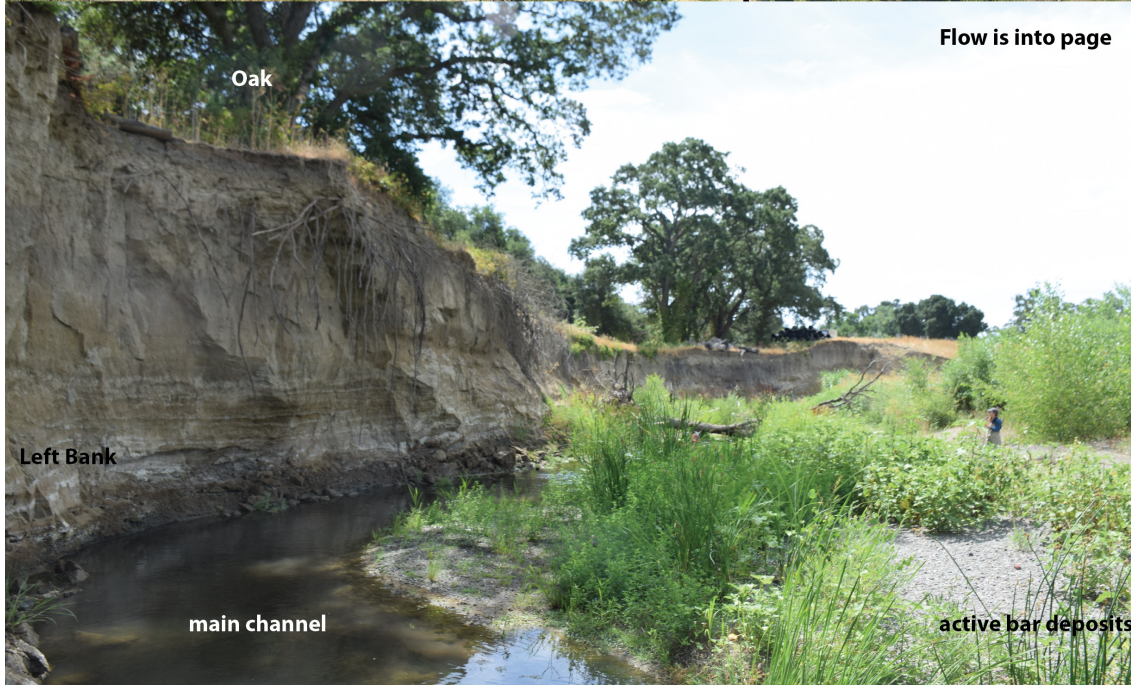
Two representative channel cross sections show the S-curve meander bend and the relatively straight reach morphology. Figure 17 illustrates an S-curve meander bend, with tall vertical banks with blocks of failed material at the toe, a main channel, and multiple other smaller channels. The developing bars and floodplains are visible at distinct elevations relating to various recurrence intervals of flows. Figure 18 illustrates a representative straight reach morphology between S-curves.

Figure 17. Representative channel cross section at an S-curve meander bend, looking downstream. The red line on the aerial photo indicates the location of the cross section. The black rectangle shows the area shown in the field photograph (looking downstream).

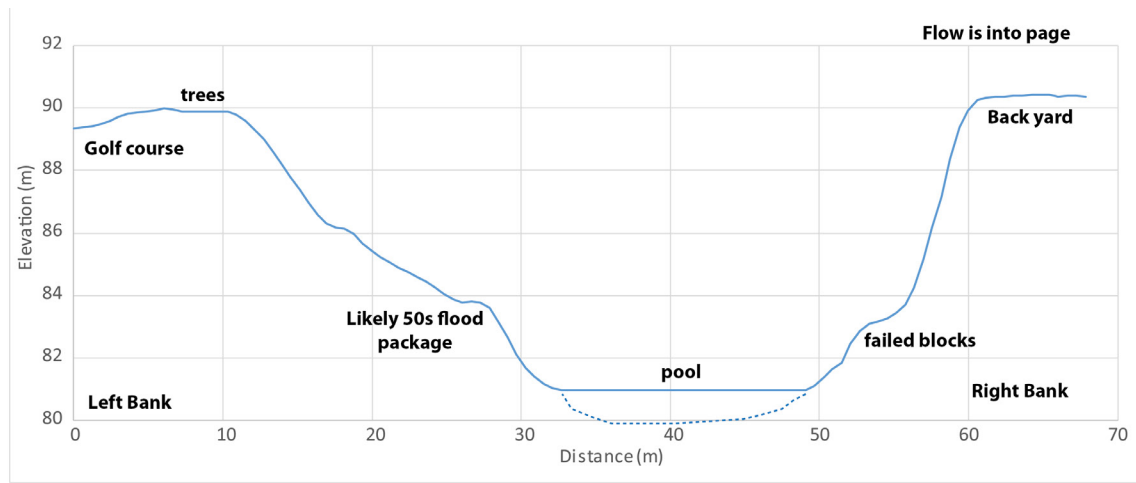
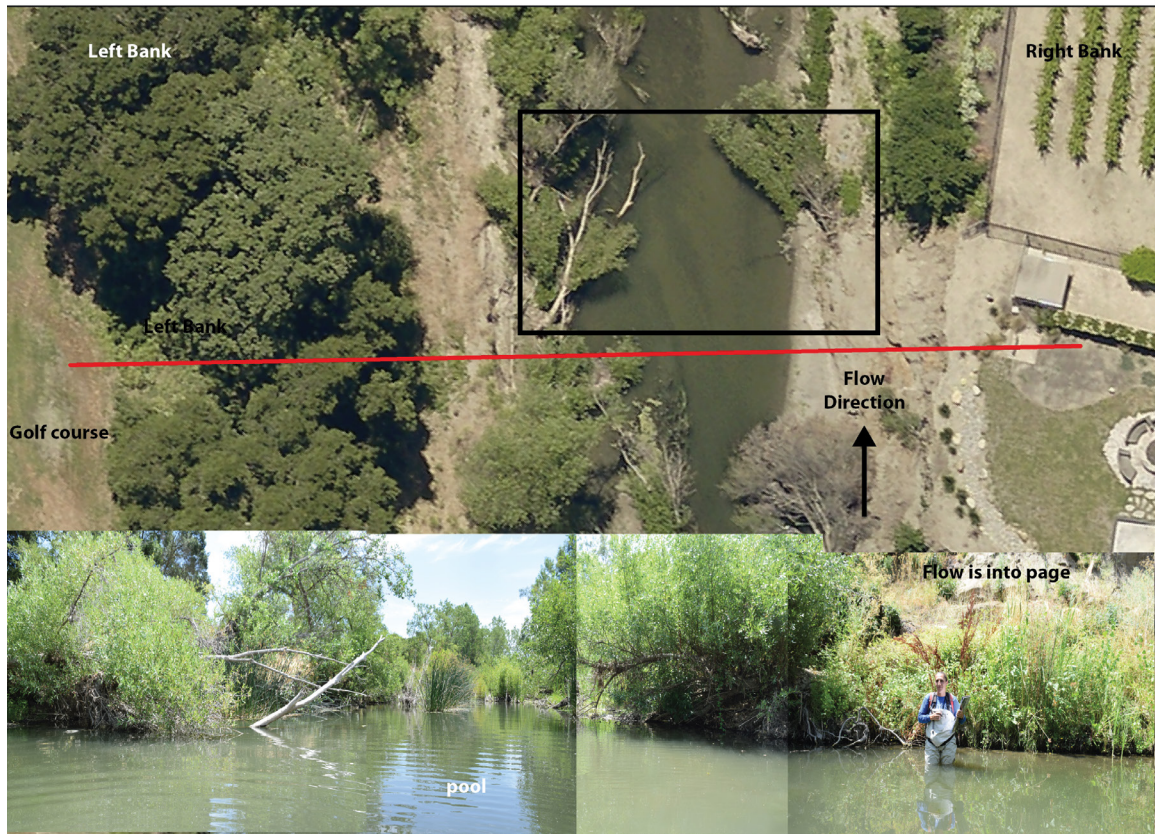
Figure 18. Representative channel cross section for the relatively straight reaches between S-curve locations (looking downstream). Solid line shows elevations directly from LiDAR, while the dashed line shows approximate elevations from field observation. The black rectangle shows the area shown in the field photograph (looking downstream).

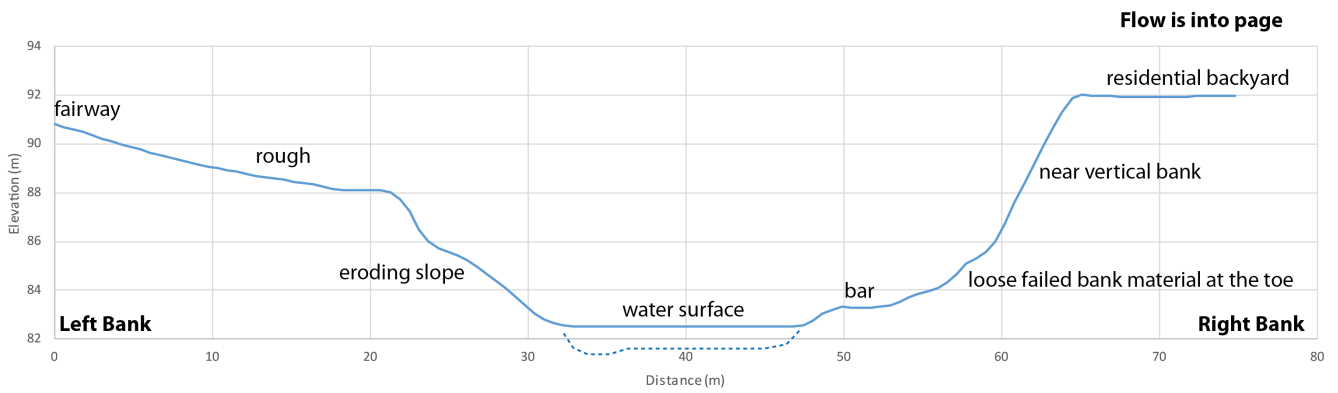
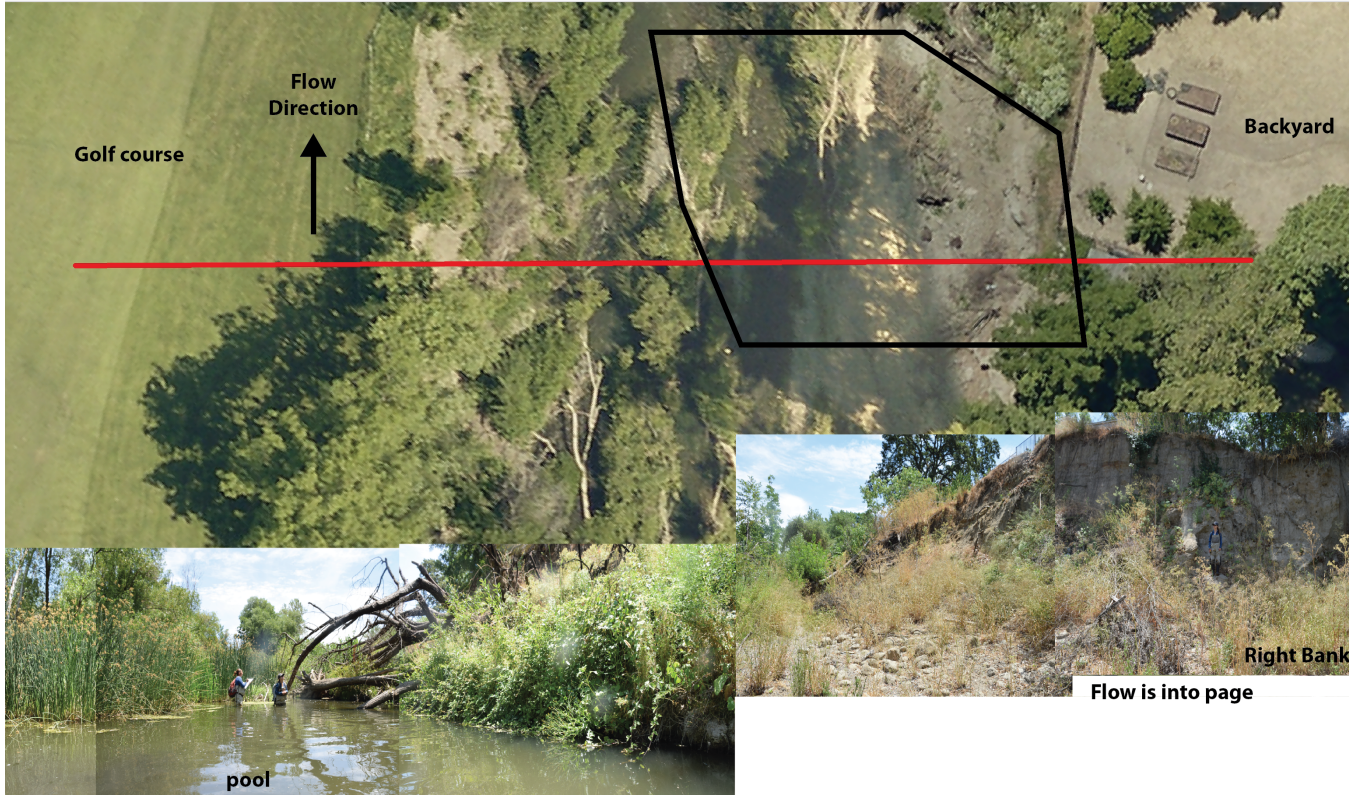
The representative cross section for this reach shows the near vertical outer bank on the right bank side, with the at-risk residential property at the top (Figure 23). It also shows the loose failed bank material piled up at the toe of the slope, and the low bar that has deposited (Figure 24). The left bank shows the slope that is failing more as a rotational-style failure, and the lower terrace surface that now has the fairway rough of the golf course. Unfortunately the detail of the channel (mid-channel bars) do not come across in the LiDAR data.

(above) Figure 23. Channel cross section cut from the LiDAR data and annotated with field notes, and the matching field photograph. Solid line shows elevations directly from LiDAR, while the dashed line shows approximate elevations from field observation. The black polygon shows the area shown in the field photograph (looking downstream).

(right) Figure 24. Right bank at cross section showing near vertical bank and failed material at the base.

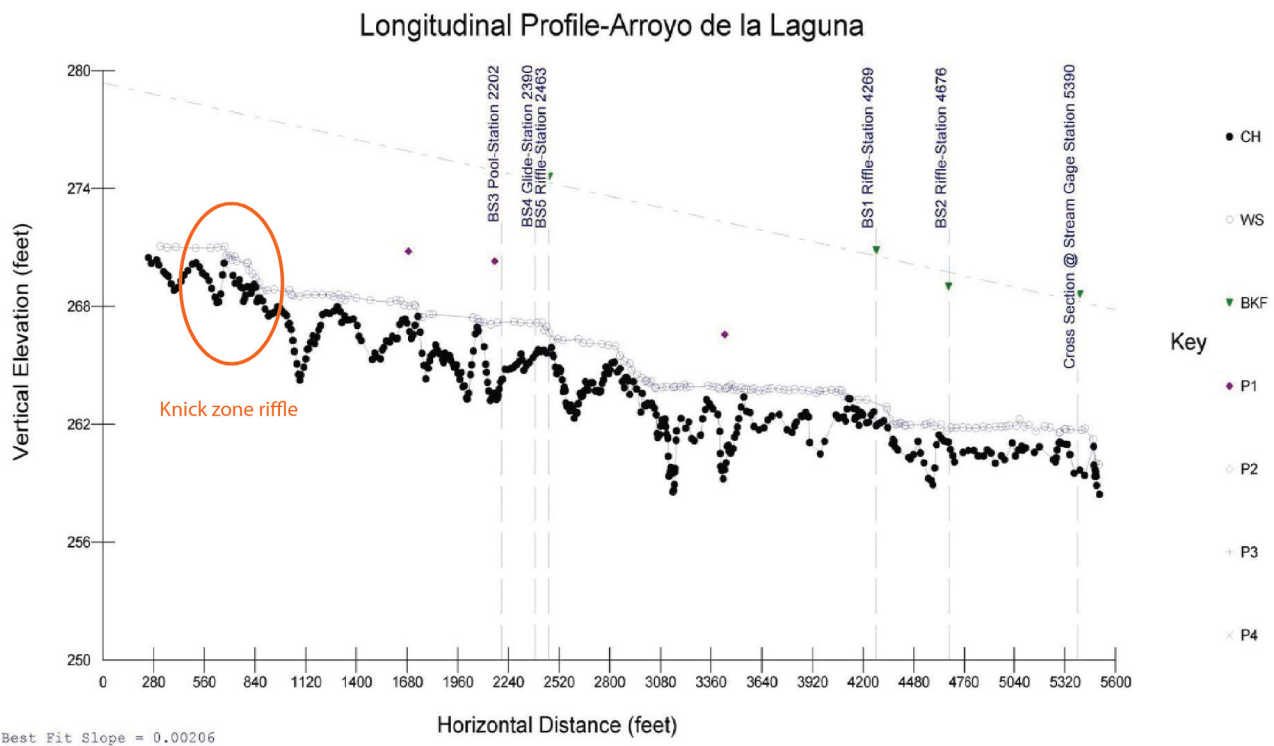
The relatively steep gradient through this reach is captured in the 2011 field-surveyed longitudinal profile (Stantec, 2011) (Figure 25). The gradient in this short reach is 0.86%, while it is 0.12% for the reach downstream and 0.11% for the reach upstream. We hypothesize that the riffle in this reach represents the current location of a knick zone. Previously, as this knick zone migrated upstream, it caused the channel to deepen, widen, and erode some of the adjacent terrace width, causing the difference in channel morphology downstream of the knick zone, as compared to upstream. However, further study is needed to evaluate this hypothesis and assess the key drivers for the bed gradient and channel morphology. Quantifying upstream migration of the knick zone will confirm that it truly is a knick zone rather than just the deposition of a slug of sediment as the channel exits the upstream confined riprap reach or from the adjacent banks, or just the expression of a resistant geologic unit.

Figure 25. Field surveyed longitudinal profile (Stantec, 2011) showing the steeper gradient in the riffle of the knick zone.

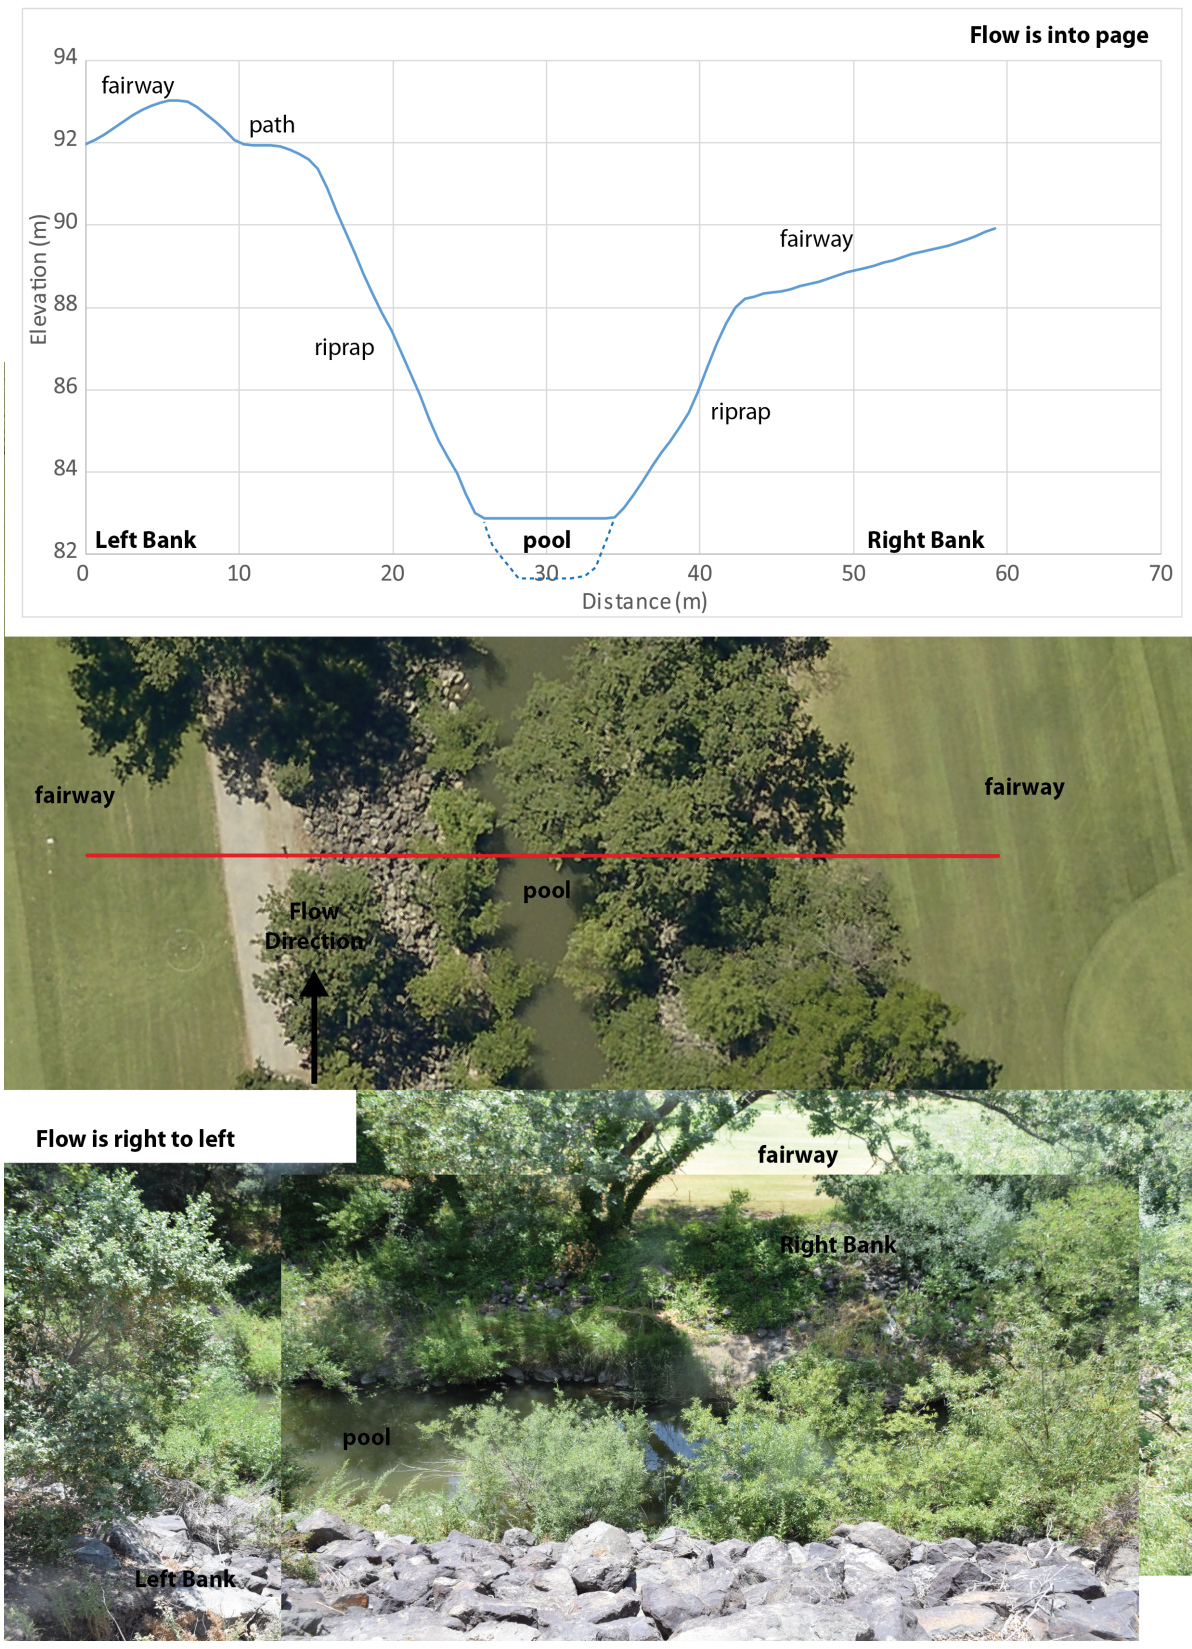
Reach 3 extends from just downstream of Castlewood Drive, upstream through a portion of the Castlewood Country Club golf course (Figure 27). This reach has been artificially relatively stable for a few decades because it is “locked in” by the riprap that is placed from the top of the bank to the toe. The riprap was placed in the late 1990s, as the Country Club was concerned about chronic bank erosion in this reach, likely due to previous incision. This hardening has significantly simplified the channel cross section, so that it is essentially a U-shaped trench that has almost no channel complexity. The channel is a long single pool with a low-flow water depth greater than 2 m. Overall this reach has low habitat value for aquatic or riparian wildlife species. Presently, none of the upper banks (e.g. those above the bankfull contour) were observed to be failing, which is different than most of the overall study area length. Because the reach was not wadeable, good observations of the toe of the riprap were not able to be made. However we believe that there may be some (<1m) recent incision at the toe, which may lead to future destabilization of the hardened banks.

Figure 28. Representative Reach 3 channel cross section. Solid line shows elevations directly from LiDAR, while the dashed line shows approximate elevations from field observation.

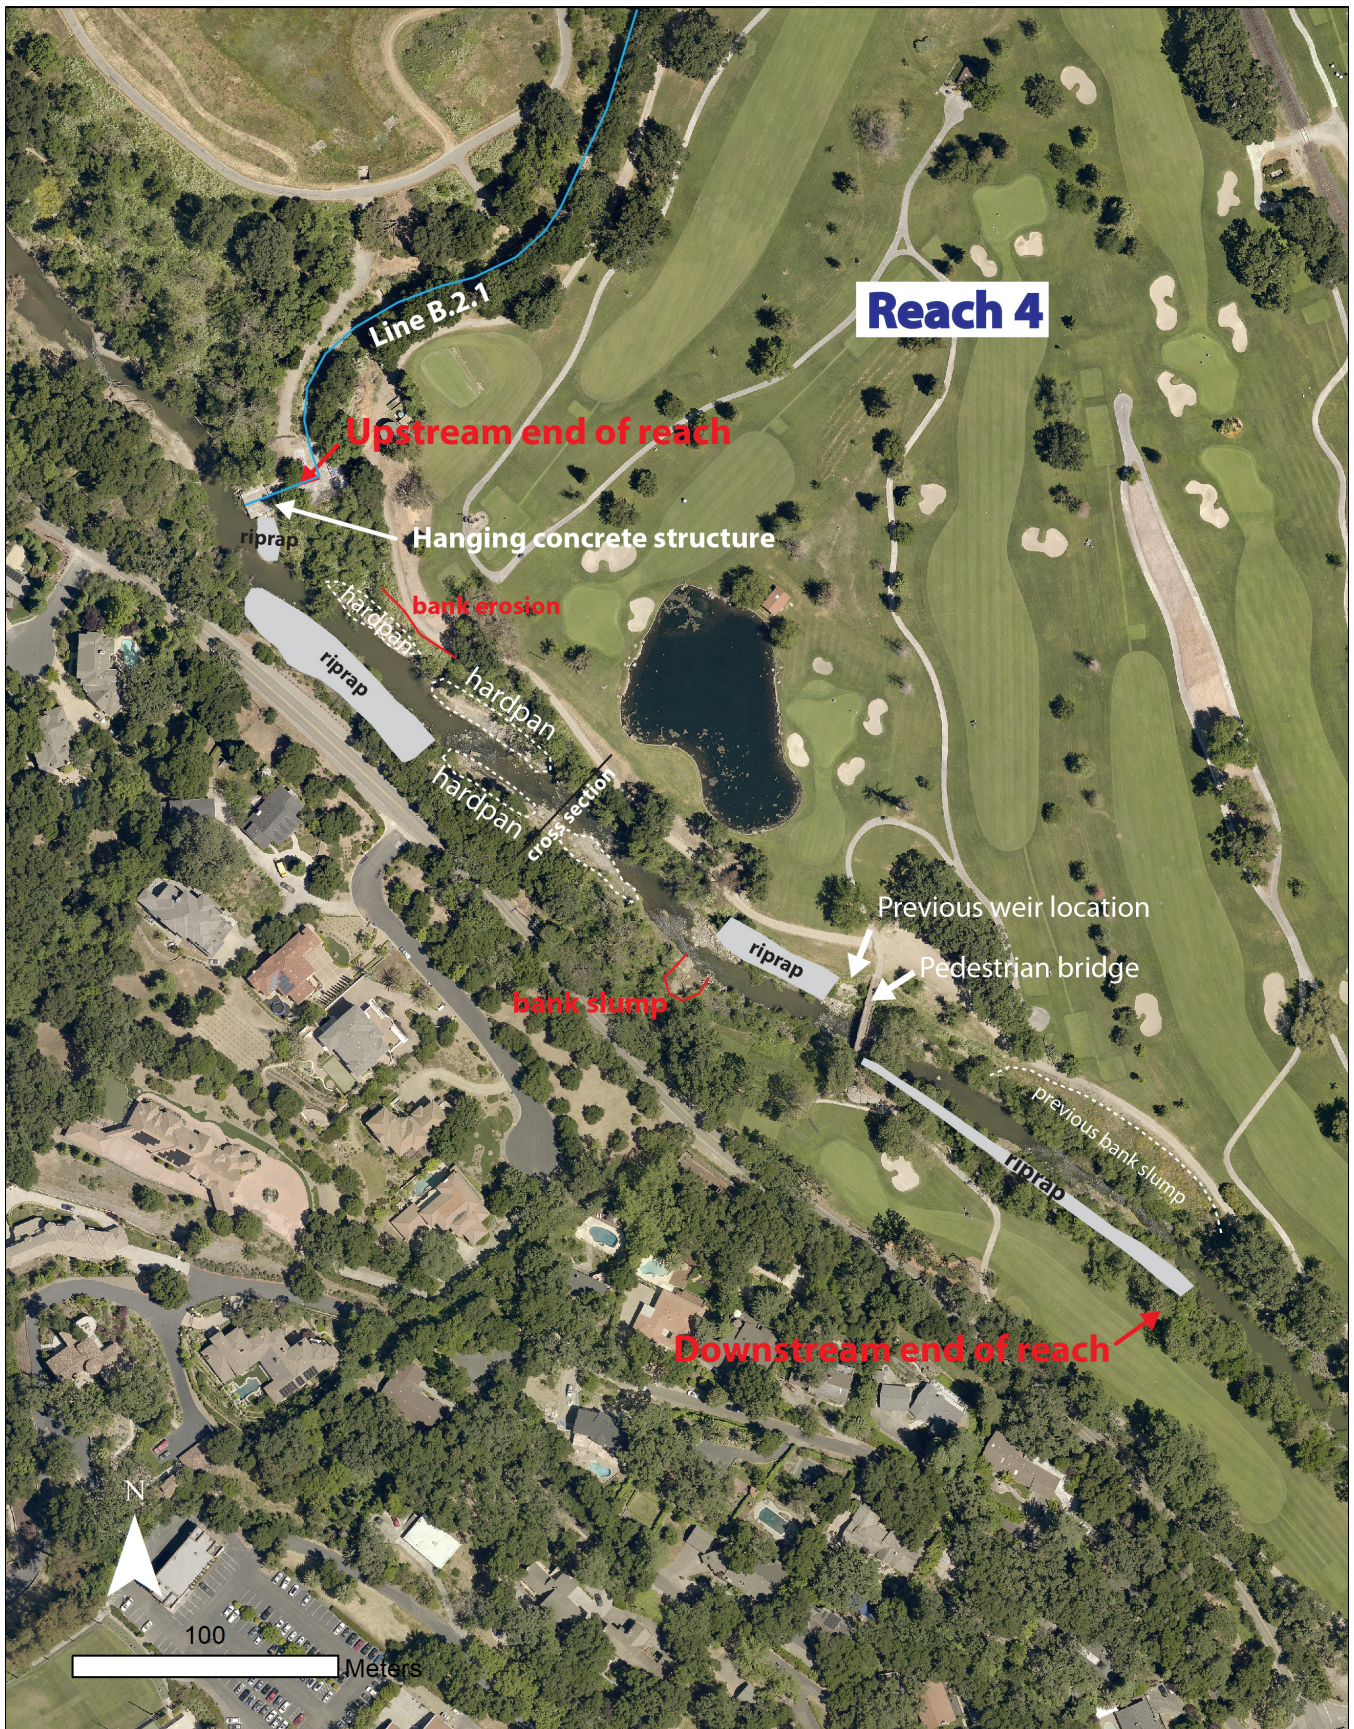
Figure 30. Channel map of Reach 4.

This reach extends from the upstream extent of the riprap in Reach 3 upstream to the confluence with Line B.2.1 (Figure 30). This reach is defined by a previous concrete weir that was located on the channel bed approximately 5 m upstream of the pedestrian bridge in the Castlewood Country Club golf course. The weir fully spanned the channel bed and caused an approximately 1m step in the channel bed gradient (Figure 31). Castlewood Country Club staff report that the slab was protecting a number of pipes that were crossing the channel, including one that brought water uphill to the “hill course” and the homes built there (John Vest, personal communication) (Figure 32). Those homes were built in the late 1950s and early 1960s, and thus our best estimate is that the slab was installed after the 1950s floods. But given that it was at approximately the same elevation as the exposed hardpan in the reach, it could have been installed at a later date, after the channel has incised to the hardpan elevation. Field photographs from 2007 shows the slab still largely functioning and intact, however golf course staff report that the slab was unstable in 2003 and likely before (John Vest, personal communication). The slab was completely undermined and collapsed during the December 2012 high flows, and was then removed in early 2013. The current channel only has scattered riprap remaining in the previous weir location (Figure 33).

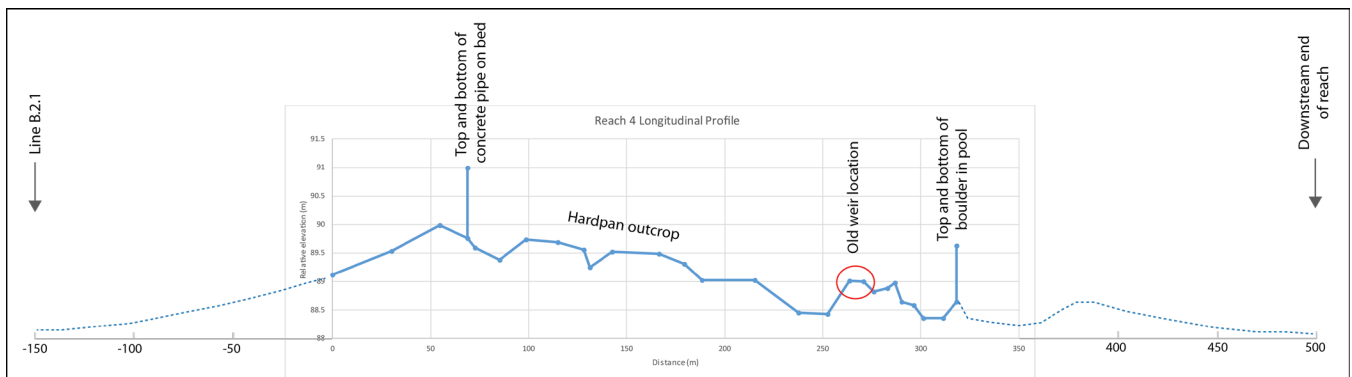
This reach also has the downstream-most exposure of hardpan in the channel. Hardpan essentially acts like a layer of impermeable concrete on the channel bed that slows incision. Likely because of the hardpan and/or the previous weir, the upstream channel gradient is more shallow than the downstream reach (Figure 34).

Overall the reach is fairly straight in planform, with a well-defined pool/riffle sequence that is evident in the surveyed longitudinal profile (Figure 34). In many locations current fluvial sediment is being deposited as a bar on top of the hardpan surface. The reach also has some larger boulders scattered across the bed; these are likely a mix of blocks of failed outer bank material and failed riprap from this reach (Foothill Road protection) and from previous development and repairs that have occurred further upstream (1988 Golden Eagle development and 1996 Zone 7 storm damage repairs). The outer banks are steep, but not quite vertical, with evidence of dry-ravel style failure (visible in the field) and slump block failure (visible in the LiDAR). There is one significant fresh bank slump location (Figure 35) that contributed a mix of sediment grain sizes directly to the channel. The reach has LWD in the channel due to outer bank failures recruiting riparian trees into the channel. Currently many other trees are located on top of the bank and are in danger of falling in with future bank failures. Terrace surfaces at different elevations on the right and left banks are clearly observed.

Figure 34. Field surveyed longitudinal profile for Reach 4 (solid line). Units in meters. Each end of the profile is estimated (dashed line). The previous weir location is circled in red. A very large and deep pool exists at the confluence of Line B.2.1; a longer profile would provide more context for this short reach, including showing the gradient change of this segment in context with the larger reach.

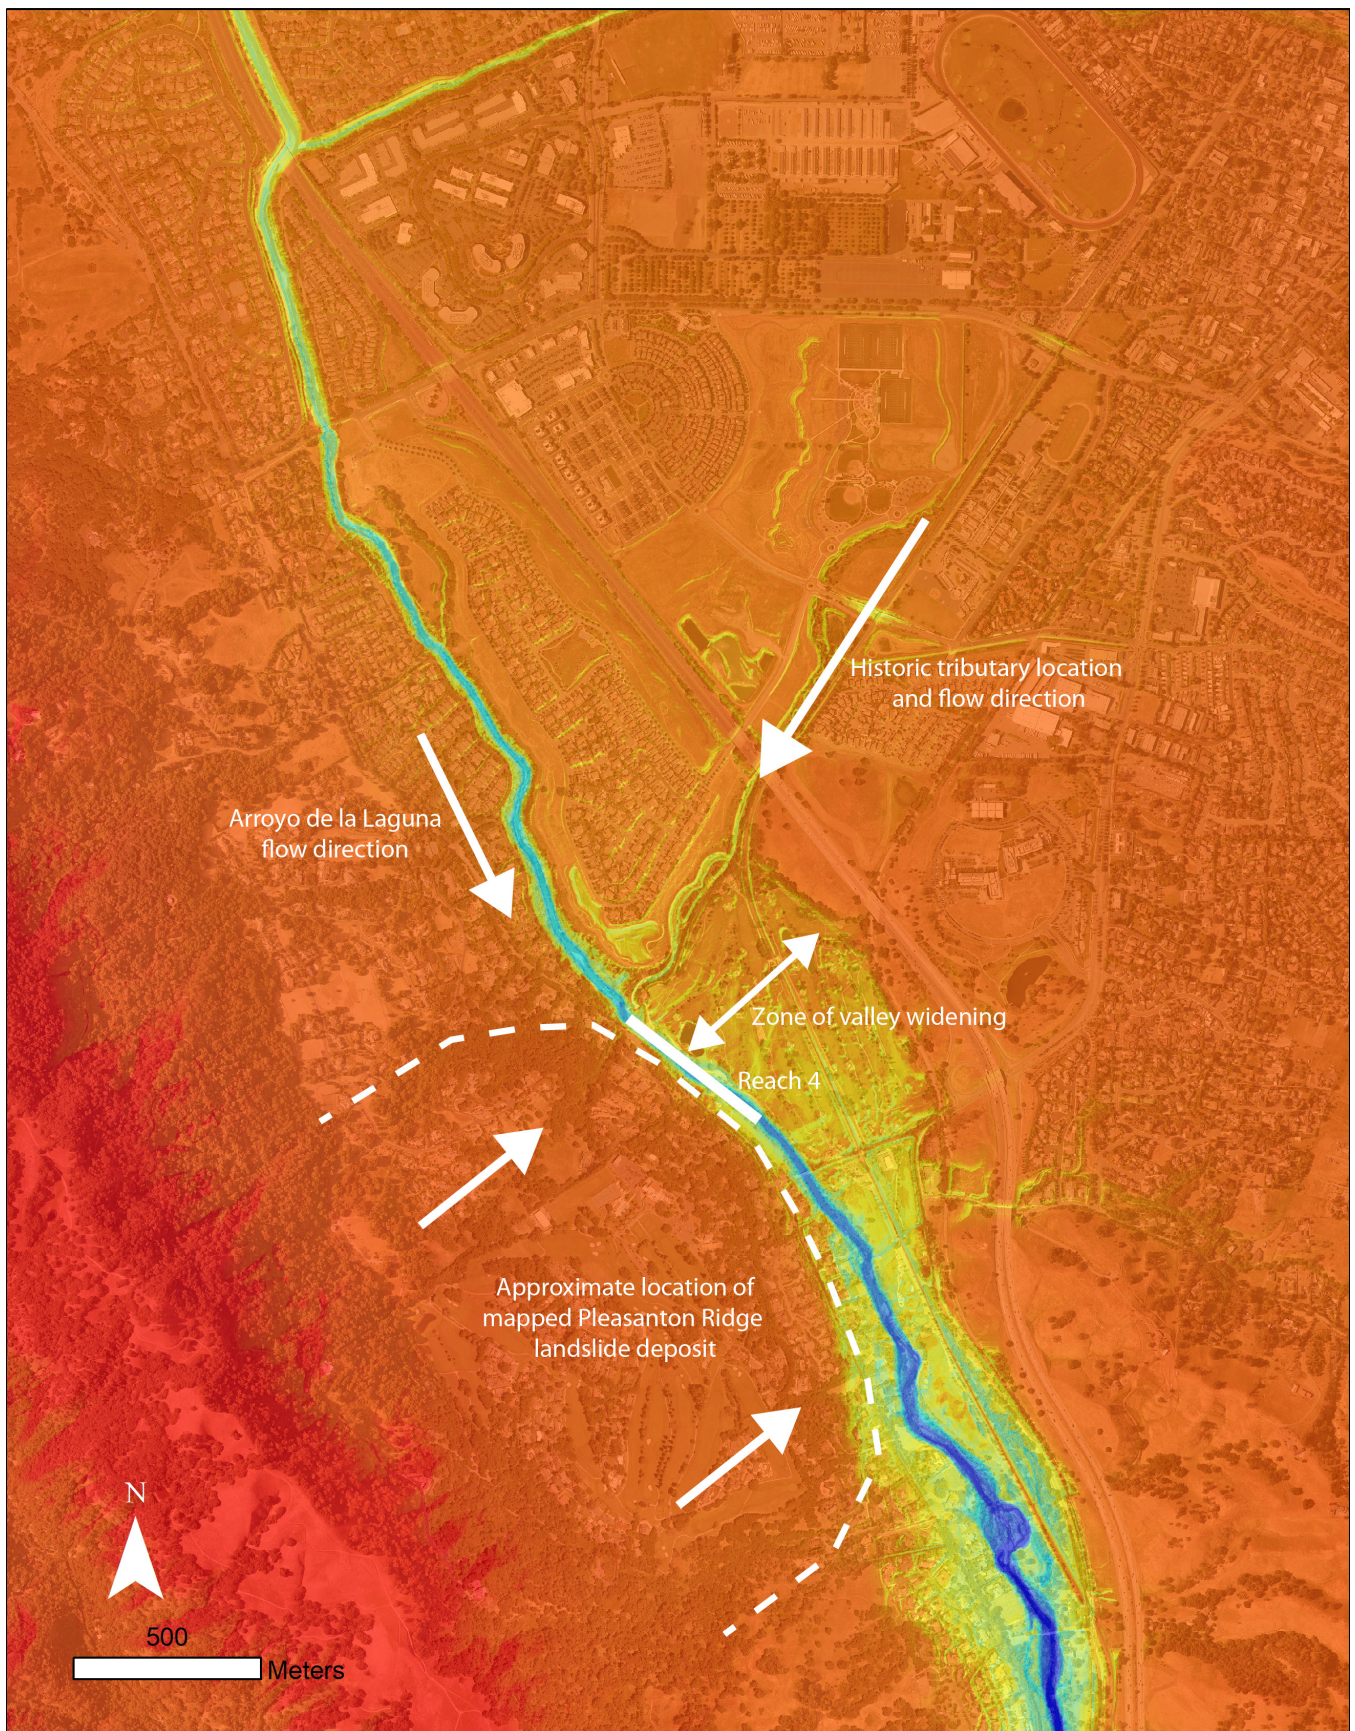
This upstream end of the reach is defined by the location where a tributary enters from the northeast, and the valley widens significantly, also to the northeast (Figure 36). Additionally, mapping of landslide deposits shows an ancient Pleasanton Ridge landslide deposit in this location (Majmundar, 1995). Although it would require significant additional study to test, we hypothesize that the interaction of the landslide (from the west), ADLL (flowing north to south), and the tributary (from the east) caused the valley widening, and may have contributed to the

Figure 36. Annotated DEM illustrating the location of a Pleasanton Ridge landslide deposit and the zone of valley widening. Warm colors are higher elevations, and cool colors are lower elevations.

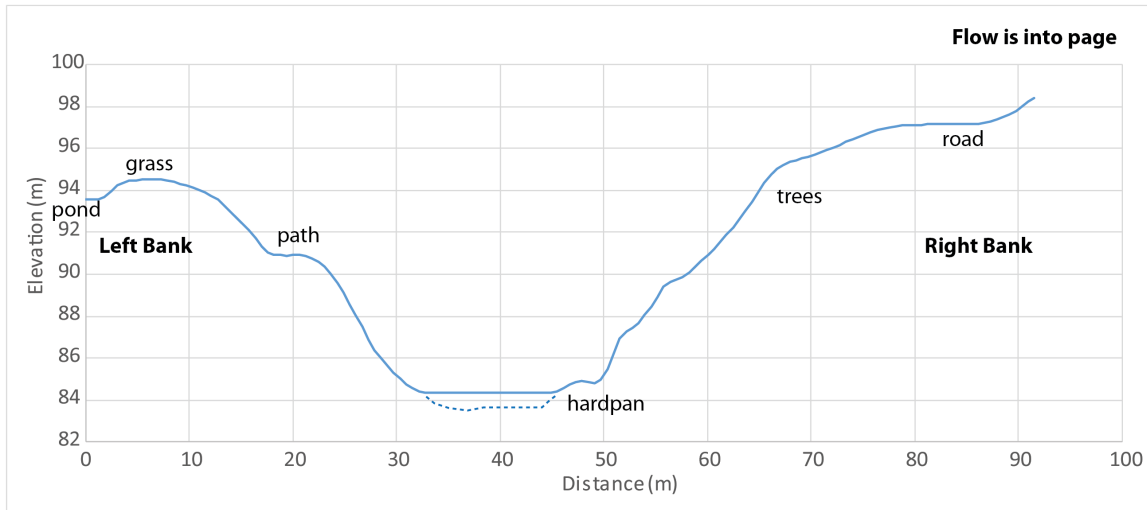
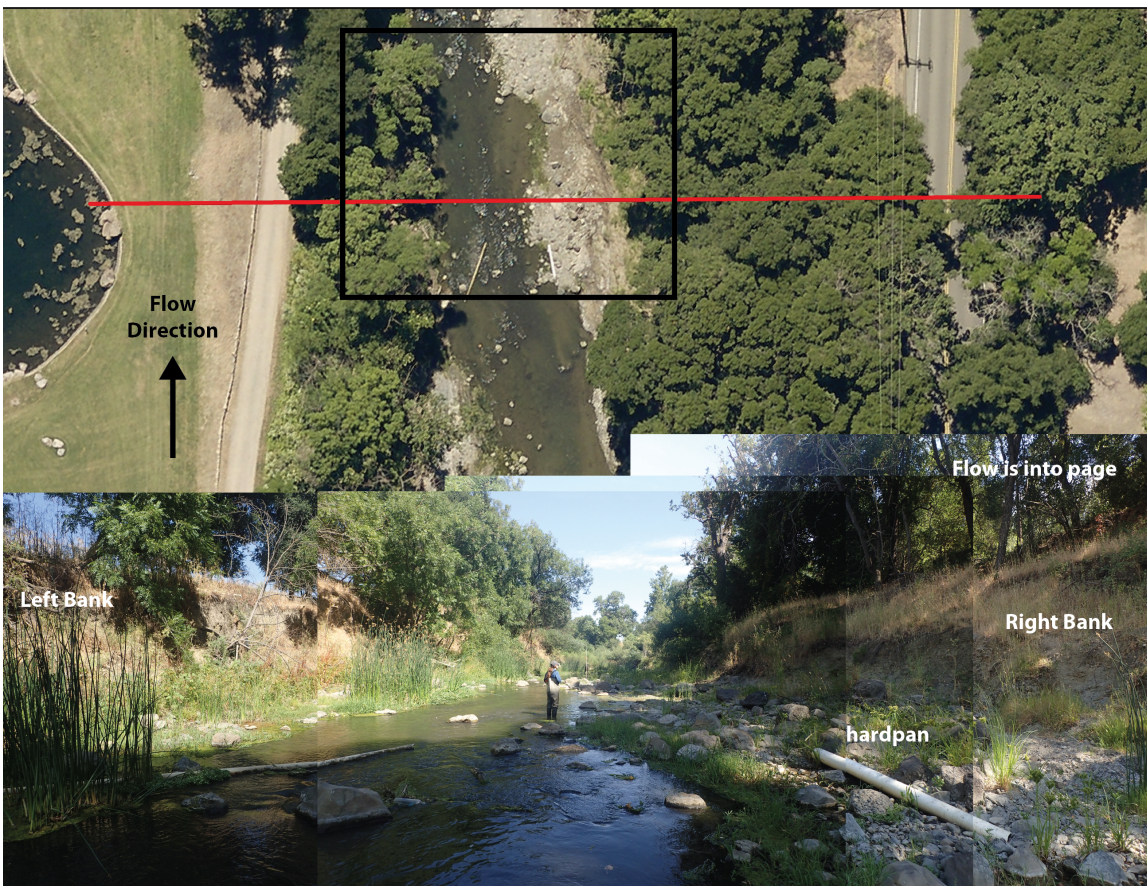
Although the terrace elevation is somewhat rounded in the representative cross section for this reach, other places in this reach have more prominent terraces that were readily visible in the field (Figure 37). A terrace surface about 5-6 m above the current bed exists on the right bank, and a terrace surface about 7-8 m above the current bed exists on the left bank. Hardpan is exposed in this reach, with the highest elevation approximately 1.5 m above the current bed.

Figure 37. Representative cross section for Reach 4. Solid line shows elevations directly from LiDAR, while the dashed line shows approximate elevations from field observation.
