ARROYO DE LA LAGUNA REACH-BASED GEOMORPHIC EVALUATION

NOVEMBER 2023

PREPARED BY
San Francisco Estuary Institute

IN PARTNERSHIP WITH
Alameda County Flood Control and
Water Conservation District, Zone 7

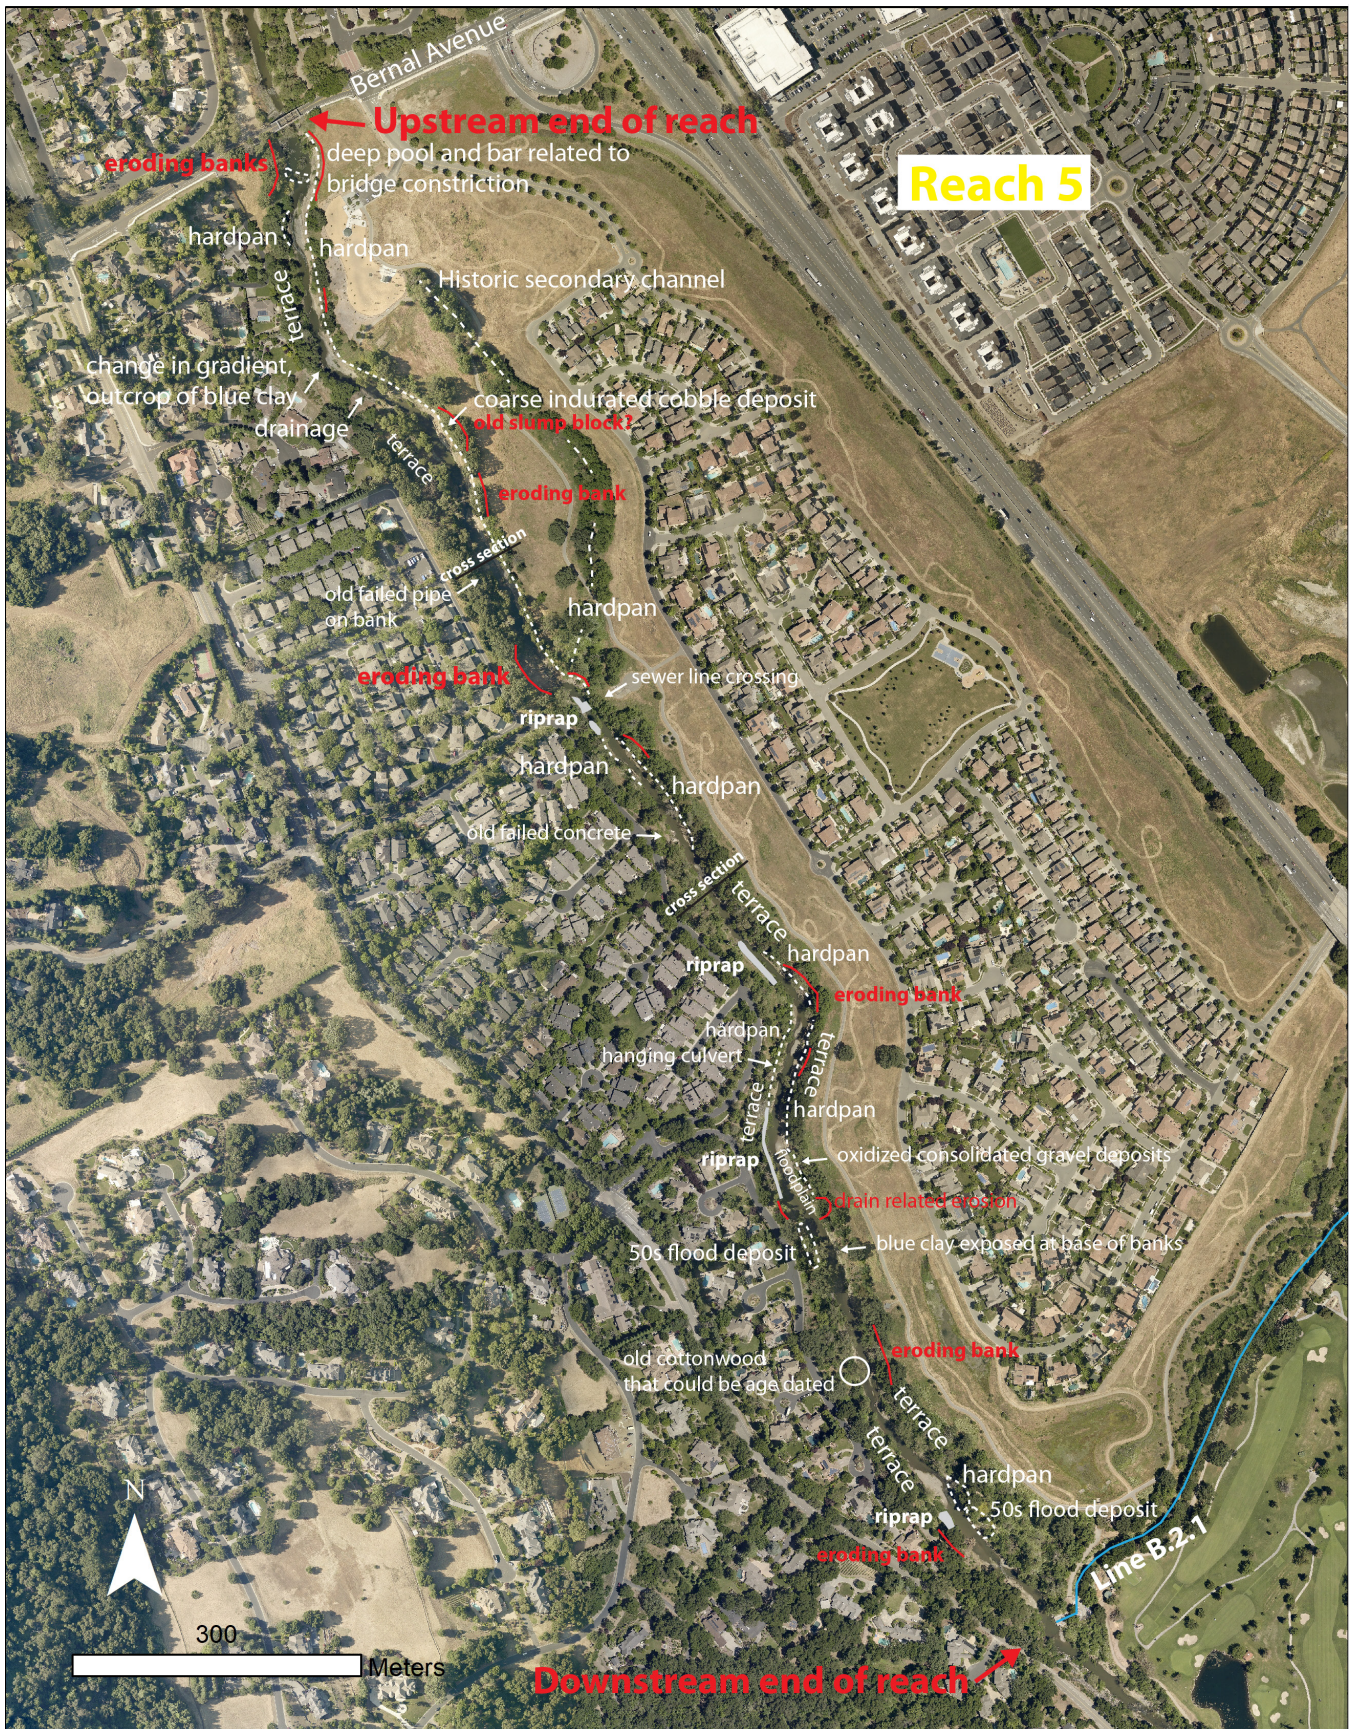
Figure 39. Channel map for Reach 5.

Reach 5 extends from the confluence with Line B.2.1 upstream to Bernal Avenue (Figure 39). This reach is marked by the presence of hardpan exposed in the channel, and currently forming a ledge approximately 1 m above the channel bed for most of the length. The channel is fairly narrow, with steep, nearly vertical outer banks. A terrace surface varying in height from 5-9 m is present throughout most of the reach (Figure 40). The banks show evidence of dry-ravel style failure, although many portions of the bank appear to not be actively eroding. Previous bank failures have recruited trees that are now in the channel as LWD, and a number of other trees are currently in danger of future recruitment. Some of the terrace slopes are seeping groundwater. Although a few riffles are present (7 over an 1,800 m distance) the majority of the reach length is characterized as a plane bed channel. There are some higher bar surfaces (about 2 m above the bed elevation) that appear to be activated during flows slightly higher than bankfull flows (i.e., approximately 1.5 to 2-year flows). The land use along the right bank is suburban residential, while the left bank is park land owned and maintained by the City of Pleasanton. The park contains an historical secondary channel of ADLL (at an elevation higher than the present mainstem channel bed), marked by the presence of remnant riparian vegetation.

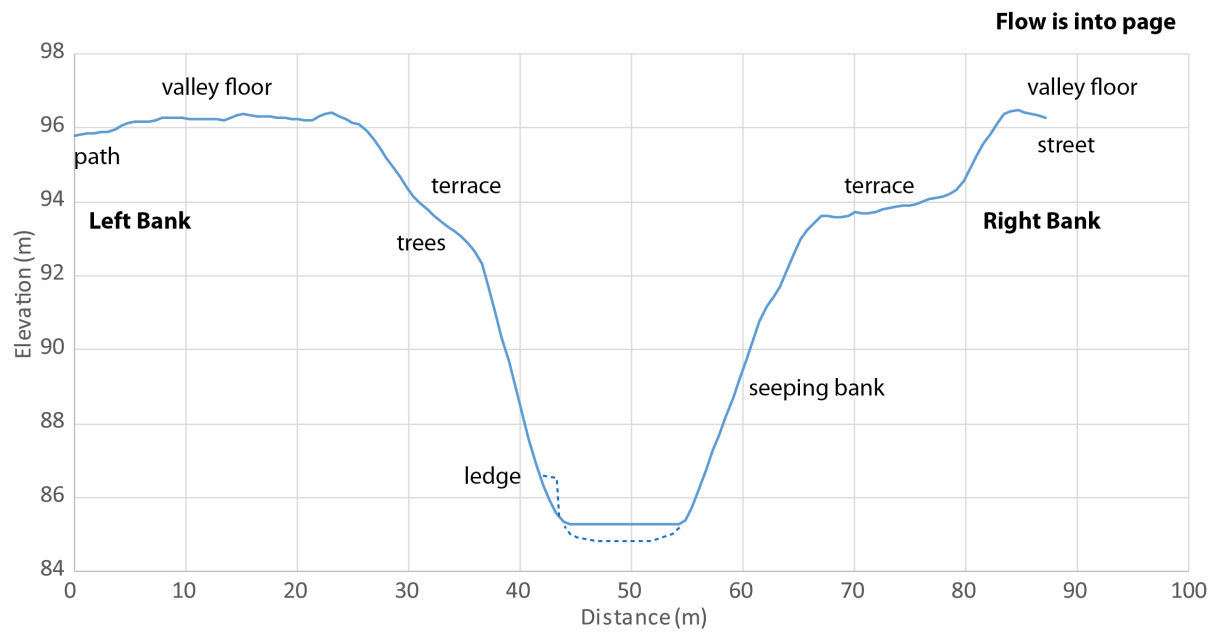
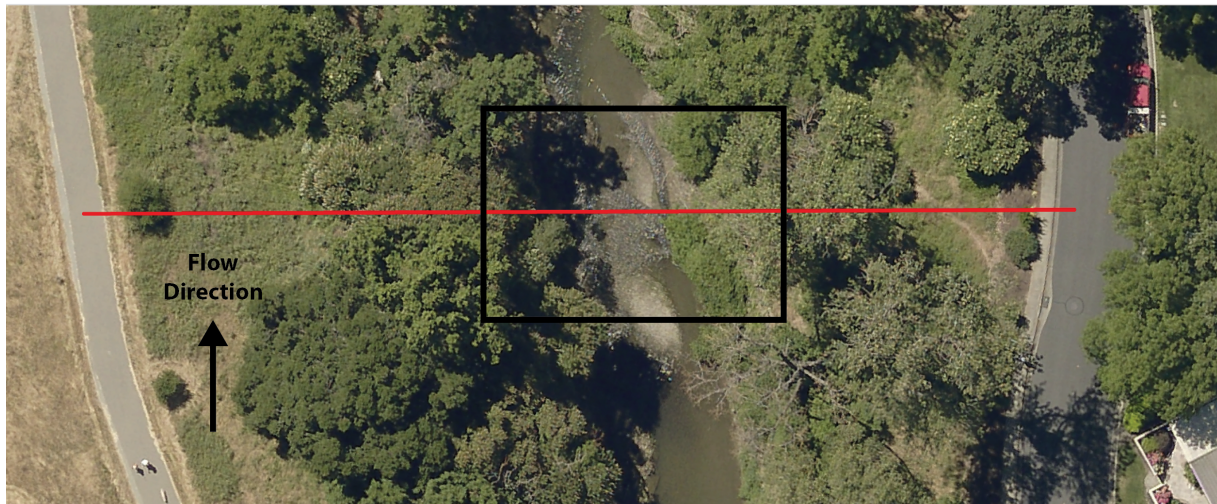
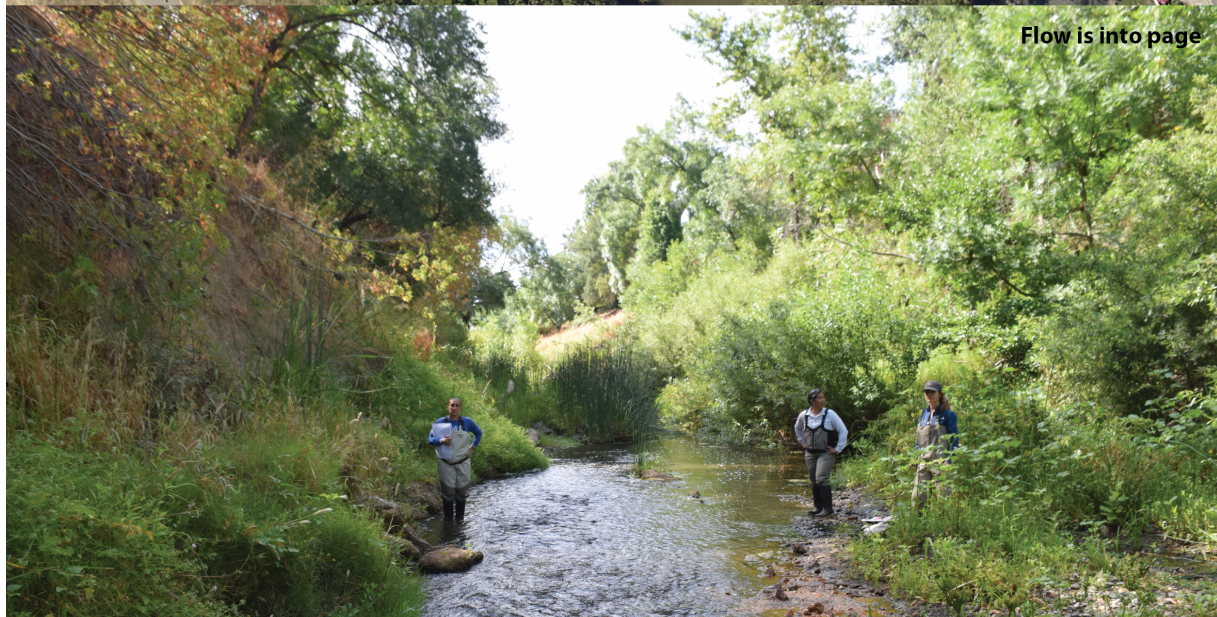
The representative cross sections for this reach show that the channel is fairly narrow, with exposed hardpan sitting slightly elevated above the current channel bed (Figures 44 and 45). The outer bank slopes are steep, with a terrace running the entire length of the reach. The overall cross section shape is much more of a “V” rather than a “U” that is observed further downstream, indicating that the incision that is occurring in this reach is younger, and the channel has not yet widened.

In the future we expect this reach to widen. Because of the presence of the hardpan in this reach and the downstream reach, we do not expect this reach to significantly incise further, unless a knickpoint works its way upstream (see more discussion on this in Reach 4). If this were to occur, incision would likely occur on the order of 2-3 decades. Instead, we anticipate erosion and failure of the outer banks, creating a wider channel cross section. Eventually the increased width will allow for deposition of bars and ultimately a floodplain.

Figure 44. Downstream representative cross section for Reach 5. Solid line shows elevations directly from LiDAR, while the dashed line shows approximate elevations from field observation.

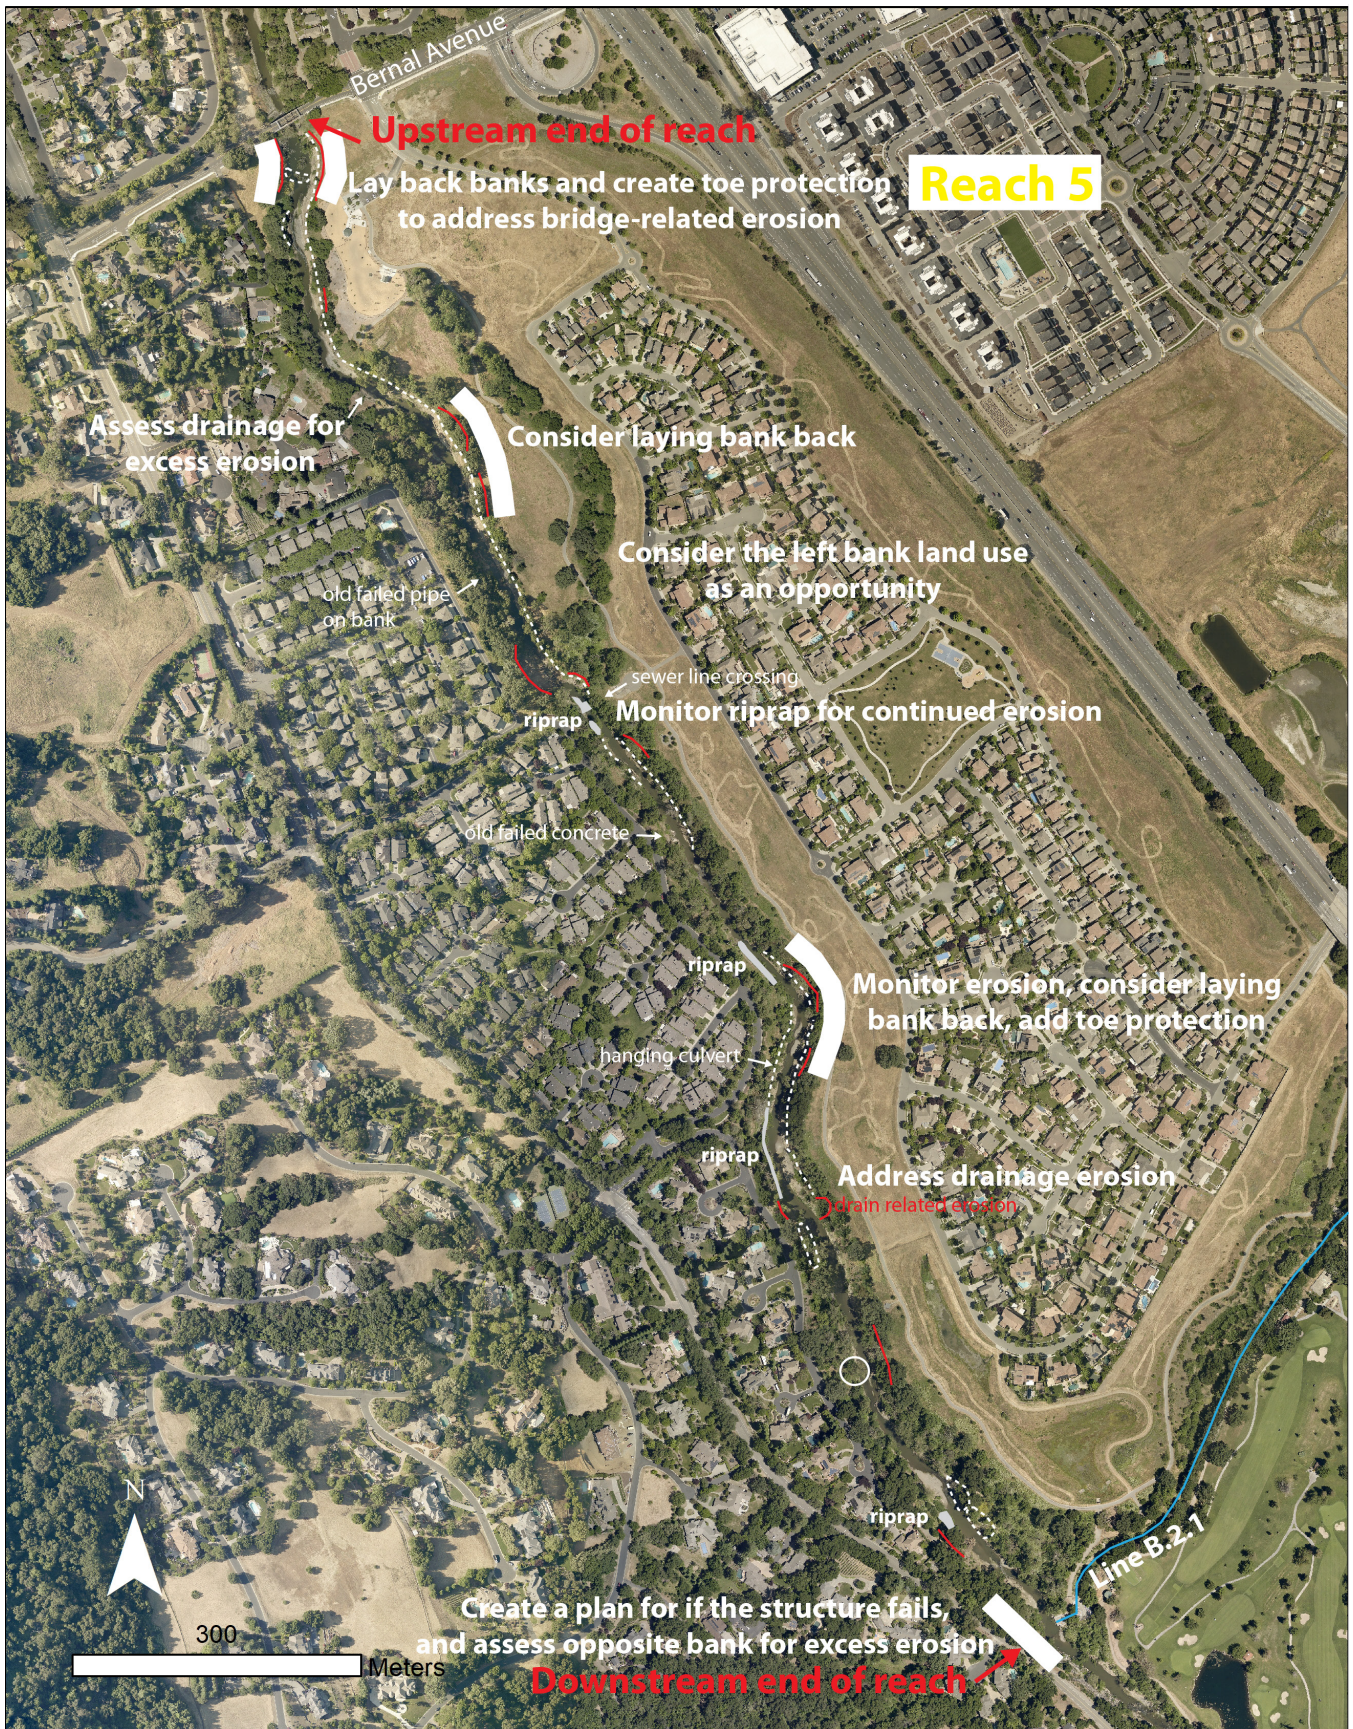
Like many of the other reaches, there is risk of further erosion of the outer banks due to channel widening that threatens to erode property on the right bank (Figure 46). This could be exacerbated if the headwardly eroding knick point moves through Reach 4, and begins to impact Reach 5. Erosion of the protective riprap placed on the pump station pipe that spans the channel bed may continue, leaving the pipe vulnerable to damage.

Figure 46. Risks and opportunities for Reach 5.

In terms of opportunities for proactive management, the left bank is entirely City of Pleasanton park area which could be laid back to limit/reduce erosion occurring on the opposite bank, without major changes to park function or alignment. An historical side channel still exists through the park, and, though its elevation is much higher than the current channel bed, and the frequency with which it activates is unknown, it could present an opportunity to engineer a solution to spread flows across a wider cross section in the reach and alleviate pressure on banks downstream. It could be evaluated for feasibility, and would increase channel complexity and habitat value of the stream. As with other reaches, an anticipatory management plan (Beagle et al., 2016) could be created to plan for failures that occur on the right bank, allowing fixes to occur that will work with the larger channel evolution in this reach, and will not deflect erosional problems onto adjacent properties.

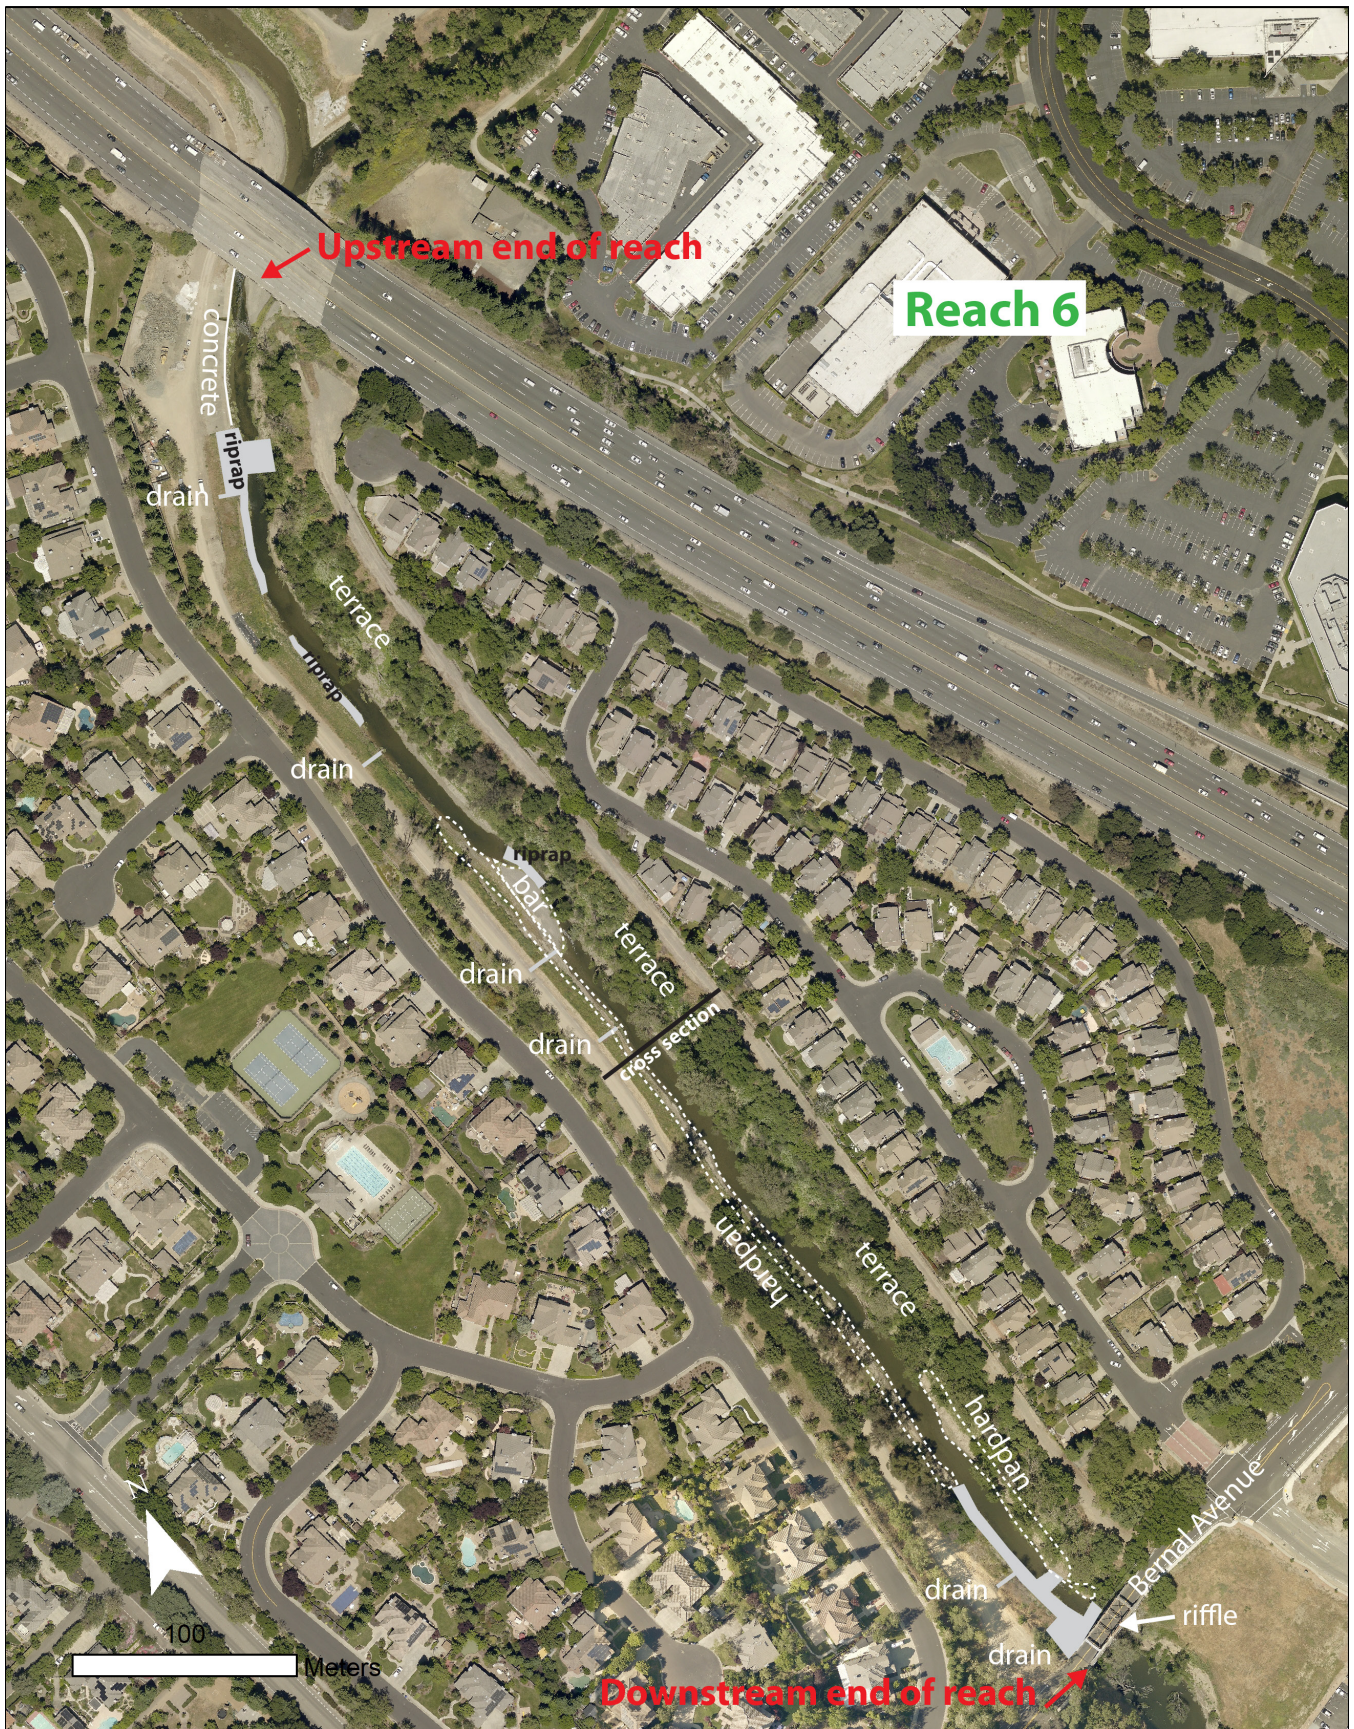
Figure 47. Reach 6 channel map.

Reach 6 extends from Bernal Avenue upstream to the Interstate 680 crossing (Figure 47). The reach overall is very homogenous, and maintains a simple shape likely due to its history as a ditched reach through the historical Pleasanton Marsh. The reach is fairly straight, except for the curve at the upstream end where it flows underneath the 680 bridge.

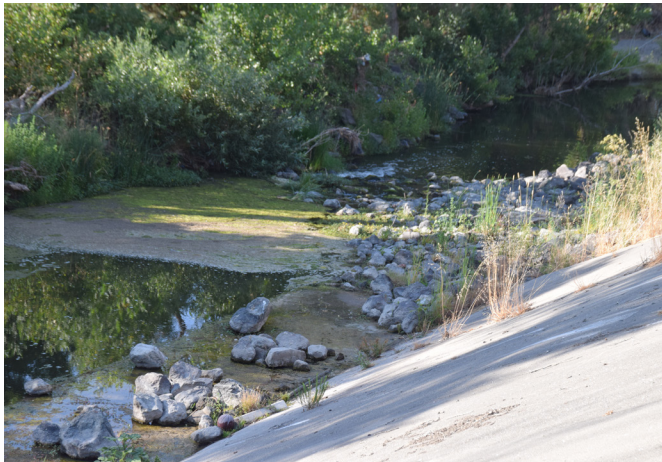
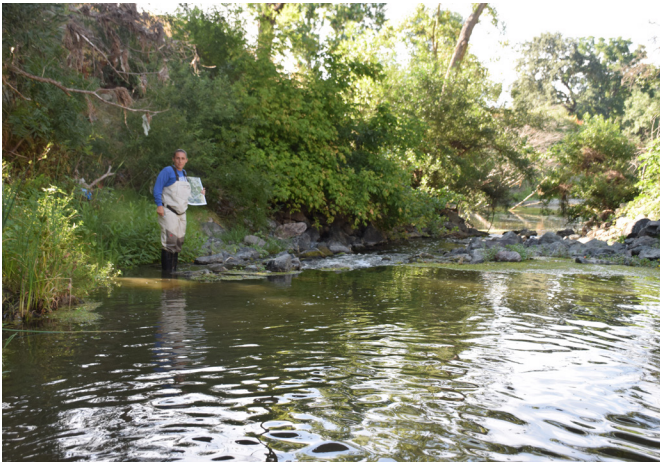
The channel pattern is mostly glide, with a riffle at the top (intentionally placed riprap that is forming a grade control), the middle as it flows over riprap (likely intentionally placed), and the bottom (intentionally placed riprap associated with the bridge footers) (Figure 49). Hardpan is exposed in the lower half of the channel reach, extending from Bernal Avenue upstream to the middle where a large low elevation bar has formed on the hardpan (Figure 50). There are no 1950s flood deposits or emerging floodplains in this reach.

Figure 49. Riprap forming riffle at top of reach; riffle at bottom of reach under Bernal Avenue bridge.

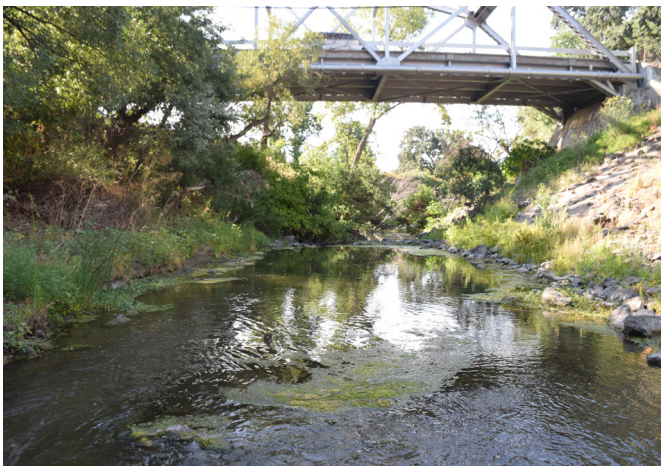
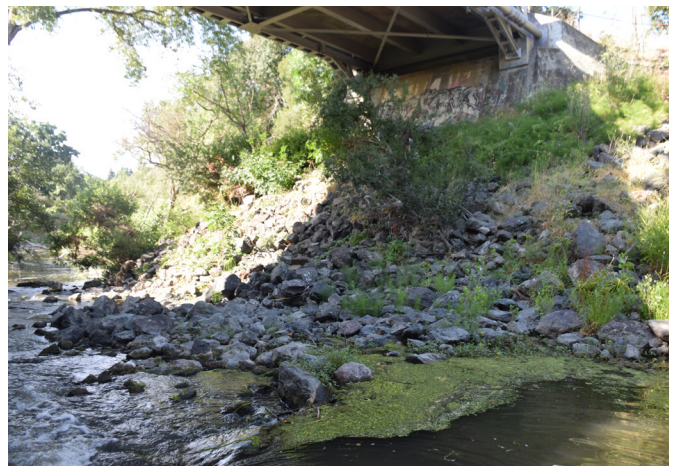
At the downstream end of the reach, the Bernal Avenue bridge deck is high above the bed, but the bridge earthen footers impinge upon the channel cross section (Figure 51). The width between footers is fairly narrow, and likely causes a hydraulic constriction during high flows. As the channel passes through the footer, a steep riffle has formed, with a gradient much higher than the channel up or downstream of the bridge. The riffle gradient is approximately 2.7%. Likely because of the constriction, downstream of the bridge the banks have blown out due to eddying, with significant failures of both the right and left vertical banks. Because these banks are 10-12 m tall, failures contribute a significant volume of sediment to the channel. In addition, a very deep pool (too deep to wade) and an arcuate bar on the downstream side of the pool have formed due to the scour and resultant deposition from the constriction (Figure 52) that are technically in Reach 5.

Figure 51. Bernal Avenue bridge footers.

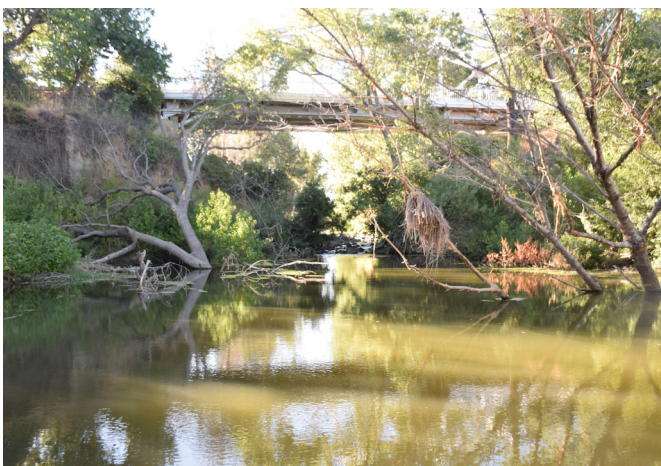
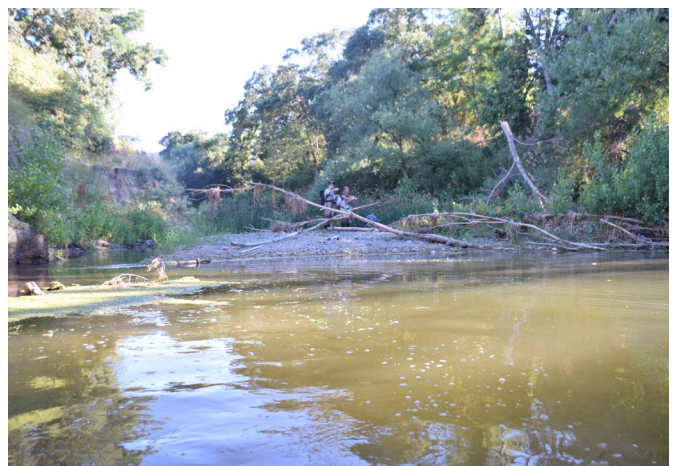
Figure 52. Looking upstream at the pool developed on the downstream side of Bernal Avenue; looking downstream at the arcuate bar deposited at the downstream end of pool.

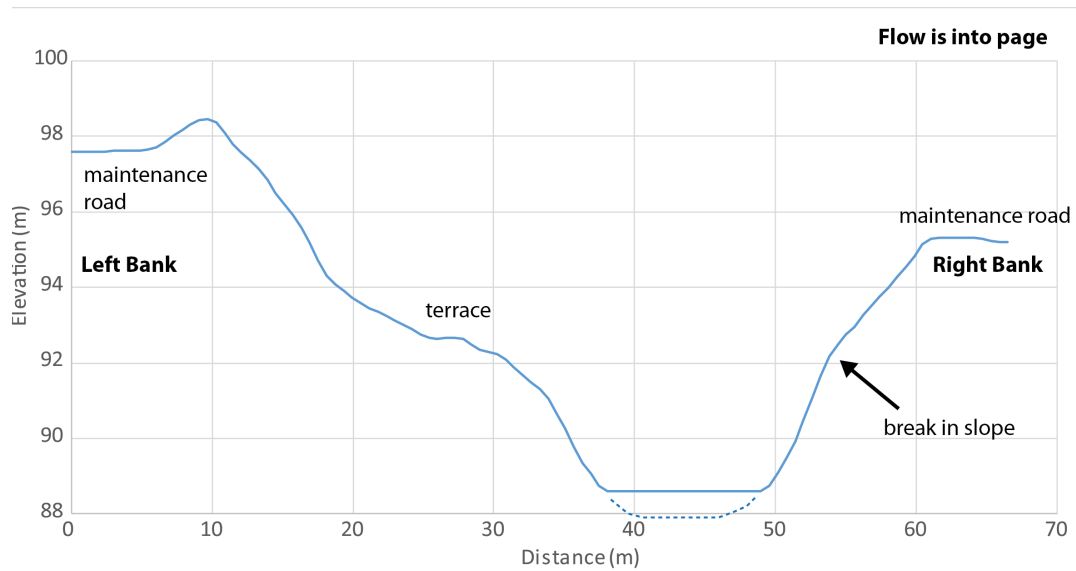
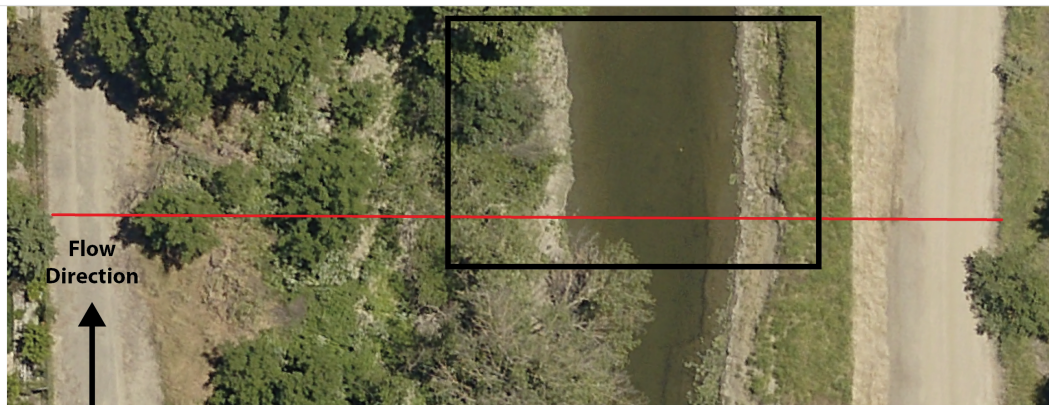
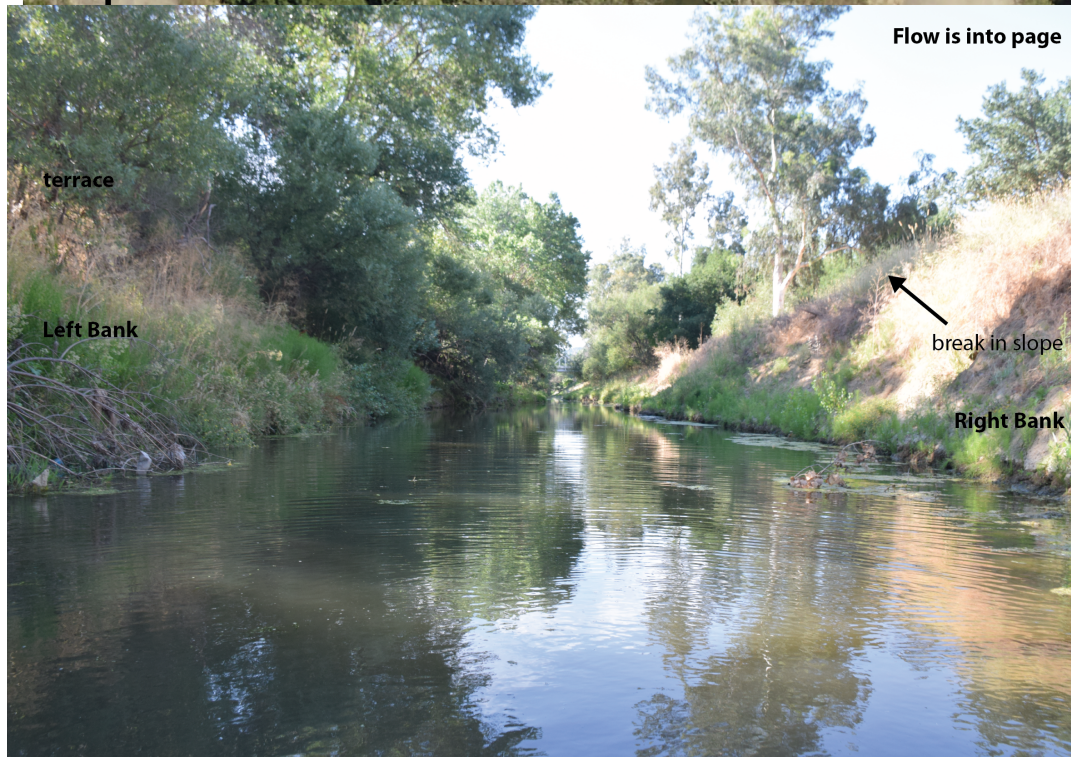
The representative cross section shows the constant constructed slope of the right bank, and the terrace on the left bank (Figure 53). It also shows the slight break in slope on the right bank that

Figure 53. Representative cross section for Reach 6. Solid line shows elevations directly from LiDAR, while the dashed line shows approximate elevations from field observation.

corresponds with the terrace elevation. It also shows the “V” shape of the lower banks, and the vertical slope of the lowest portion of the bank.

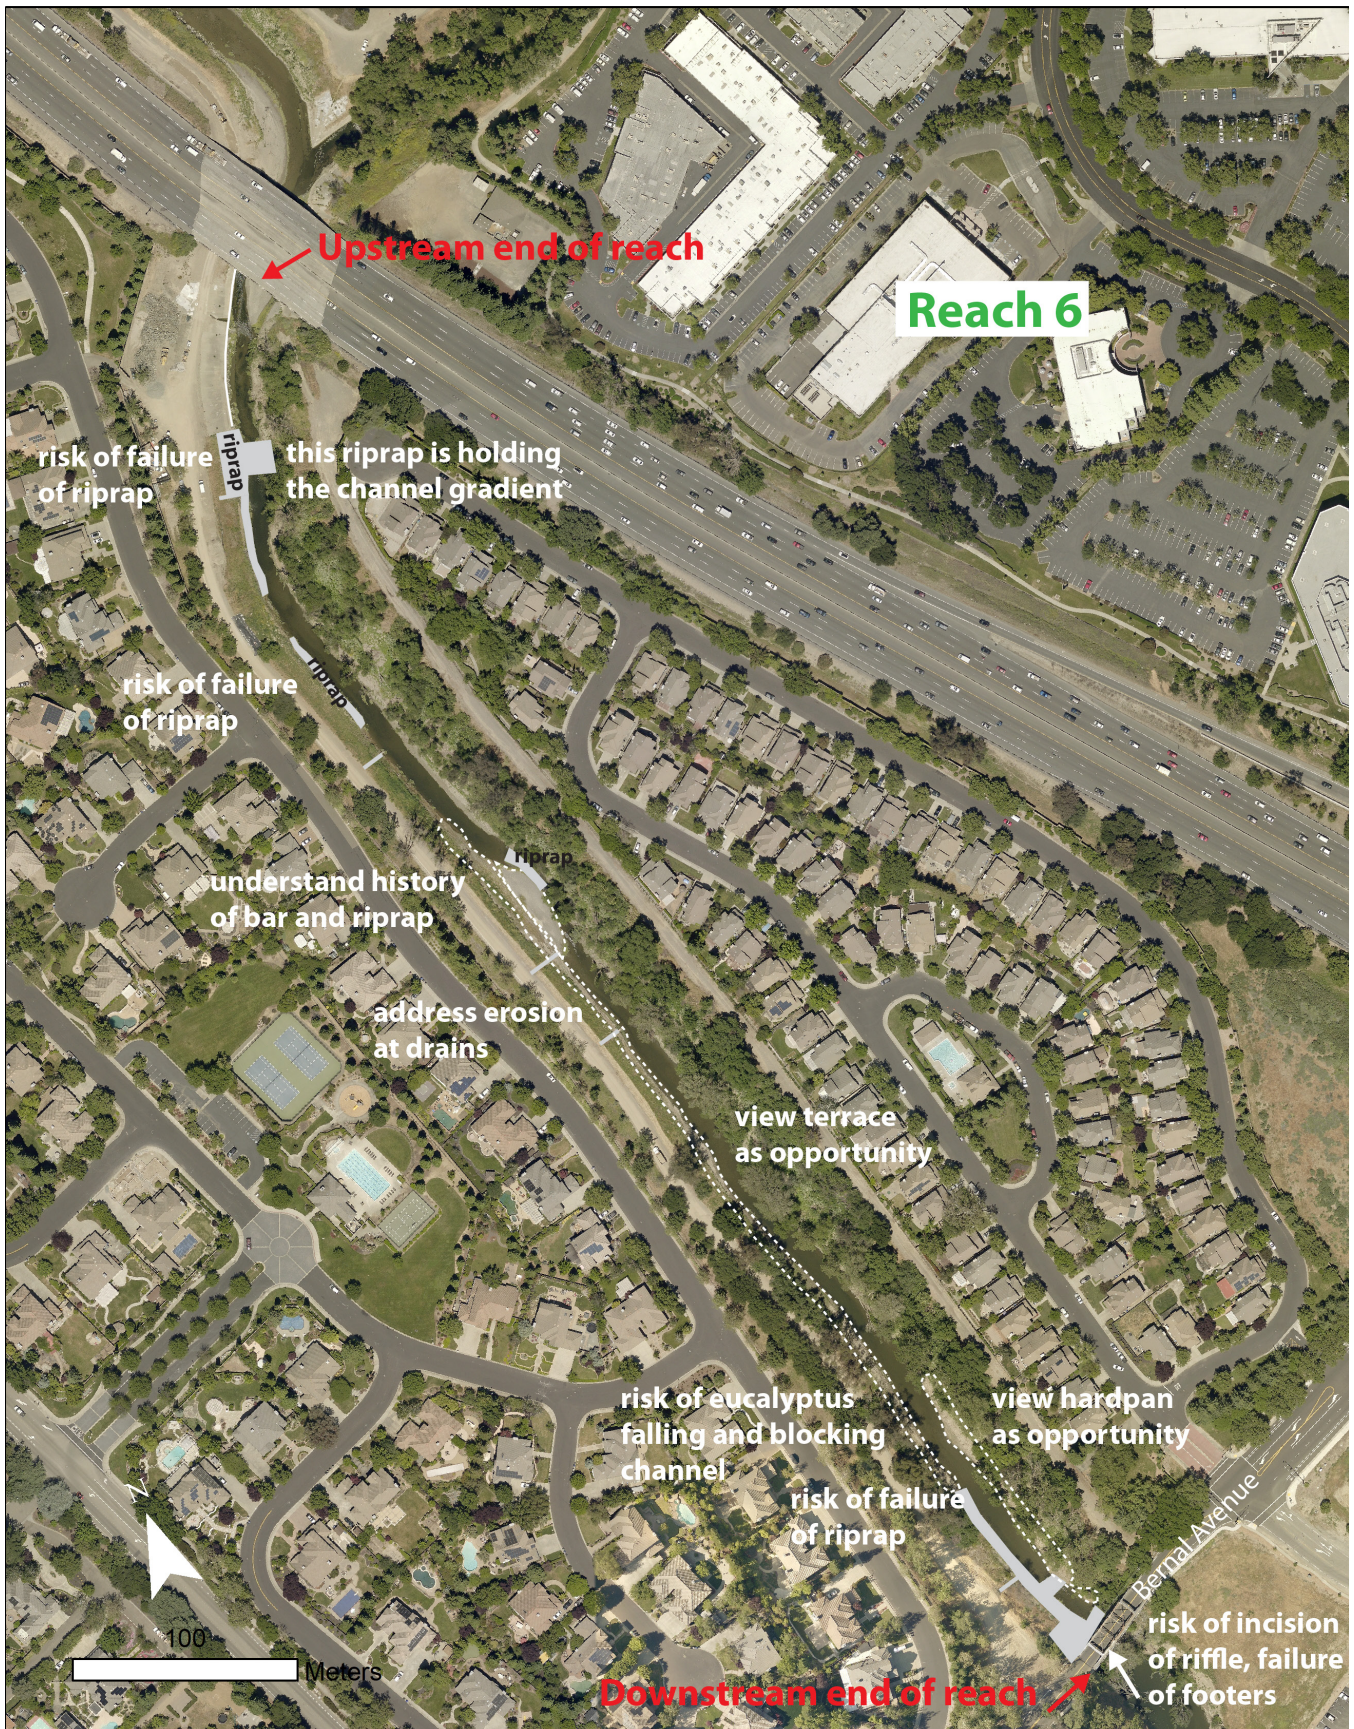
Risks in this reach are minimal, yet should be considered in a plan for the entire stream (Figure 54). It is possible, though unlikely that a knick point will move through this reach. More likely would include an undermining failure associated with the Bernal Avenue bridge footers, as well as rotational style failures of the right bank. If large enough, these failures could constrict part of the channel, which is fairly narrow in this reach. If one of the large trees (e.g. eucalyptus) were recruited or wind-blown and fell into the channel, it could block the narrow channel width at the Bernal Avenue bridge footer.

Figure 54. Reach 6 risks and opportunities.

However, the right bank might provide opportunity to set the bank back or to create an inset floodplain, given that it has some available distance between the creek and the property boundary. The maintenance road could be narrowed, although it would need to remain wide enough to allow maintenance and construction vehicles, or it could be moved to the west so that it is immediately adjacent to the property boundary. The hardpan in the lower half of the reach should also be viewed as an opportunity because it will likely help hold the channel gradient.
