ARROYO DE LA LAGUNA REACH-BASED GEOMORPHIC EVALUATION

NOVEMBER 2023

PREPARED BY
San Francisco Estuary Institute

IN PARTNERSHIP WITH
Alameda County Flood Control and
Water Conservation District, Zone 7

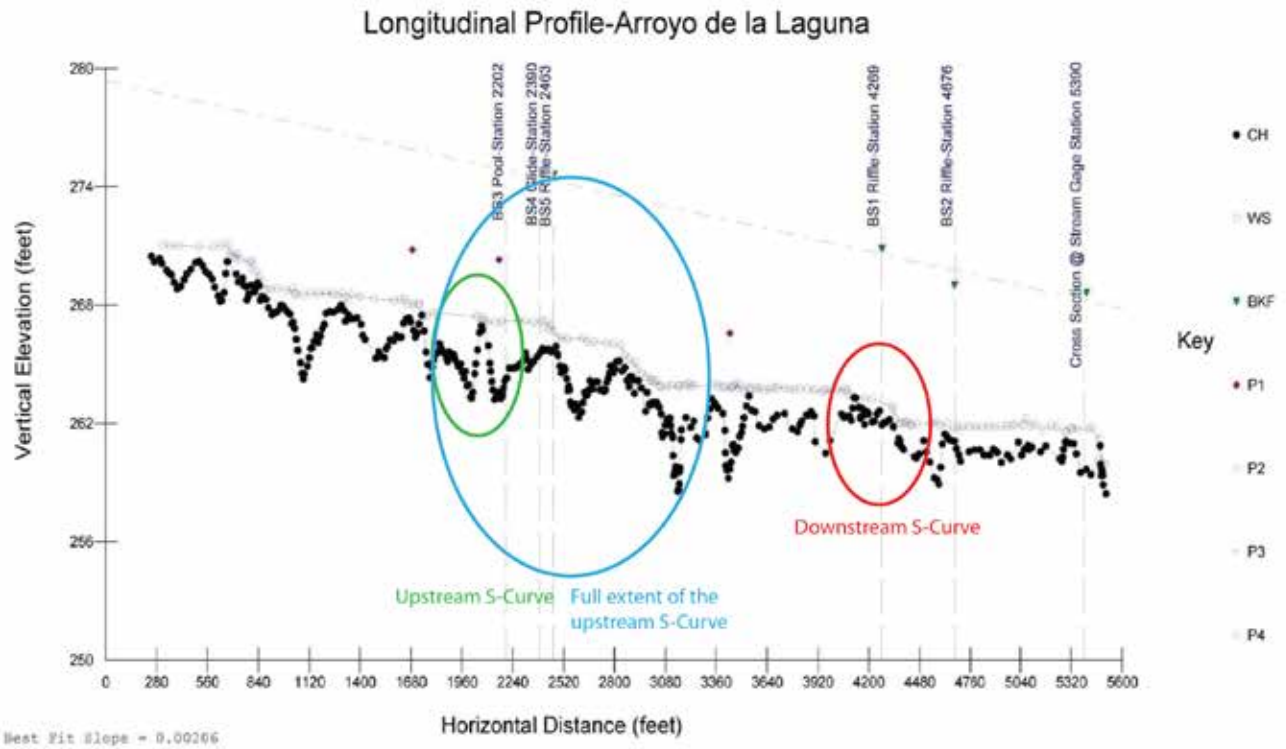
The channel bed riffles in this reach are visible on field-surveyed longitudinal profiles (Stantec, 2011) as steeper reaches, as compared to up and downstream reaches (Figure 14). It is not clear if the bed coarsening is due to deposition of transported bedload due to loss of stream power in the wider reach, or if the locally-sourced failed bank material is unable to be effectively transported, and thus acting as a “slug” of sediment.

Figure 14. Field surveyed longitudinal profile (Stantec, 2011) showing the steeper gradient in the downstream S-curve (red oval). The upstream S-curve is shown in the green oval, with the larger extent of the S-curve shown in the blue oval, also displaying a steeper gradient.

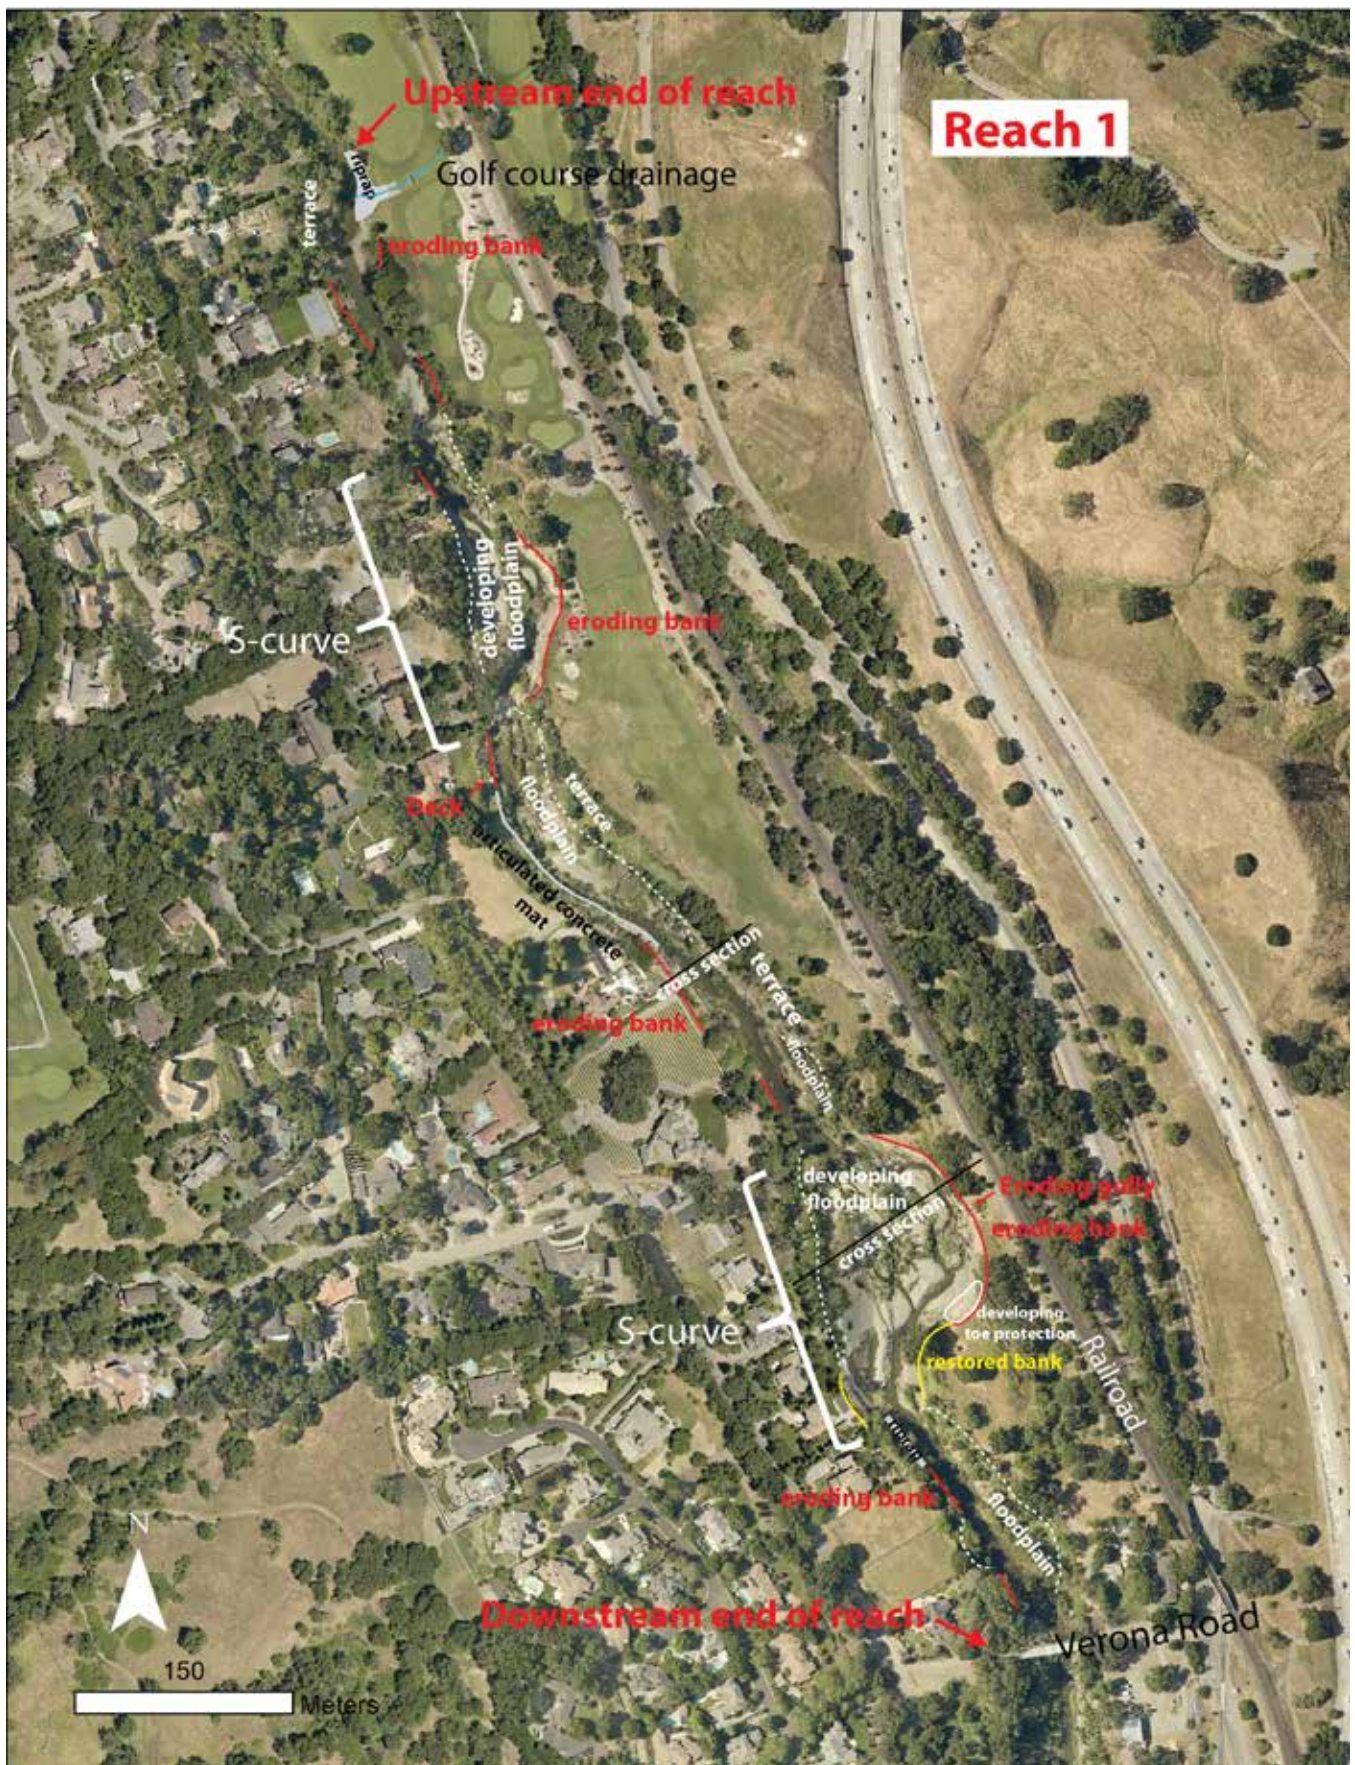
The current land use adjacent to channel is variable throughout the reach (Figure 16). In general the left bank is either Castlewood Country Club property (golf course) or undeveloped land. The right bank is largely residential properties. Specifically at the downstream S-curve, the left bank is primarily open space recently transferred to Zone 7 ownership and the berm for the BNSF railroad trestle.

Figure 16. Channel map of Reach 1.

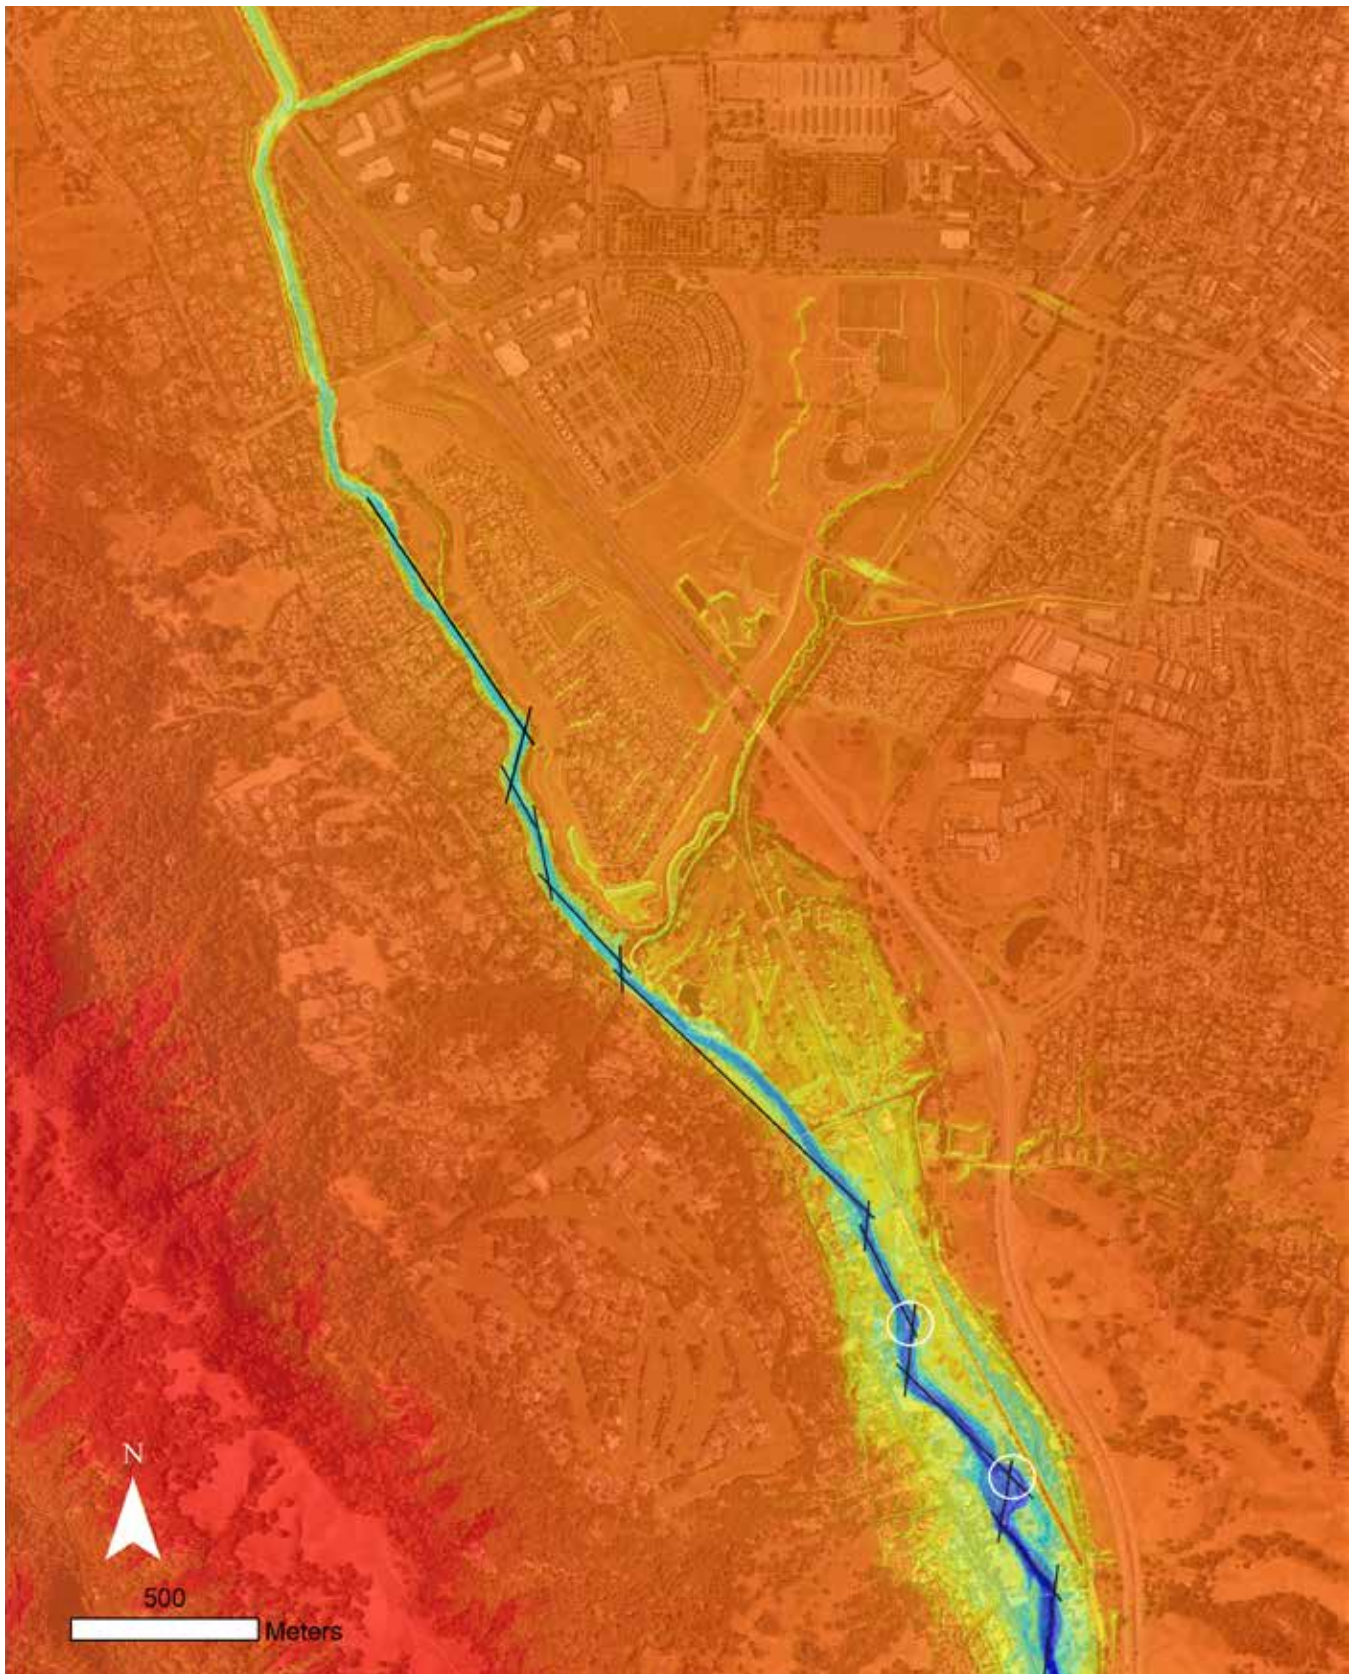
transition points in flow direction from SE to SW (Figure 19). While the stream pattern is not superimposed directly upon the location of faults, it does appear to be mimicking the regional NW-SE strain orientation. This pattern is most clear in Reach 1, likely due to the more advanced evolution, however it occurs the entire length of study area. Of note, the S-curve locations downstream of Verona also follow this pattern. If this hypothesis is true, and knowing that we can't control tectonic movement, then perhaps additional management focus can be placed on the upstream flow direction transition points, as we know they might be future potential nodes of erosion. Thus, following this hypothesis and based upon flow direction and the steepness of the longitudinal profile, we expect the upstream S-curve in Reach 1 to be the next large node of erosion.

Figure 19. DEM for the ADLL study area, with generalized flow direction (north to south) of the channel superimposed (black lines). The lower right corner shows Reach 1, with nodes of erosion (circles on the downstream and upstream S-curve locations) indicating the transition points in flow direction.

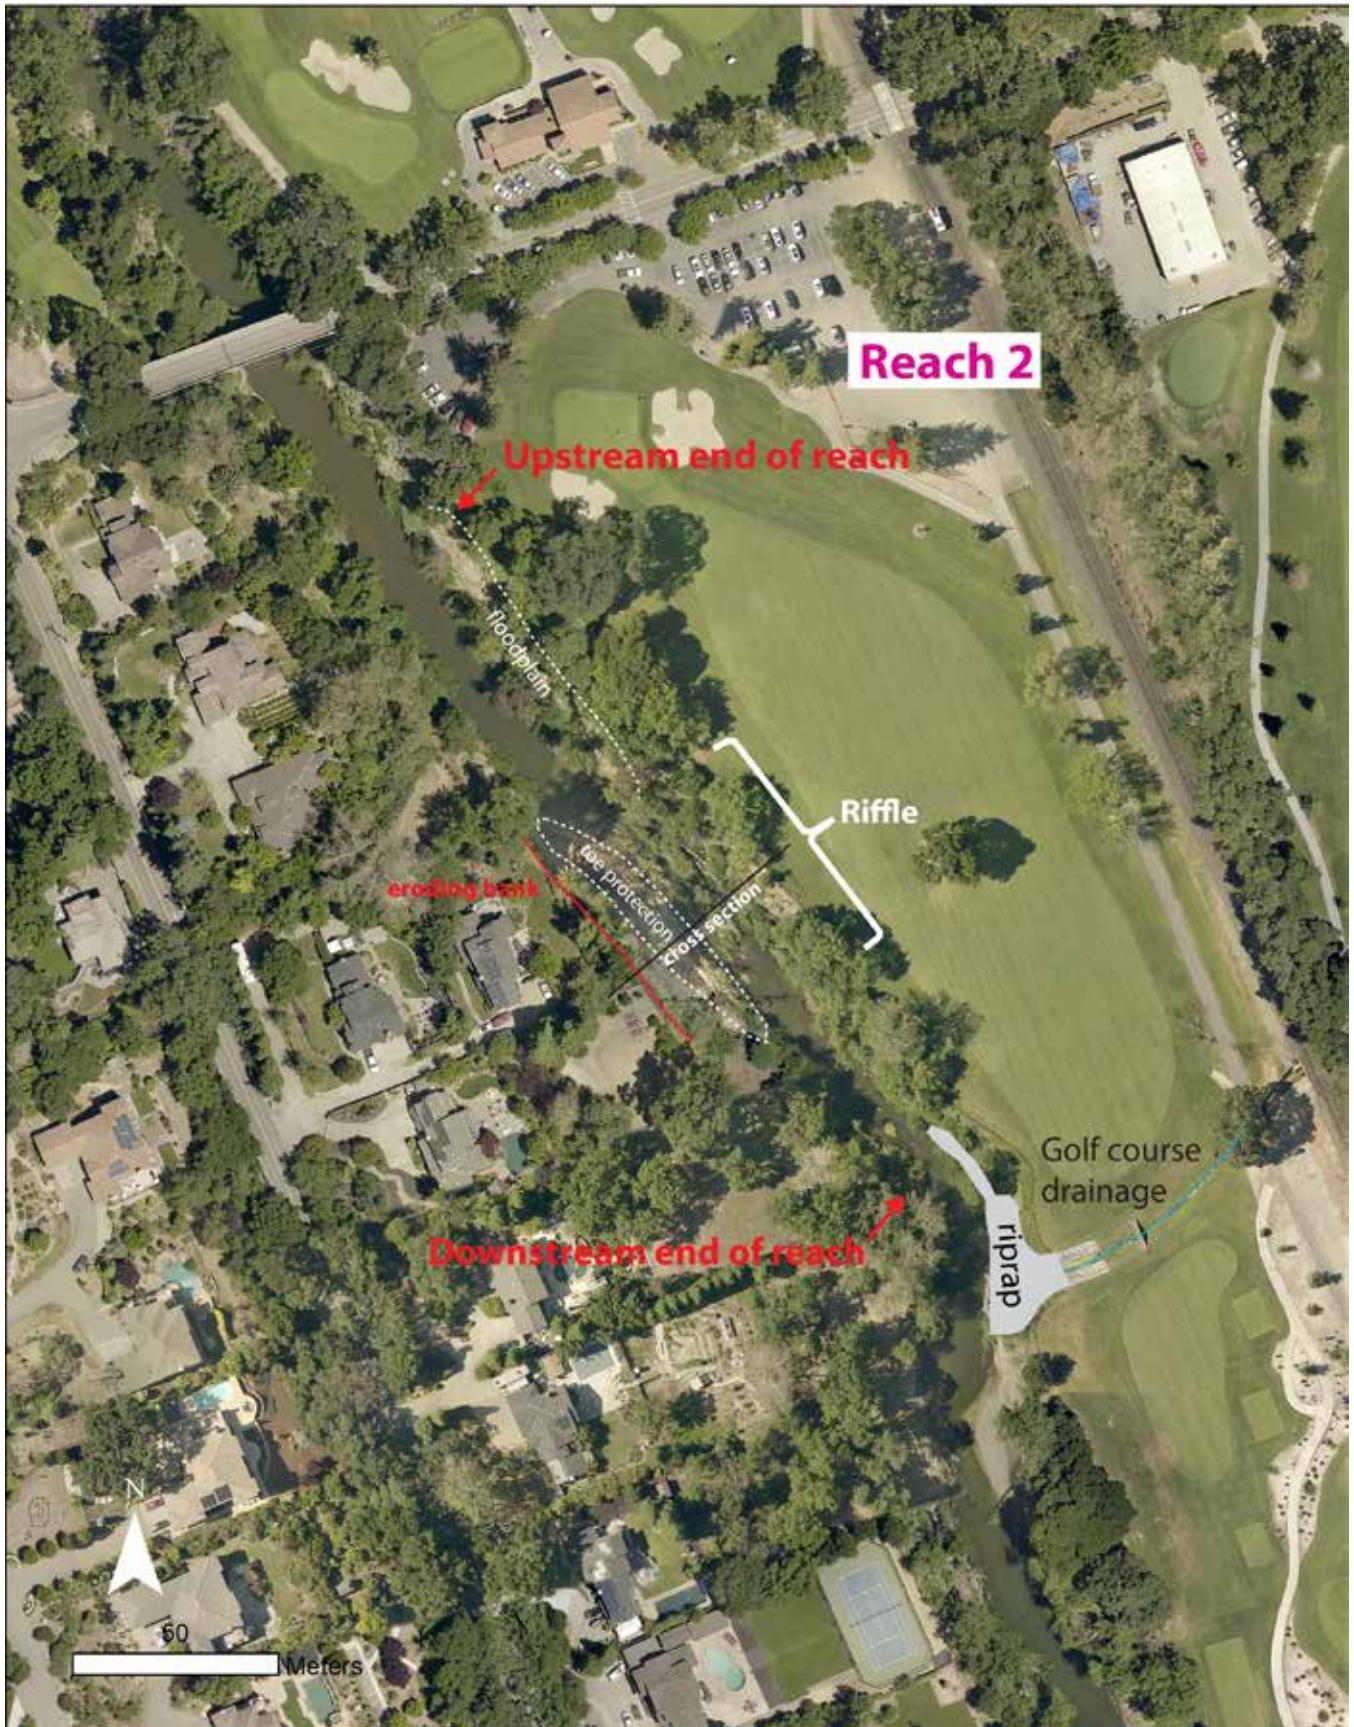
Figure 21. Channel map of Reach 2.

Reach 2 appears to encompass a knick zone, or a zone where a knickpoint (or significant change in channel bed grade) is present and is likely currently headwardly eroding along the channel length (Figure 21). The primary characteristic of this relatively short reach is the steeper gradient and coarser grain size, compared to the adjacent upstream or downstream reaches. The gradient change is observed in the field, accompanied also by a change in substrate, and distinctive bed morphology. The reach is a long, steep, coarse grained riffle that has a multi-thread channel pattern with active depositional bars. The bars support growth of dense young willow trees (*Salix lasiolepis*) that further increase the channel complexity (Figure 22). The channel outer banks are vertical through this reach. The outer right bank appears to be failing episodically, primarily by dry-ravel failure of the fine-grained valley fill material. The toe of the outer banks is protected by either bars or failed bank material deposits, which prevent lower flows from exerting shear stress forces upon the bank.

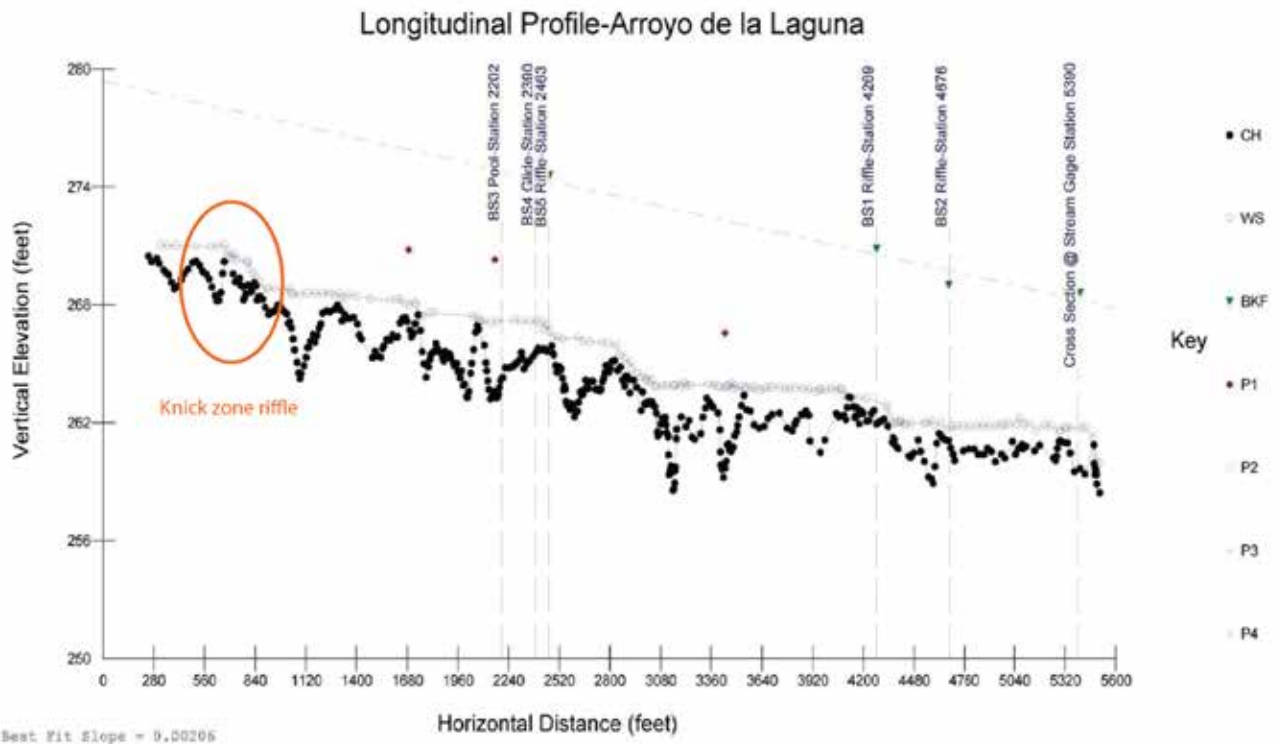
The relatively steep gradient through this reach is captured in the 2011 field-surveyed longitudinal profile (Stantec, 2011) (Figure 25). The gradient in this short reach is 0.86%, while is it 0.12% for the reach downstream and 0.11% for the reach upstream. We hypothesize that the riffle in this reach represents the current location of a knick zone. Previously, as this knick zone migrated upstream, it caused the channel to deepen, widen, and erode some of the adjacent terrace width, causing the difference in channel morphology downstream of the knick zone, as compared to upstream. However, further study is needed to evaluate this hypothesis and assess the key drivers for the bed gradient and channel morphology. Quantifying upstream migration of the knick zone will confirm that is truly is a knick zone rather than just the deposition of a slug of sediment as the channel exits the upstream confined riprap reach or from the adjacent banks, or just the expression of a resistant geologic unit.

Figure 25. Field surveyed longitudinal profile (Stantec, 2011) showing the steeper gradient in the riffle of the knick zone.

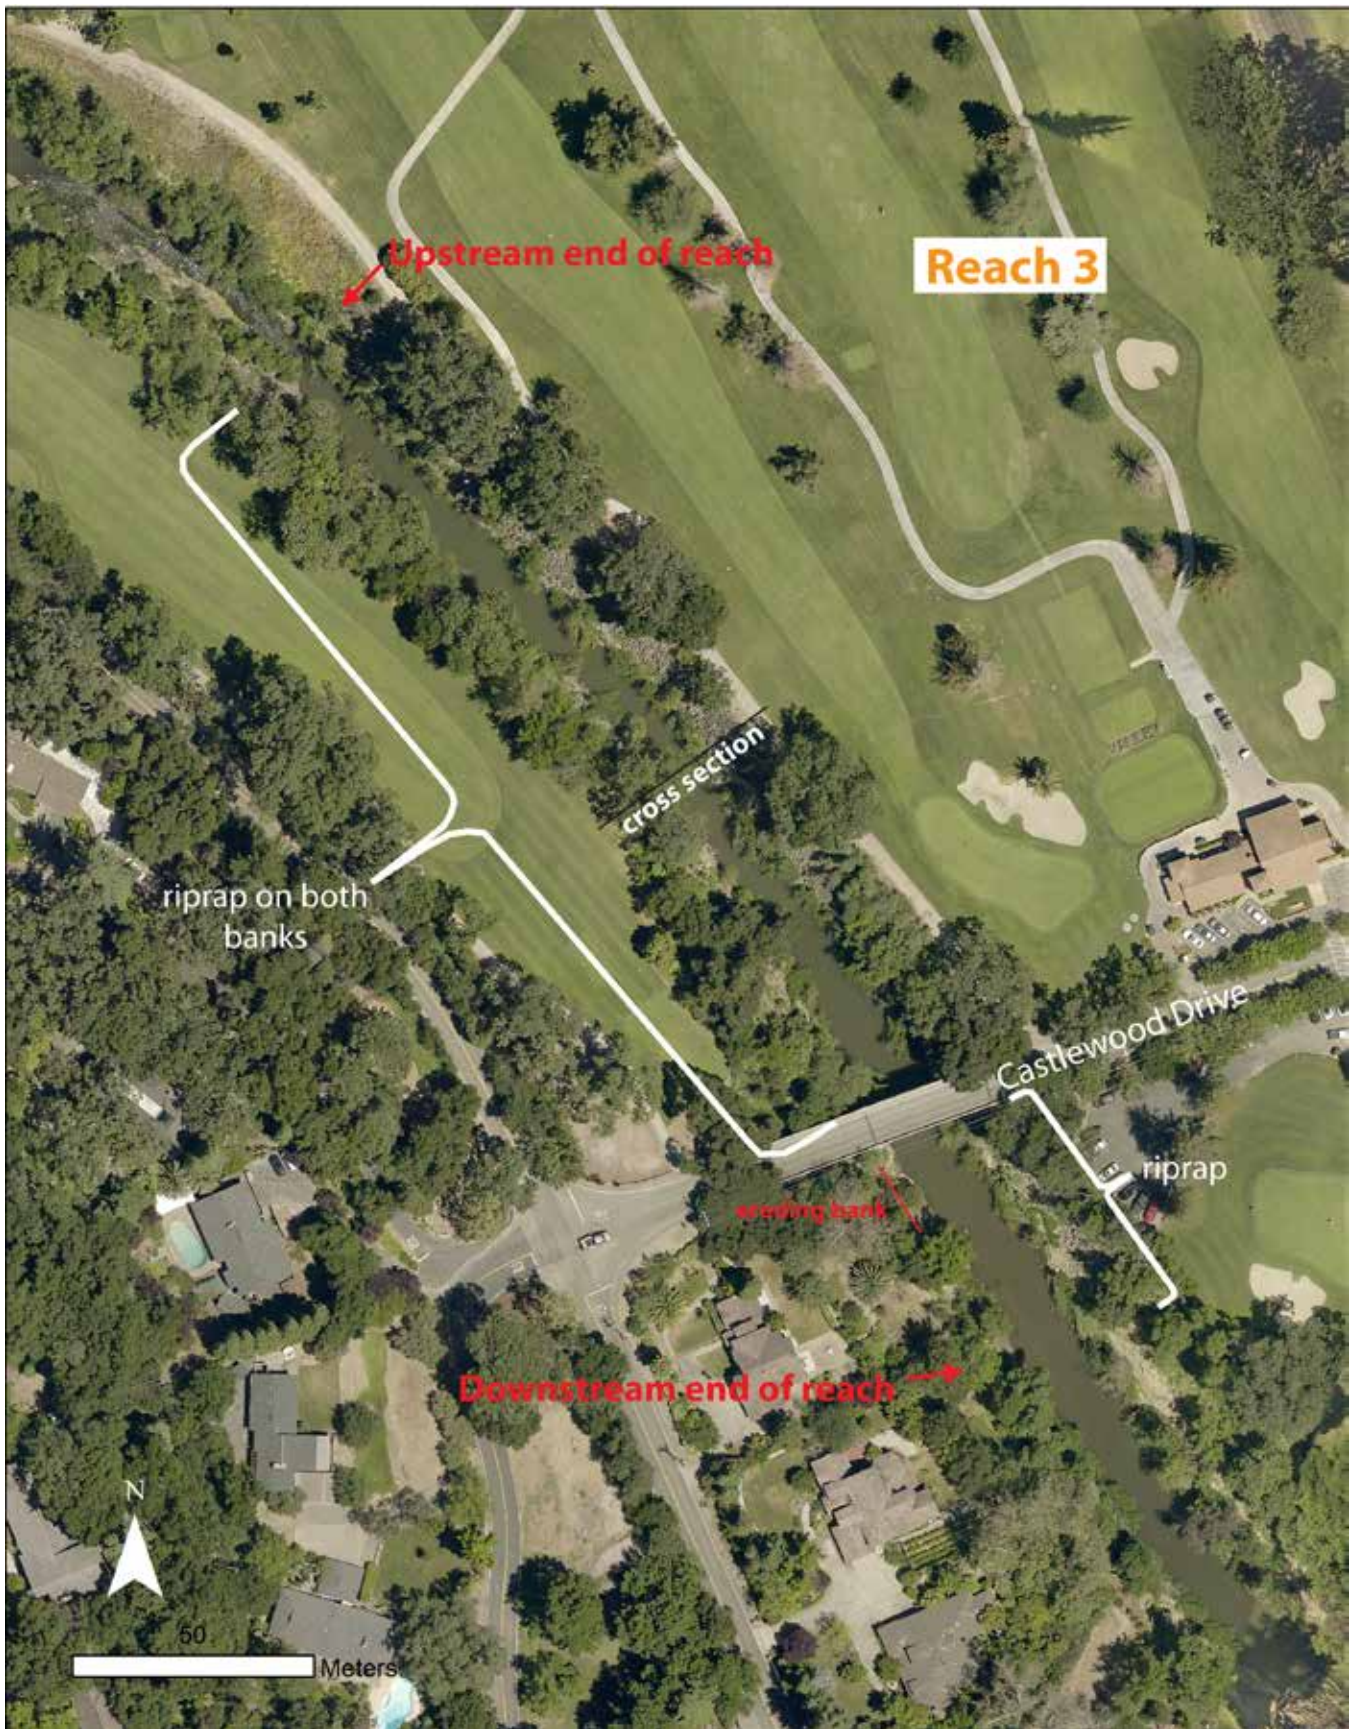
Reach 3 extends from just downstream of Castlewood Drive, upstream through a portion of the Castlewood Country Club golf course (Figure 27). This reach has been artificially relatively stable for a few decades because it is “locked in” by the riprap that is placed from the top of the bank to the toe. The riprap was placed in the late 1990s, as the Country Club was concerned about chronic bank erosion in this reach, likely due to previous incision. This hardening has significantly simplified the channel cross section, so that it is essentially a U-shaped trench that has almost no channel complexity. The channel is a long single pool with a low-flow water depth greater than 2 m. Overall this reach has low habitat value for aquatic or riparian wildlife species. Presently, none of the upper banks (e.g. those above the bankfull contour) were observed to be failing, which is different than most of the overall study area length. Because the reach was not wadeable, good observations of the toe of the riprap were not able to be made. However we believe that there may be some (<1m) recent incision at the toe, which may lead to future destabilization of the hardened banks.

Figure 27. Channel map of Reach 3.

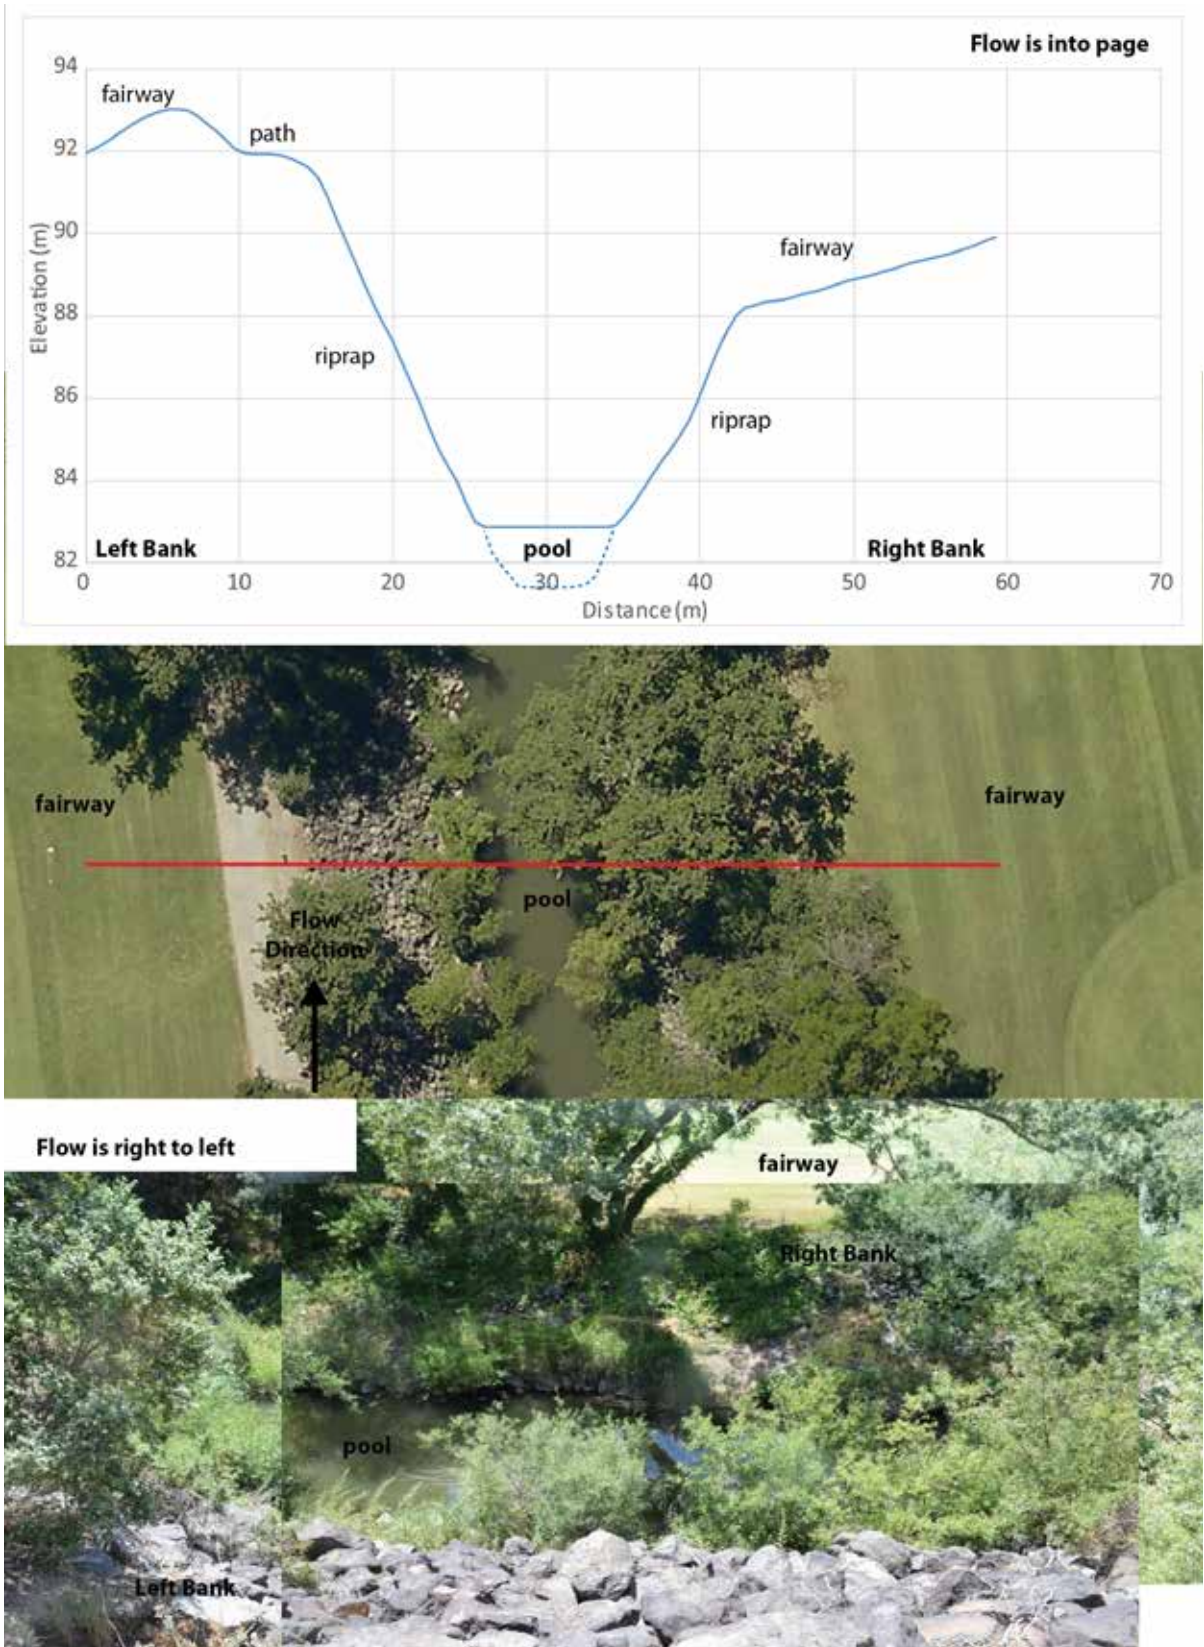
Current land use along the banks in this reach includes Country Club property on both banks upstream of Castlewood Drive, and Country Club property along the left bank and residential properties along the right bank downstream of Castlewood Drive (Figure 28). We note that the terrace surface along the right bank is lower in elevation than the left bank in the reach upstream of Castlewood Drive.

Figure 28. Representative Reach 3 channel cross section. Solid line shows elevations directly from LiDAR, while the dashed line shows approximate elevations from field observation.

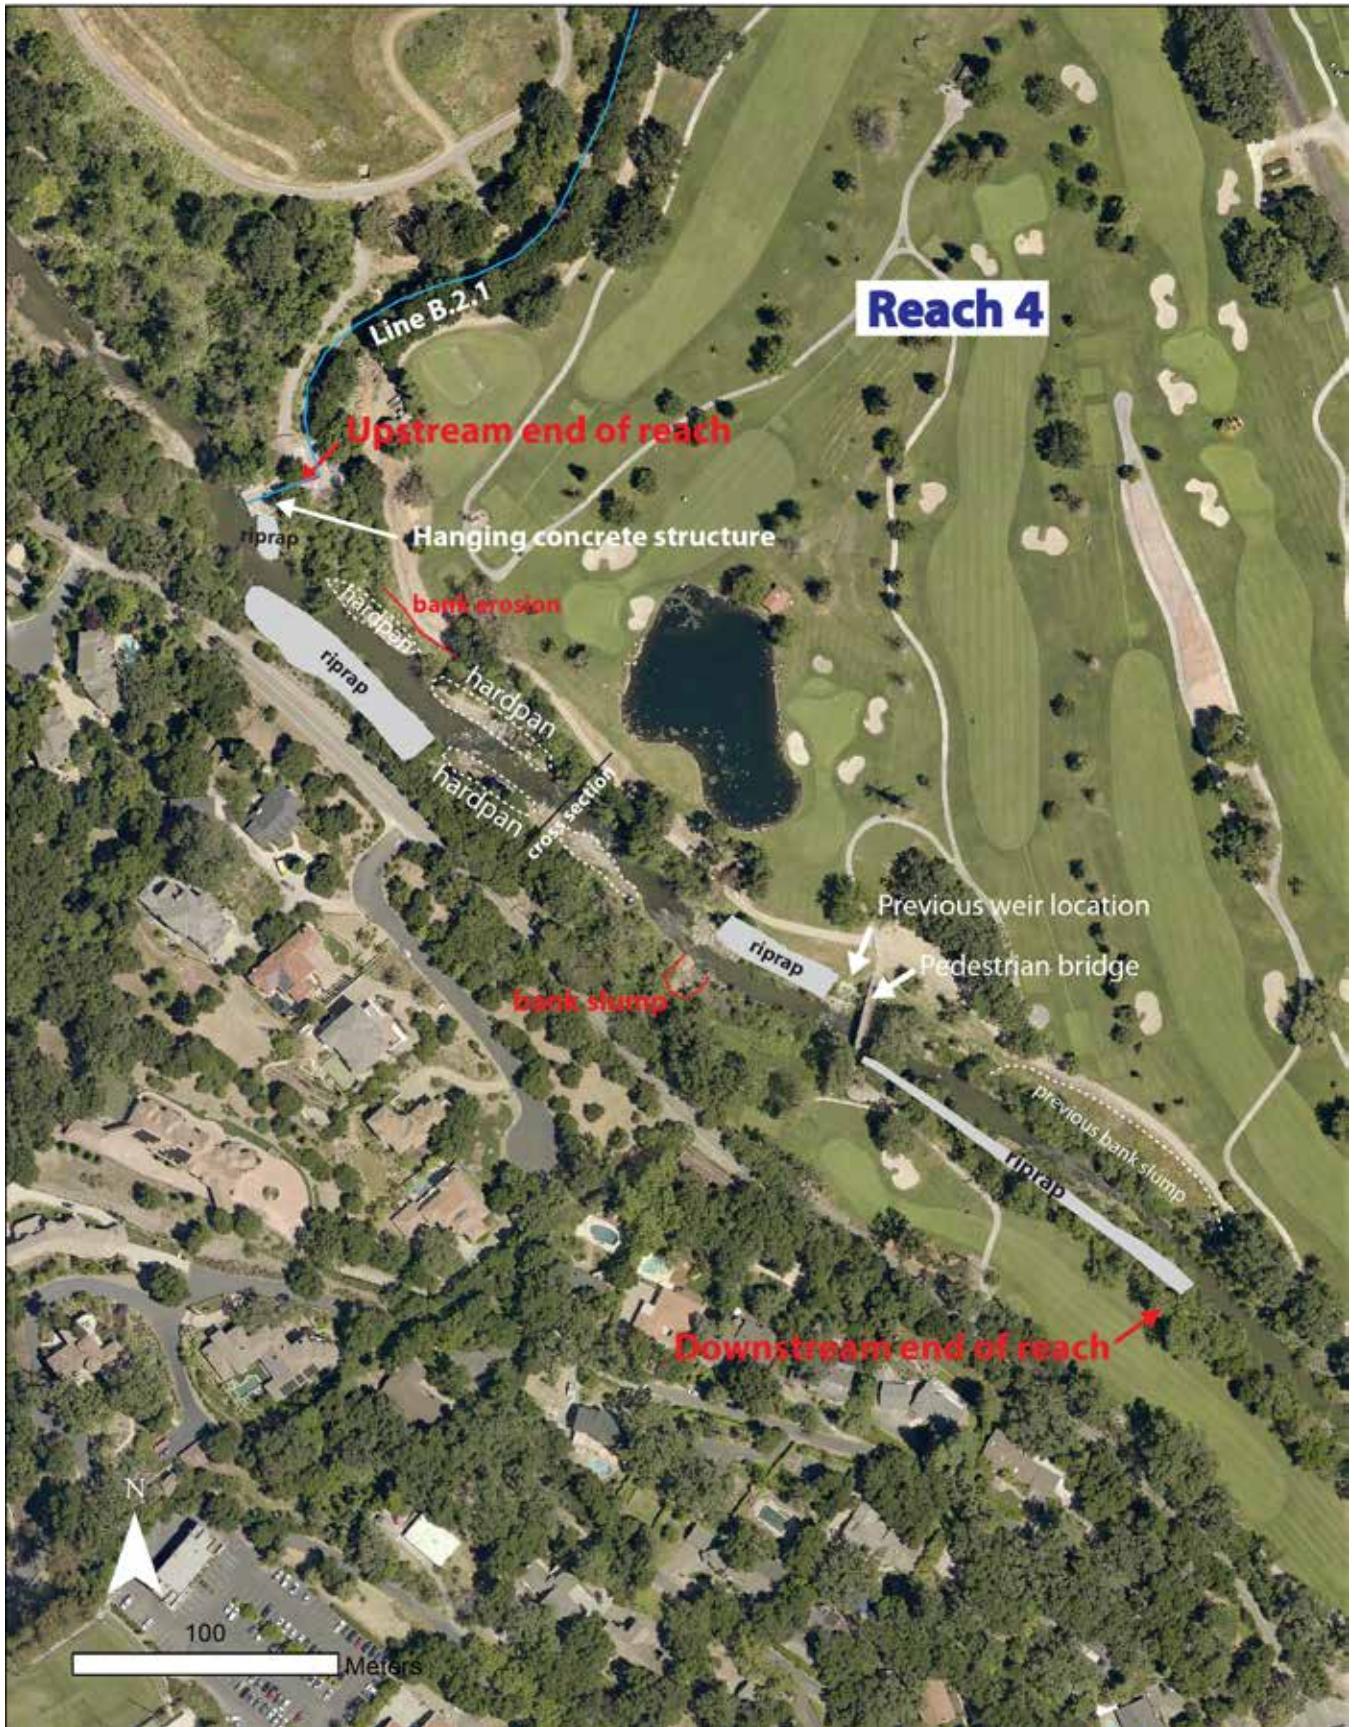
This reach extends from the upstream extent of the riprap in Reach 3 upstream to the confluence with Line B.2.1 (Figure 30). This reach is defined by a previous concrete weir that was located on the channel bed approximately 5 m upstream of the pedestrian bridge in the Castlewood Country Club golf course. The weir fully spanned the channel bed and caused an approximately 1m step in the channel bed gradient (Figure 31). Castlewood Country Club staff report that the slab was protecting a number of pipes that were crossing the channel, including one that brought water uphill to the “hill course” and the homes built there (John Vest, personal communication) (Figure 32). Those homes were built in the late 1950s and early 1960s, and thus our best estimate is that the slab was installed after the 1950s floods. But given that it was at approximately the same elevation as the exposed hardpan in the reach, it could have been installed at a later date, after the channel has incised to the hardpan elevation. Field photographs from 2007 shows the slab still largely functioning and intact, however golf course staff report that the slab was unstable in 2003 and likely before (John Vest, personal communication). The slab was completely undermined and collapsed during the December 2012 high flows, and was then removed in early 2013. The current channel only has scattered riprap remaining in the previous weir location (Figure 33).

Figure 30. Channel map of Reach 4.

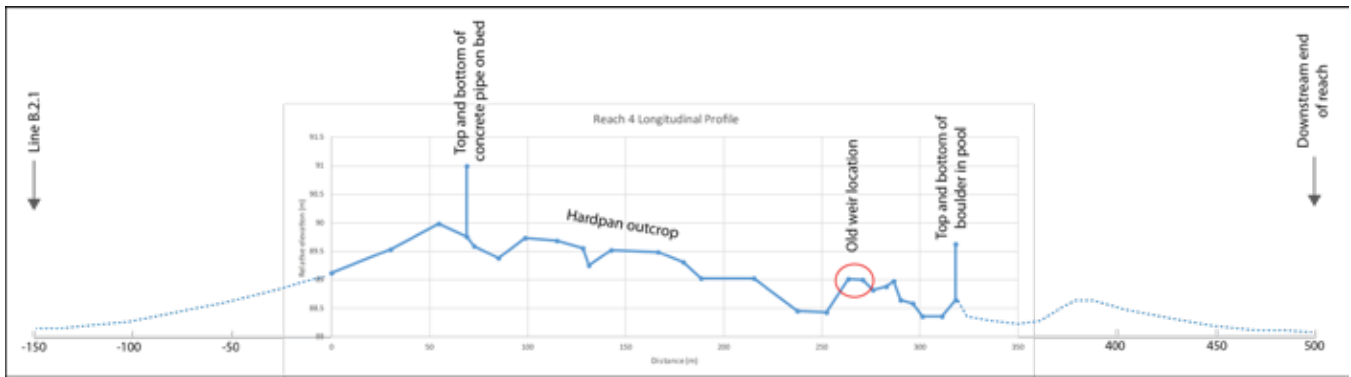
This reach also has the downstream-most exposure of hardpan in the channel. Hardpan essentially acts like a layer of impermeable concrete on the channel bed that slows incision. Likely because of the hardpan and/or the previous weir, the upstream channel gradient is more shallow than the downstream reach (Figure 34).

Overall the reach is fairly straight in planform, with a well-defined pool/riffle sequence that is evident in the surveyed longitudinal profile (Figure 34). In many locations current fluvial sediment is being deposited as a bar on top of the hardpan surface. The reach also has some larger boulders scattered across the bed; these are likely a mix of blocks of failed outer bank material and failed riprap from this reach (Foothill Road protection) and from previous development and repairs that have occurred further upstream (1988 Golden Eagle development and 1996 Zone 7 storm damage repairs). The outer banks are steep, but not quite vertical, with evidence of dry-ravel style failure (visible in the field) and slump block failure (visible in the LiDAR). There is one significant fresh bank slump location (Figure 35) that contributed a mix of sediment grain sizes directly to the channel. The reach has LWD in the channel due to outer bank failures recruiting riparian trees into the channel. Currently many other trees are located on top of the bank and are in danger of falling in with future bank failures. Terrace surfaces at different elevations on the right and left banks are clearly observed.

Figure 34. Field surveyed longitudinal profile for Reach 4 (solid line). Units in meters. Each end of the profile is estimated (dashed line). The previous weir location is circled in red. A very large and deep pool exists at the confluence of Line B.2.1; a longer profile would provide more context for this short reach, including showing the gradient change of this segment in context with the larger reach.

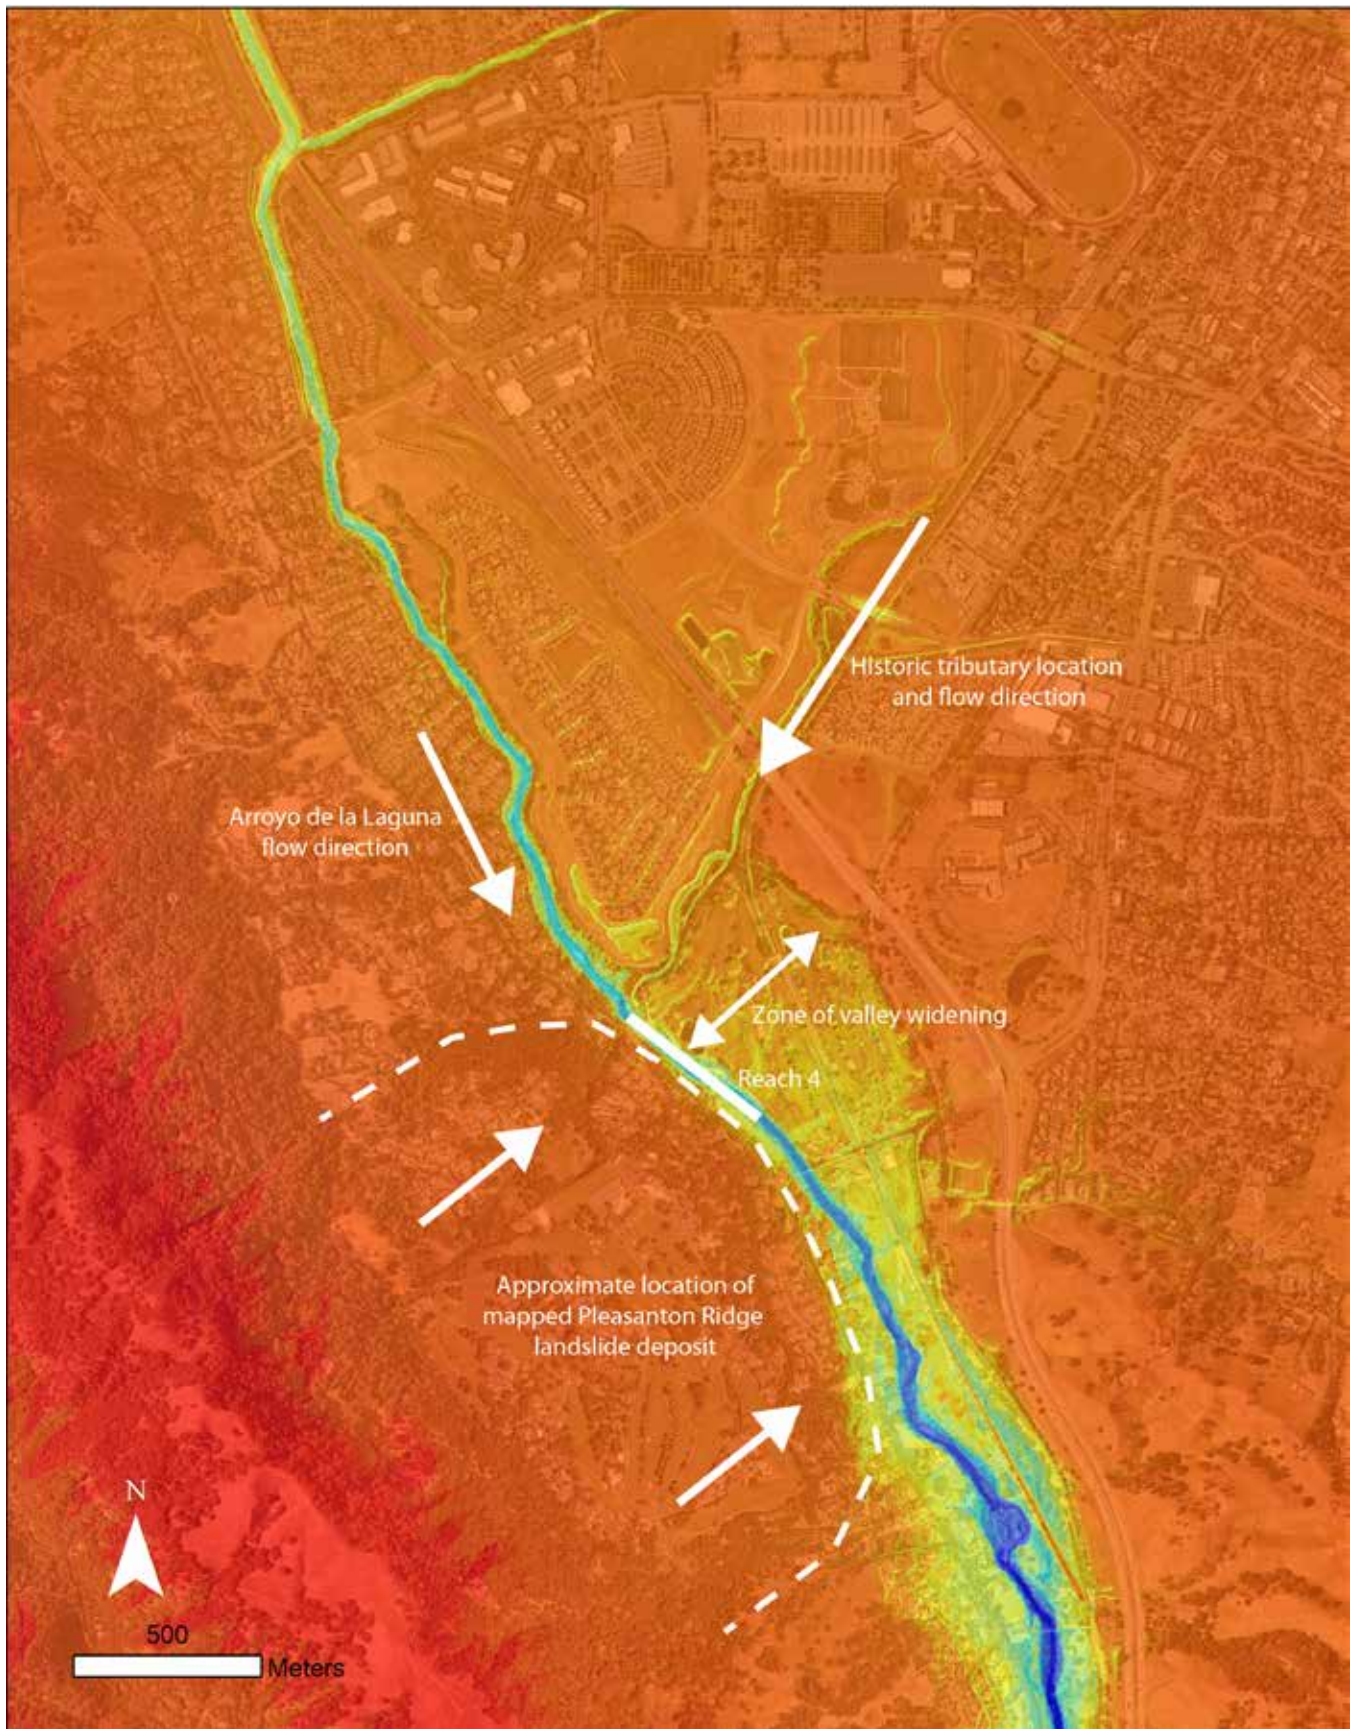
This upstream end of the reach is defined by the location where a tributary enters from the northeast, and the valley widens significantly, also to the northeast (Figure 36). Additionally, mapping of landslide deposits shows an ancient Pleasanton Ridge landslide deposit in this location (Majmundar, 1995). Although it would require significant additional study to test, we hypothesize that the interaction of the landslide (from the west), ADLL (flowing north to south), and the tributary (from the east) caused the valley widening, and may have contributed to the

Figure 36. Annotated DEM illustrating the location of a Pleasanton Ridge landslide deposit and the zone of valley widening. Warm colors are higher elevations, and cool colors are lower elevations.

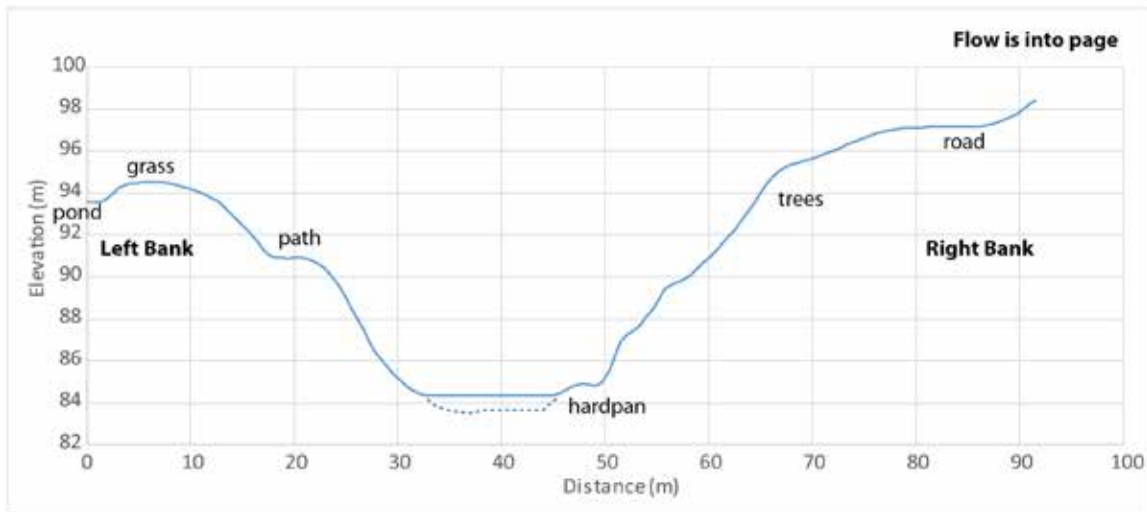
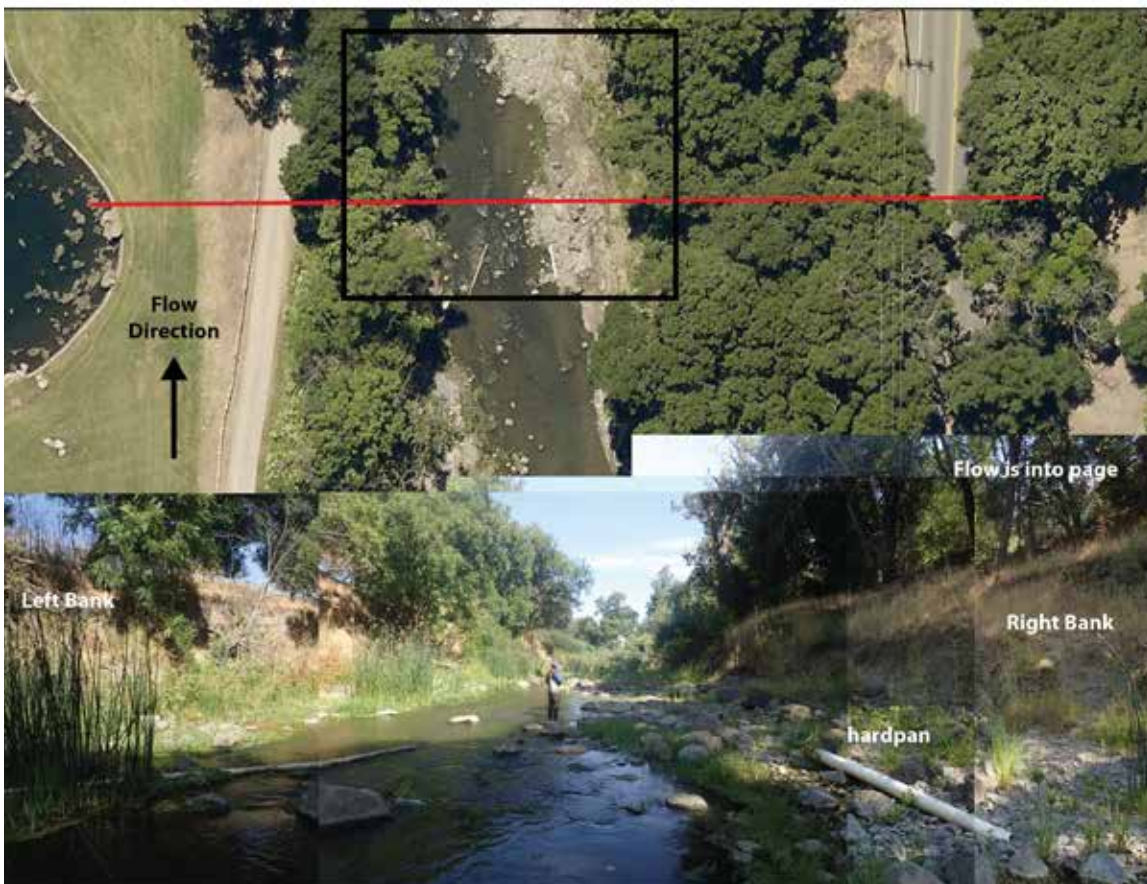
Figure 37. Representative cross section for Reach 4. Solid line shows elevations directly from LiDAR, while the dashed line shows approximate elevations from field observation.
