ARROYO DE LA LAGUNA REACH-BASED GEOMORPHIC EVALUATION

NOVEMBER 2023

PREPARED BY
San Francisco Estuary Institute

IN PARTNERSHIP WITH
Alameda County Flood Control and
Water Conservation District, Zone 7

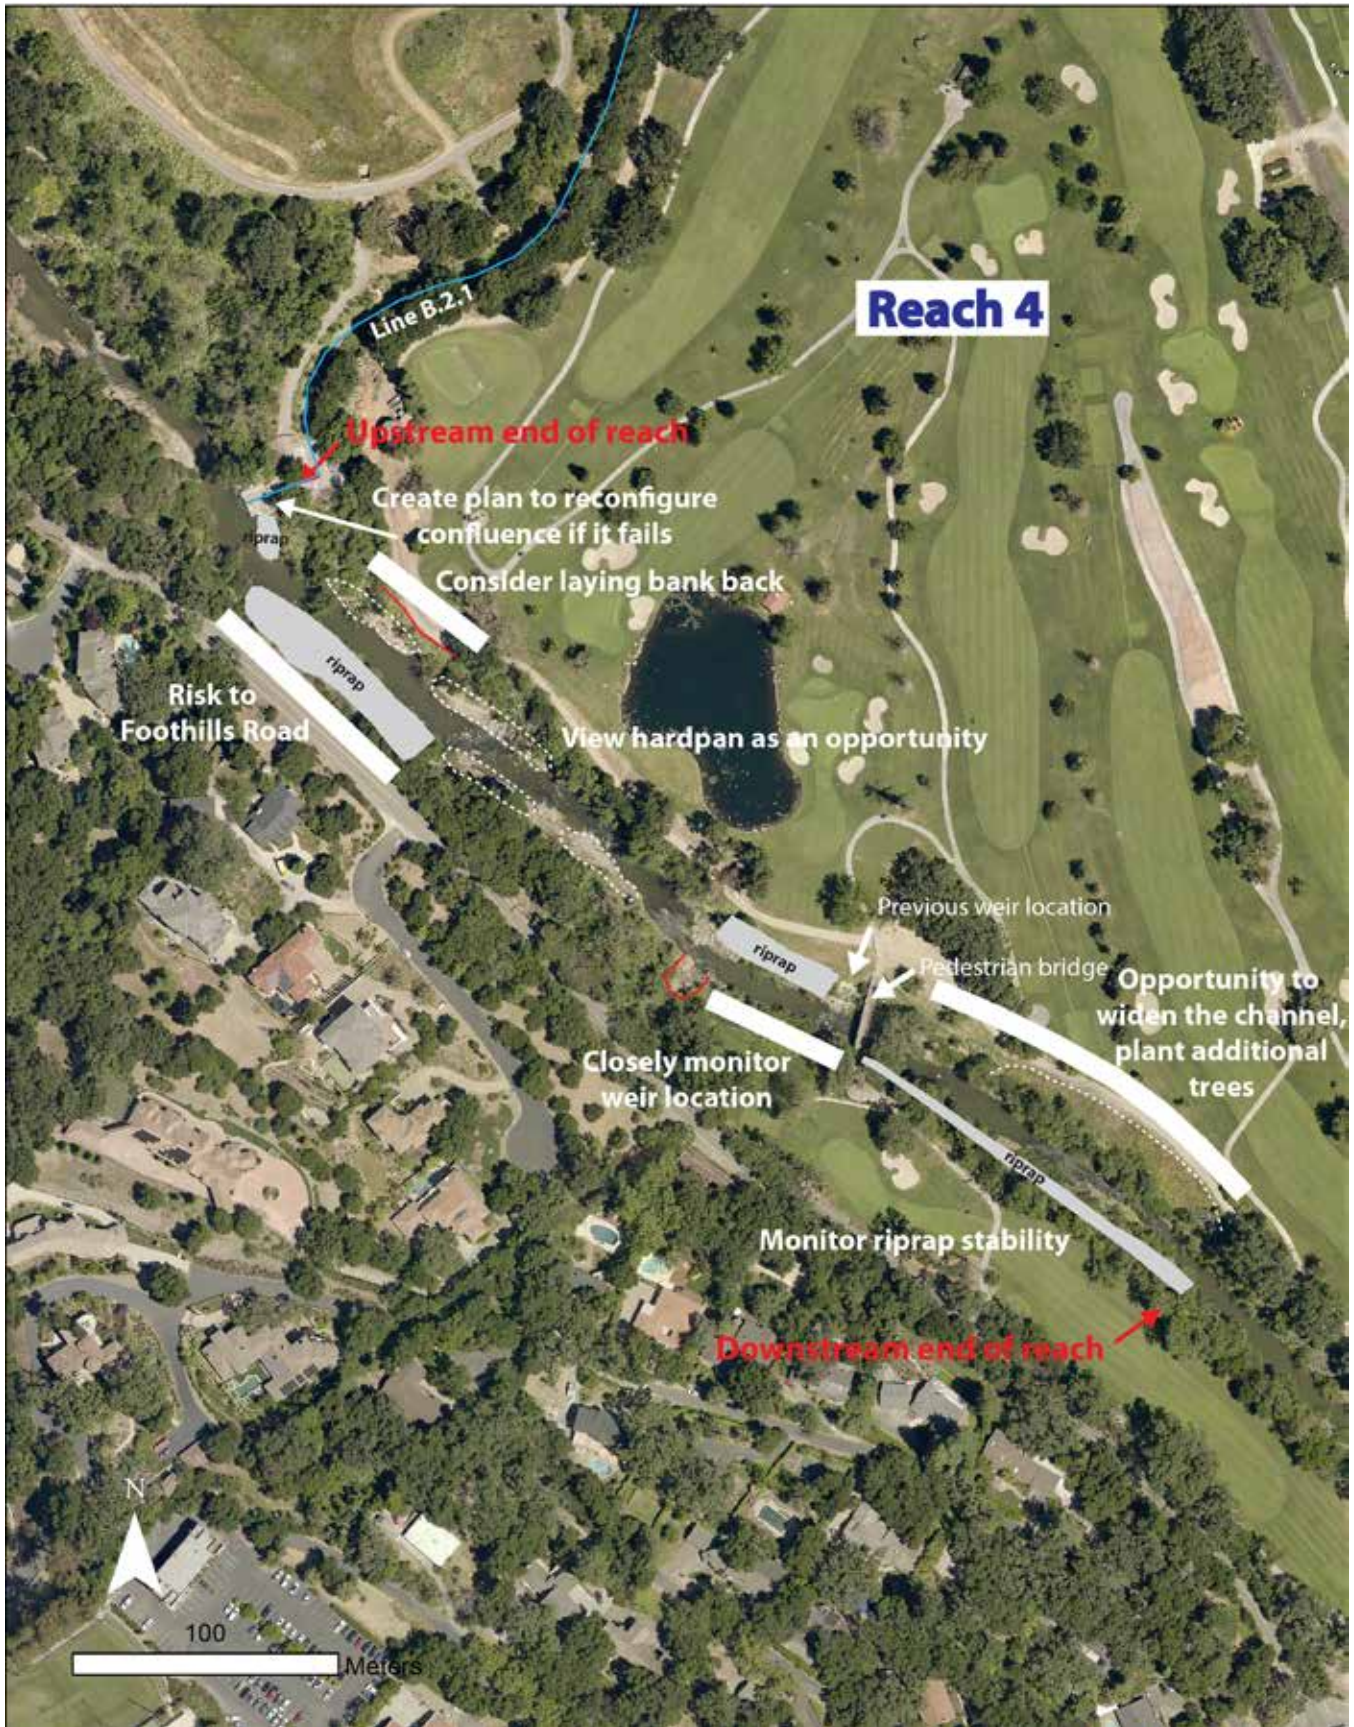
While removal of constraints upon a channel, such as the historic weir, is a benefit and allows the channel to fully adjust any aspect of its geometry, in this instance the channel has evolved since the weir was installed, adjusting to the increased volume of water delivered as the upstream Valley developed (Figure 38). The 2013 removal of the weir may pose a set of risks to this reach, as a new wave of incision incited by the weir removal could undermine already failing banks. This could lead to increased outer bank failures due to incision, which would primarily be characterized as slump-block style failure. Foothill Road is at the top of the right bank along a portion of this reach which increases stress on the toe of the slope, and may lead to more failure, or more riprap, which could enter the channel. Although unlikely, there is potential for undercutting of the Line B.2.1 outfall structure.

Figure 38. Risks and opportunities for Reach 4.

Although the Country Club need not be fully responsible for restoring Arroyo de la Laguna, in this reach there are opportunities for laying back the banks on the left side, on Country Club property. This would limit the erosive force against Foothill Road. There are several areas with limited riparian vegetation in this reach, and planting an additional row of trees behind the current trees located at the top of bank would increase habitat, shade, bank stability, as well as other benefits. Stream managers should examine the functioning of the Line B.2.1 structure, and installing an energy dissipator at the bottom to reduce scour from inflows. In addition, managers should discourage any new riprap intended as bank stabilization in this reach, and create an anticipatory management plan with landowners (Beagle et al., 2016), especially the Country Club, to carefully plan out potential future responses if incision does begin to occur. This plan should also explore if any new opportunities exist because the weir is no longer present.

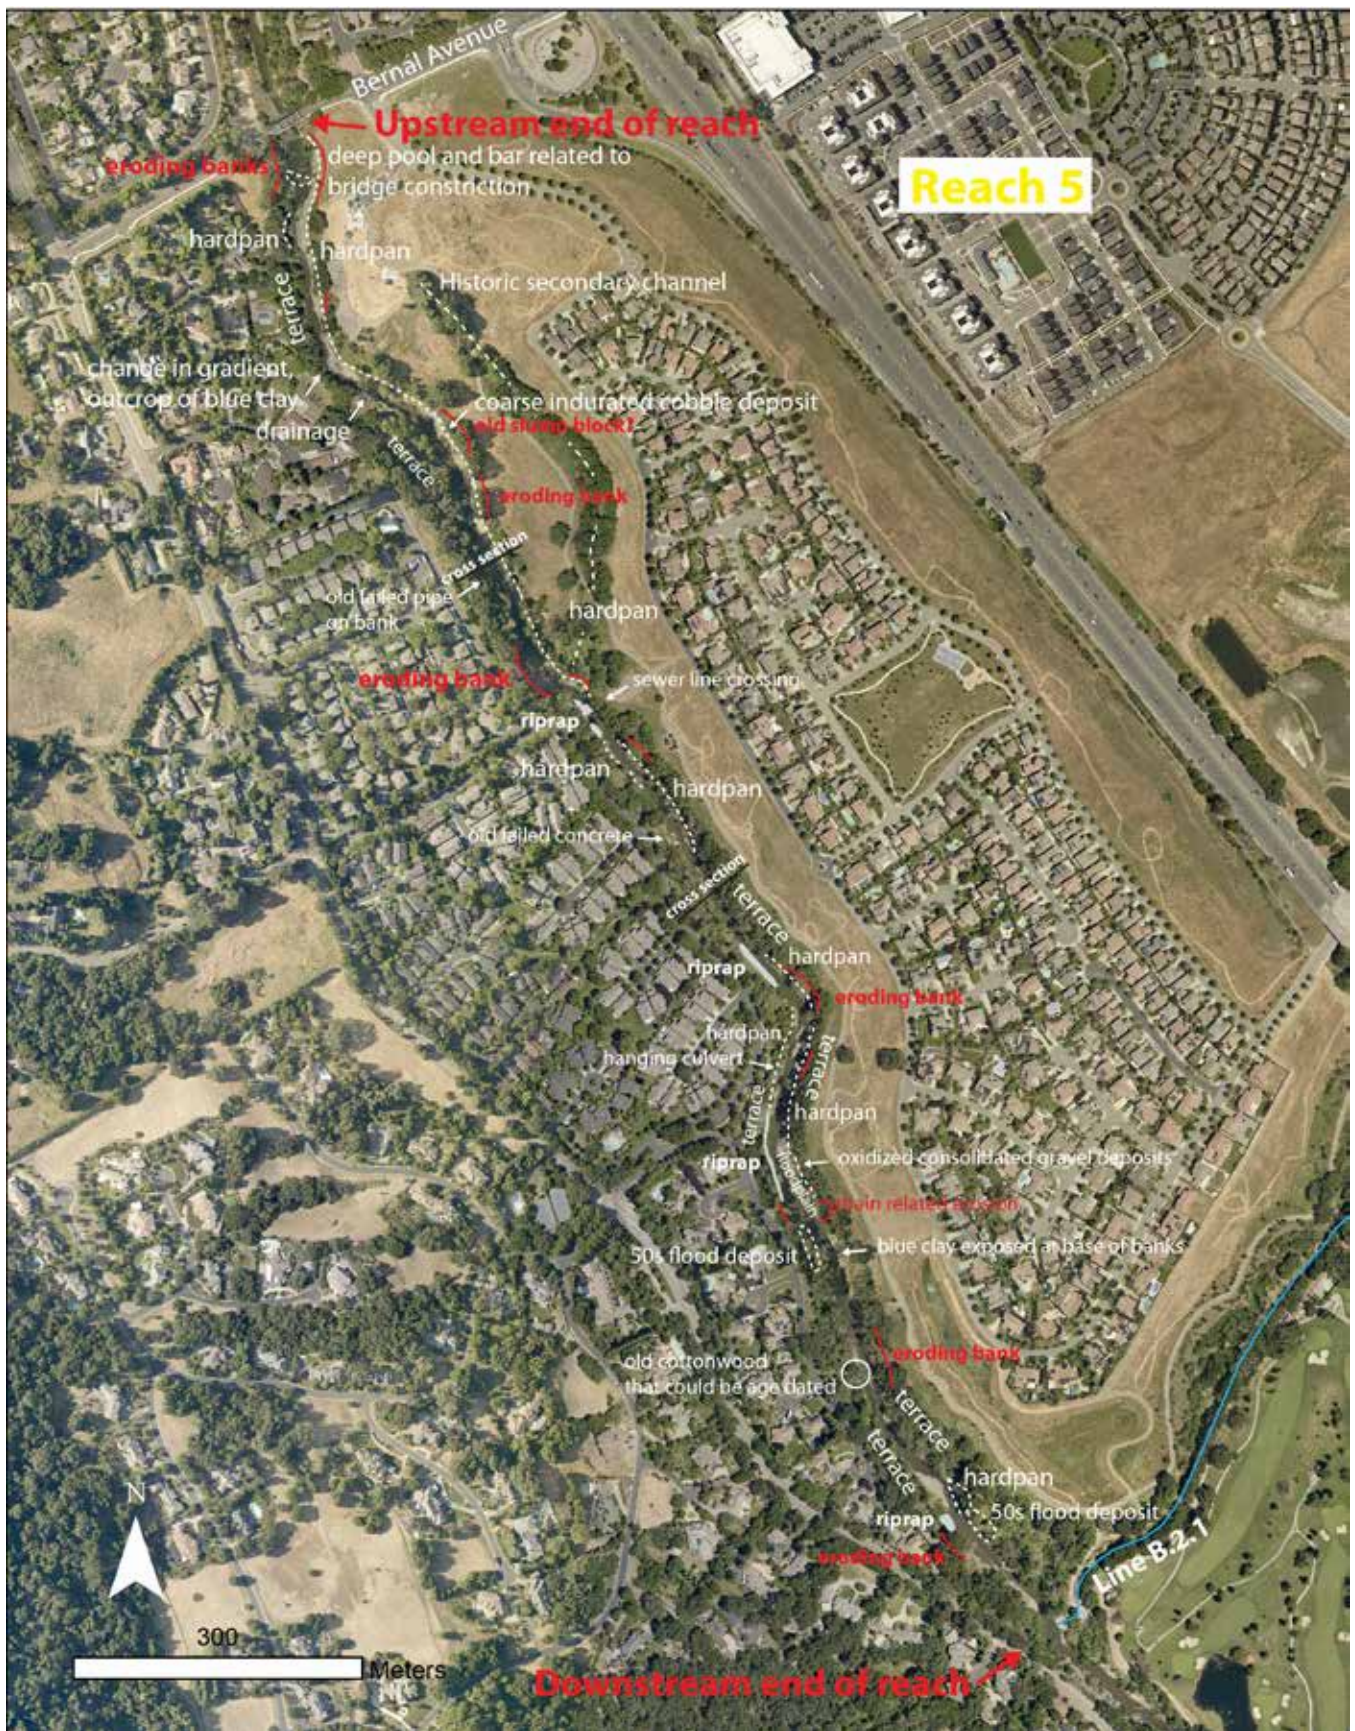
Figure 39. Channel map for Reach 5.

Reach 5 extends from the confluence with Line B.2.1 upstream to Bernal Avenue (Figure 39). This reach is marked by the presence of hardpan exposed in the channel, and currently forming a ledge approximately 1 m above the channel bed for most of the length. The channel is fairly narrow, with steep, nearly vertical outer banks. A terrace surface varying in height from 5-9 m is present throughout most of the reach (Figure 40). The banks show evidence of dry-ravel style failure, although many portions of the bank appear to not be actively eroding. Previous bank failures have recruited trees that are now in the channel as LWD, and a number of other trees are currently in danger of future recruitment. Some of the terrace slopes are seeping groundwater. Although a few riffles are present (7 over an 1,800 m distance) the majority of the reach length is characterized as a plane bed channel. There are some higher bar surfaces (about 2 m above the bed elevation) that appear to be activated during flows slightly higher than bankfull flows (i.e., approximately 1.5 to 2-year flows). The land use along the right bank is suburban residential, while the left bank is park land owned and maintained by the City of Pleasanton. The park contains an historical secondary channel of ADLL (at an elevation higher than the present mainstem channel bed), marked by the presence of remnant riparian vegetation.

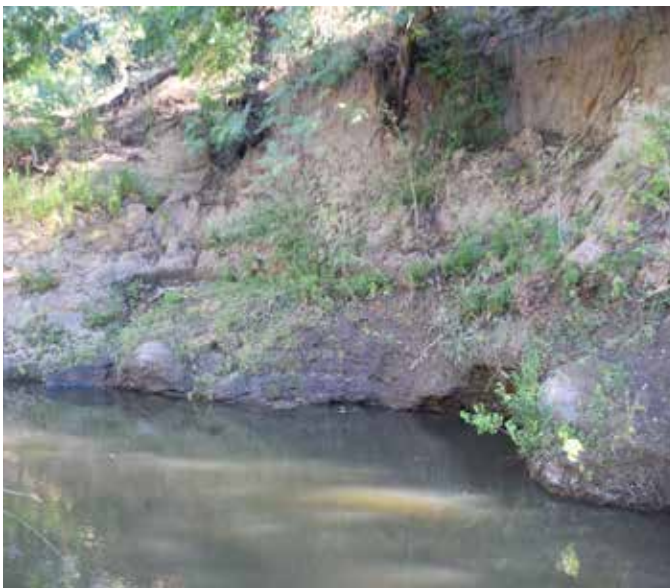
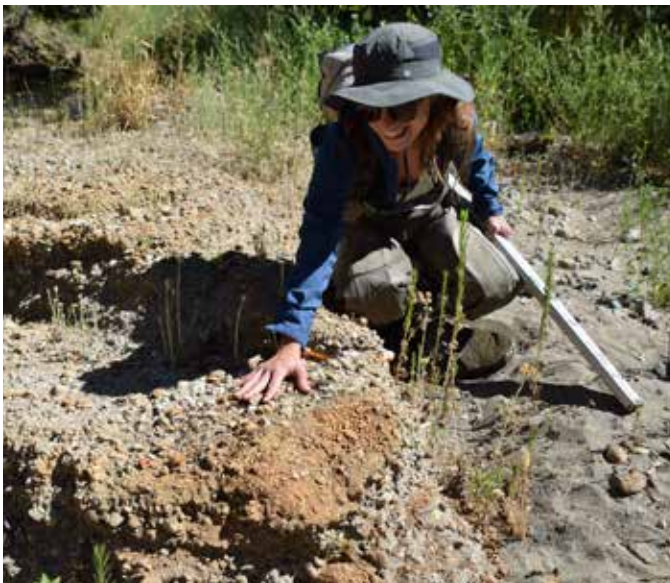
This reach has more variable stratigraphy within the valley geologic deposits as compared to downstream reaches. Here is the first observed occurrence of a blueish clay deposit near the base of the exposed banks that was likely deposited in the historical Pleasanton Marsh Complex. We also observed a surface approximately 2-3m above the bed surface that was composed of consolidated gravels that have oxidized and turned a rusty red color, possibly an older stream channel. Using information from Bigelow et al. (2008), we see that Figure 41 shows an historical cross section near Castlewood Drive with stratigraphy that includes the blue clay, hardpan, and sands and gravels.

Figure 41. Historical cross section near Castlewood Drive (in Bigelow, 2008; original cross section from Williams, 1912); blue clay deposit at the base of the bank; oxidized gravel deposit.

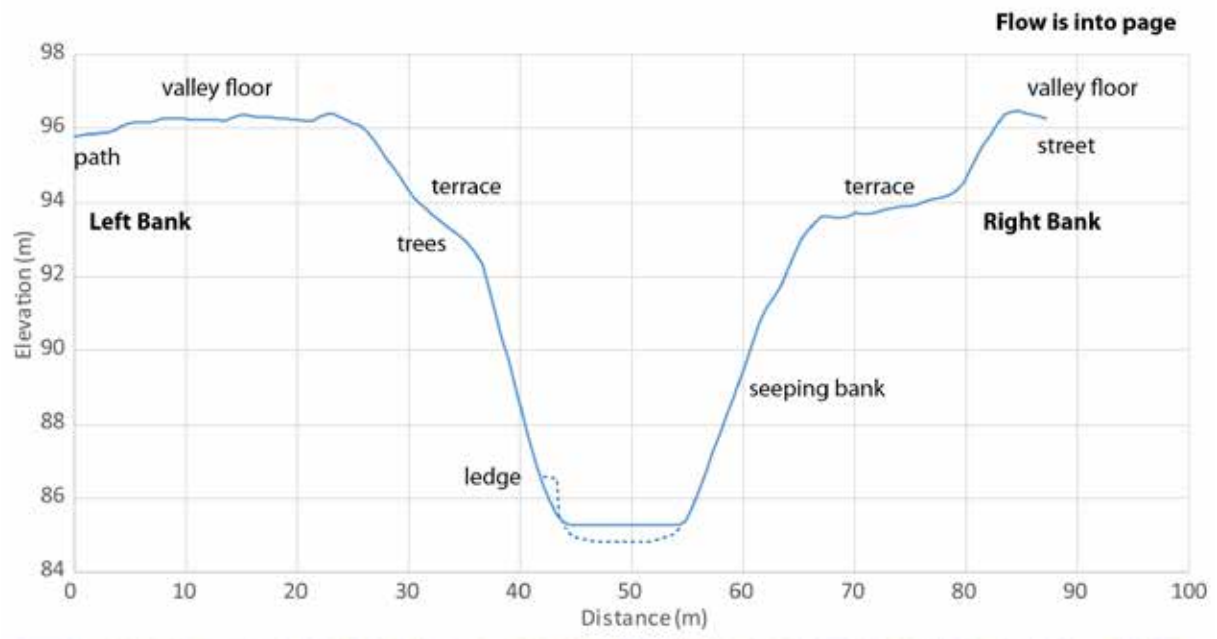
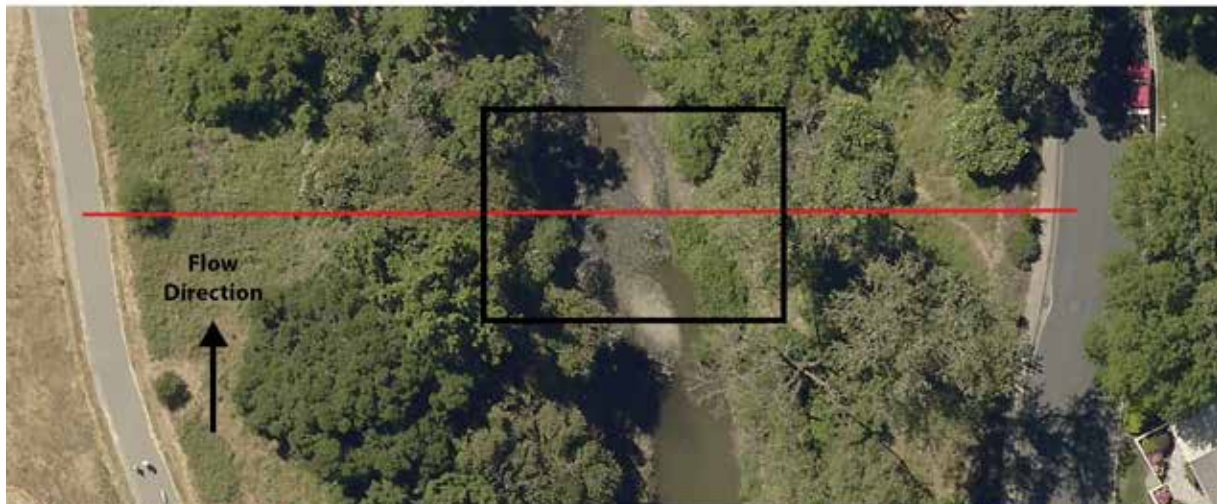
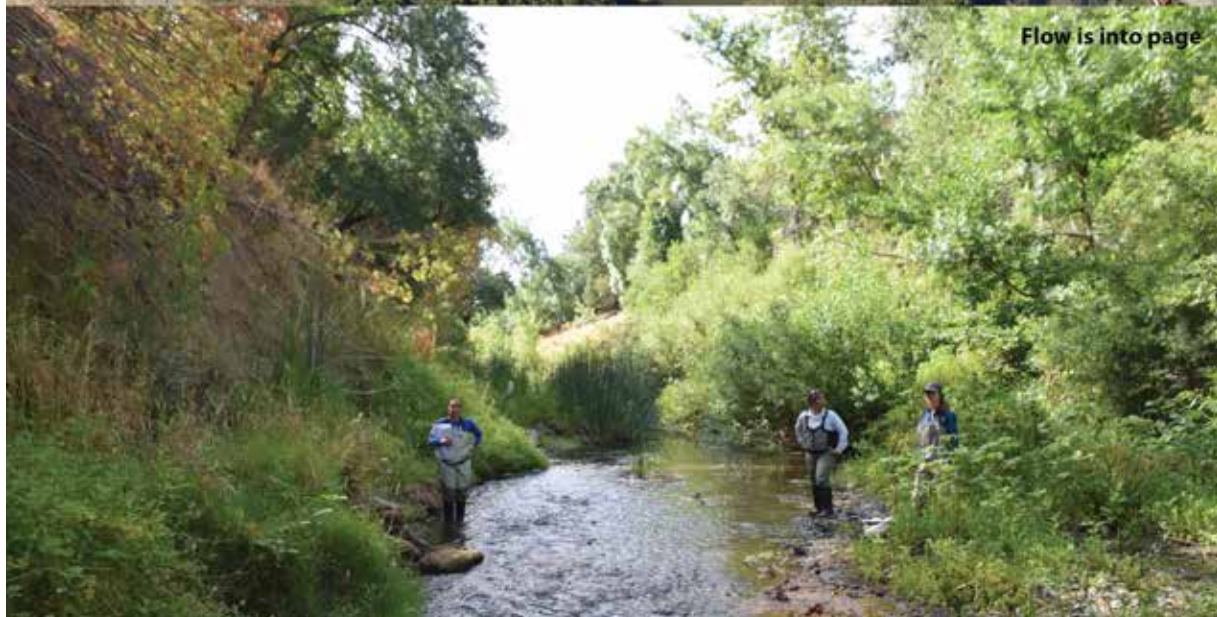
The representative cross sections for this reach show that the channel is fairly narrow, with exposed hardpan sitting slightly elevated above the current channel bed (Figures 44 and 45). The outer bank slopes are steep, with a terrace running the entire length of the reach. The overall cross section shape is much more of a “V” rather than a “U” that is observed further downstream, indicating that the incision that is occurring in this reach is younger, and the channel has not yet widened.

Figure 44. Downstream representative cross section for Reach 5. Solid line shows elevations directly from LiDAR, while the dashed line shows approximate elevations from field observation.

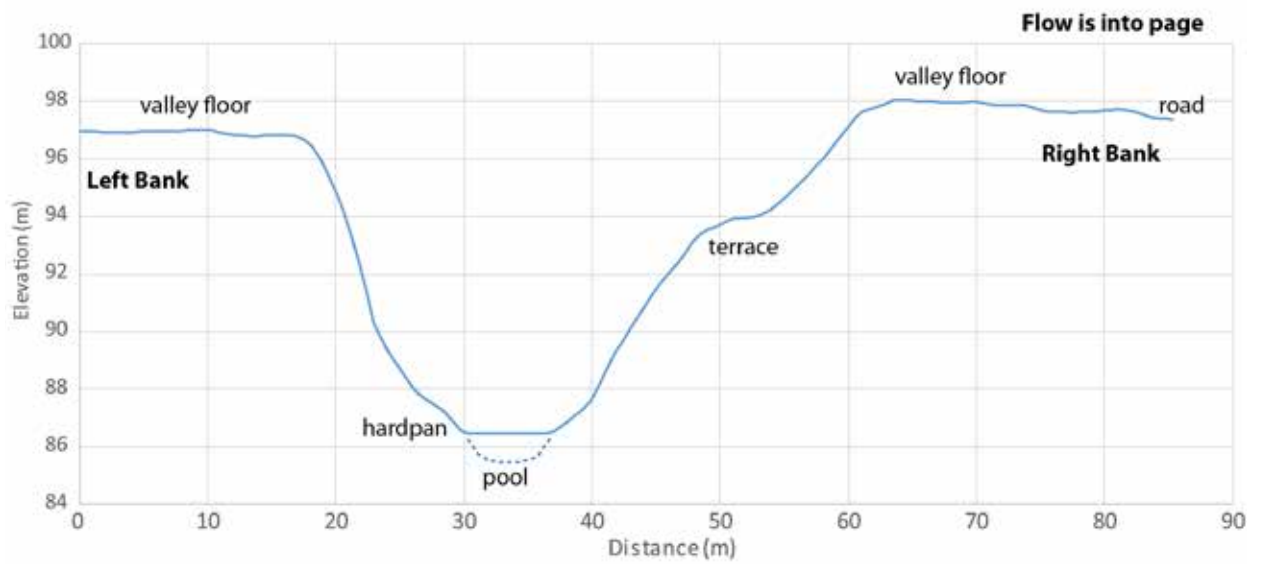
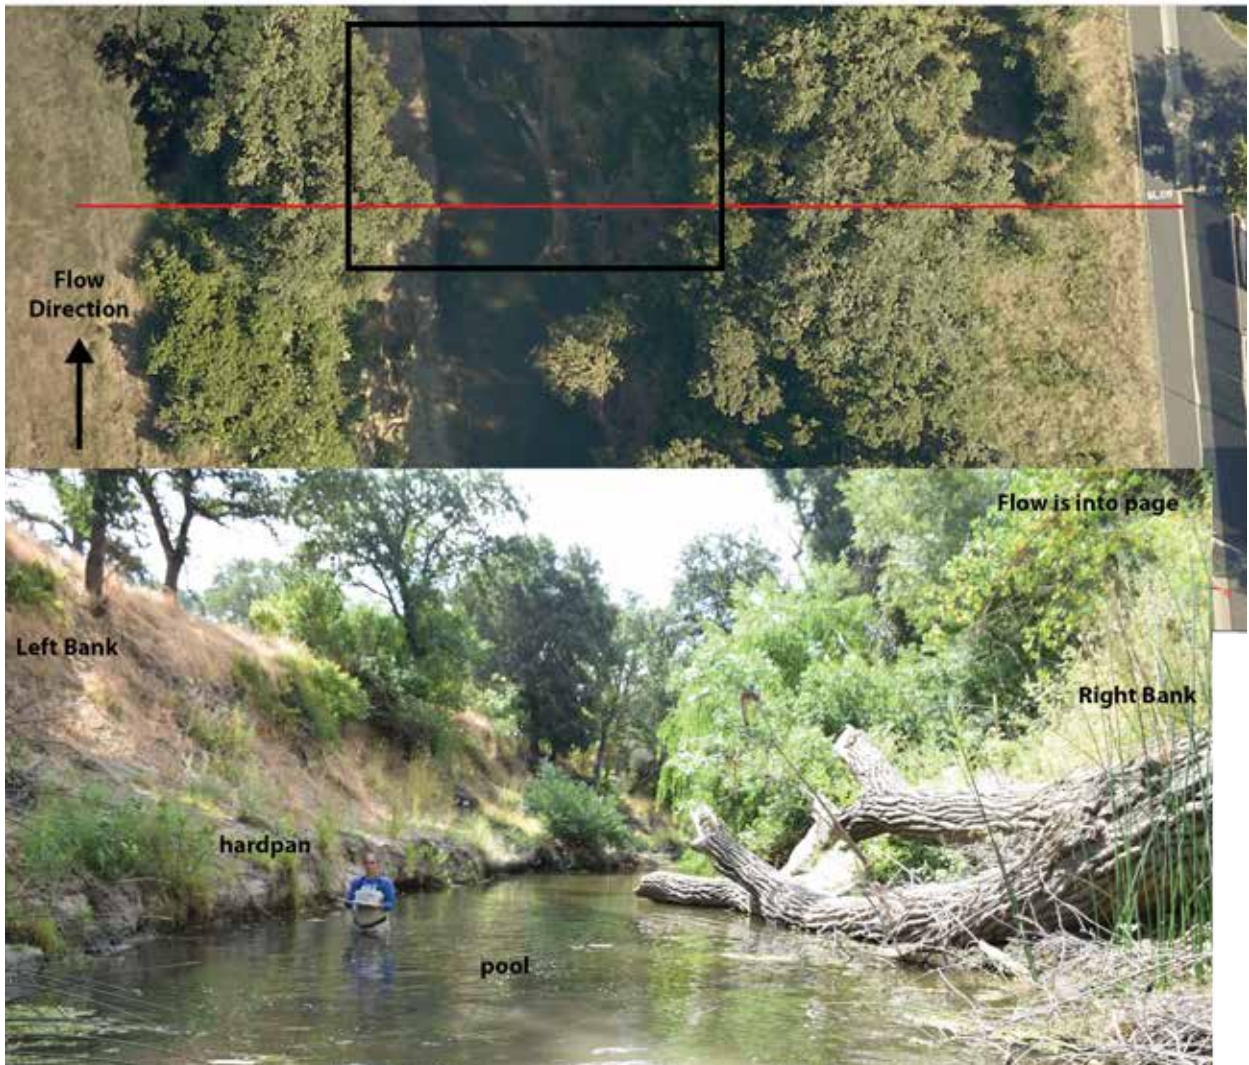
Figure 45. Upstream representative cross section for Reach 5. Solid line shows elevations directly from LiDAR, while the dashed line shows approximate elevations from field observation.

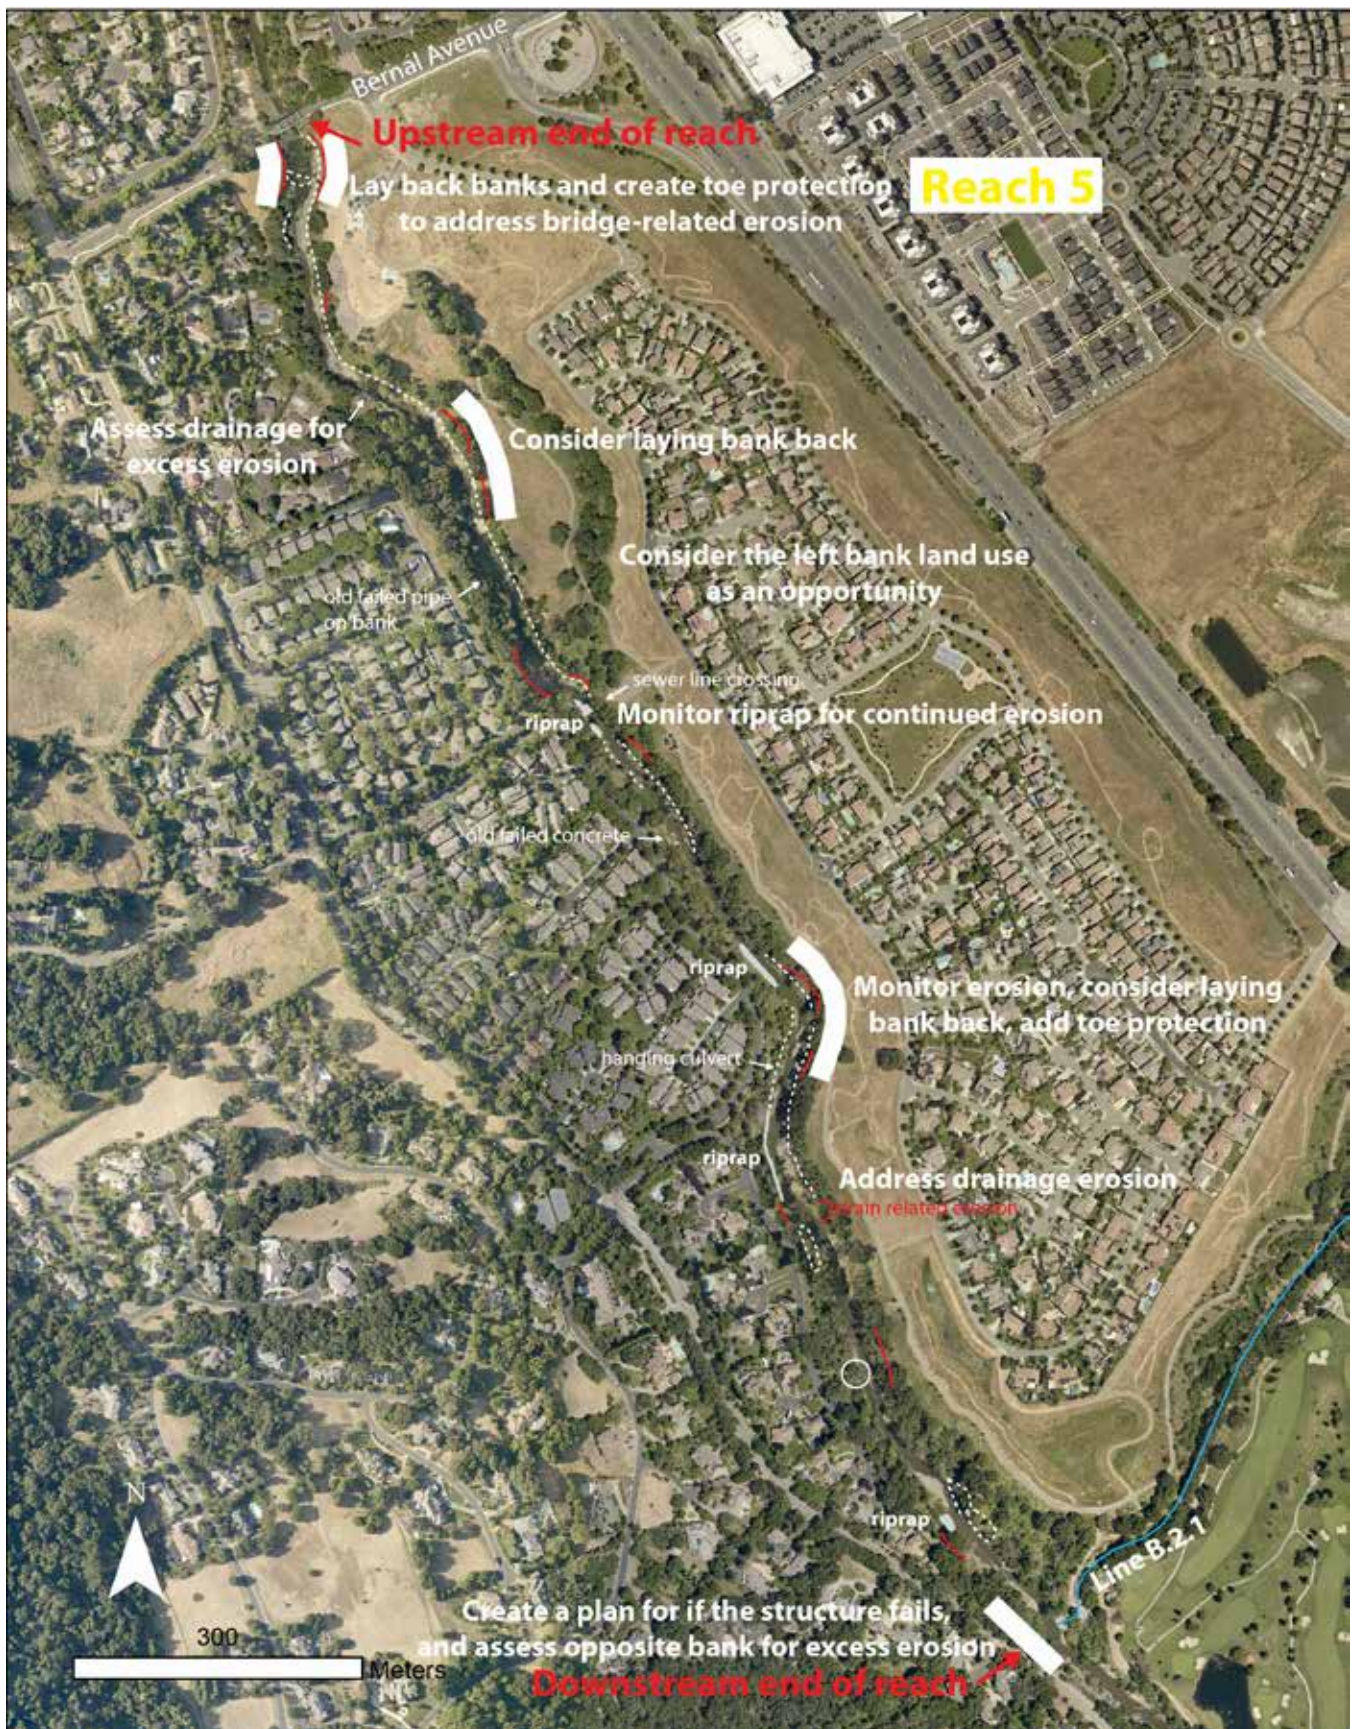
Like many of the other reaches, there is risk of further erosion of the outer banks due to channel widening that threatens to erode property on the right bank (Figure 46). This could be exacerbated if the headwardly eroding knick point moves through Reach 4, and begins to impact Reach 5. Erosion of the protective riprap placed on the pump station pipe that spans the channel bed may continue, leaving the pipe vulnerable to damage.

Figure 46. Risks and opportunities for Reach 5.

5	IV Widening/ Incision	IV Widening/ Incision	Erosion of the outer banks due to channel widening; property at risk on the right bank.	Lay back the left bank to limit/reduce erosion occurring on the opposite bank; re-activate historical side channel; create an anticipatory management plan
6	III Incision	? Depends on management	Incision from downstream knickpoint or failure of Bernal Avenue bridge footers; right bank erosion; tree blocking the channel at Bernal Avenue bridge	Right bank has space available; exposed hardpan will help to hold channel gradient

In terms of opportunities for proactive management, the left bank is entirely City of Pleasanton park area which could be laid back to limit/reduce erosion occurring on the opposite bank, without major changes to park function or alignment. An historical side channel still exists through the park, and, though its elevation is much higher than the current channel bed, and the frequency with which it activates is unknown, it could present an opportunity to engineer a solution to spread flows across a wider cross section in the reach and alleviate pressure on banks downstream. It could be evaluated for feasibility, and would increase channel complexity and habitat value of the stream. As with other reaches, an anticipatory management plan (Beagle et al., 2016) could be created to plan for failures that occur on the right bank, allowing fixes to occur that will work with the larger channel evolution in this reach, and will not deflect erosional problems onto adjacent properties.

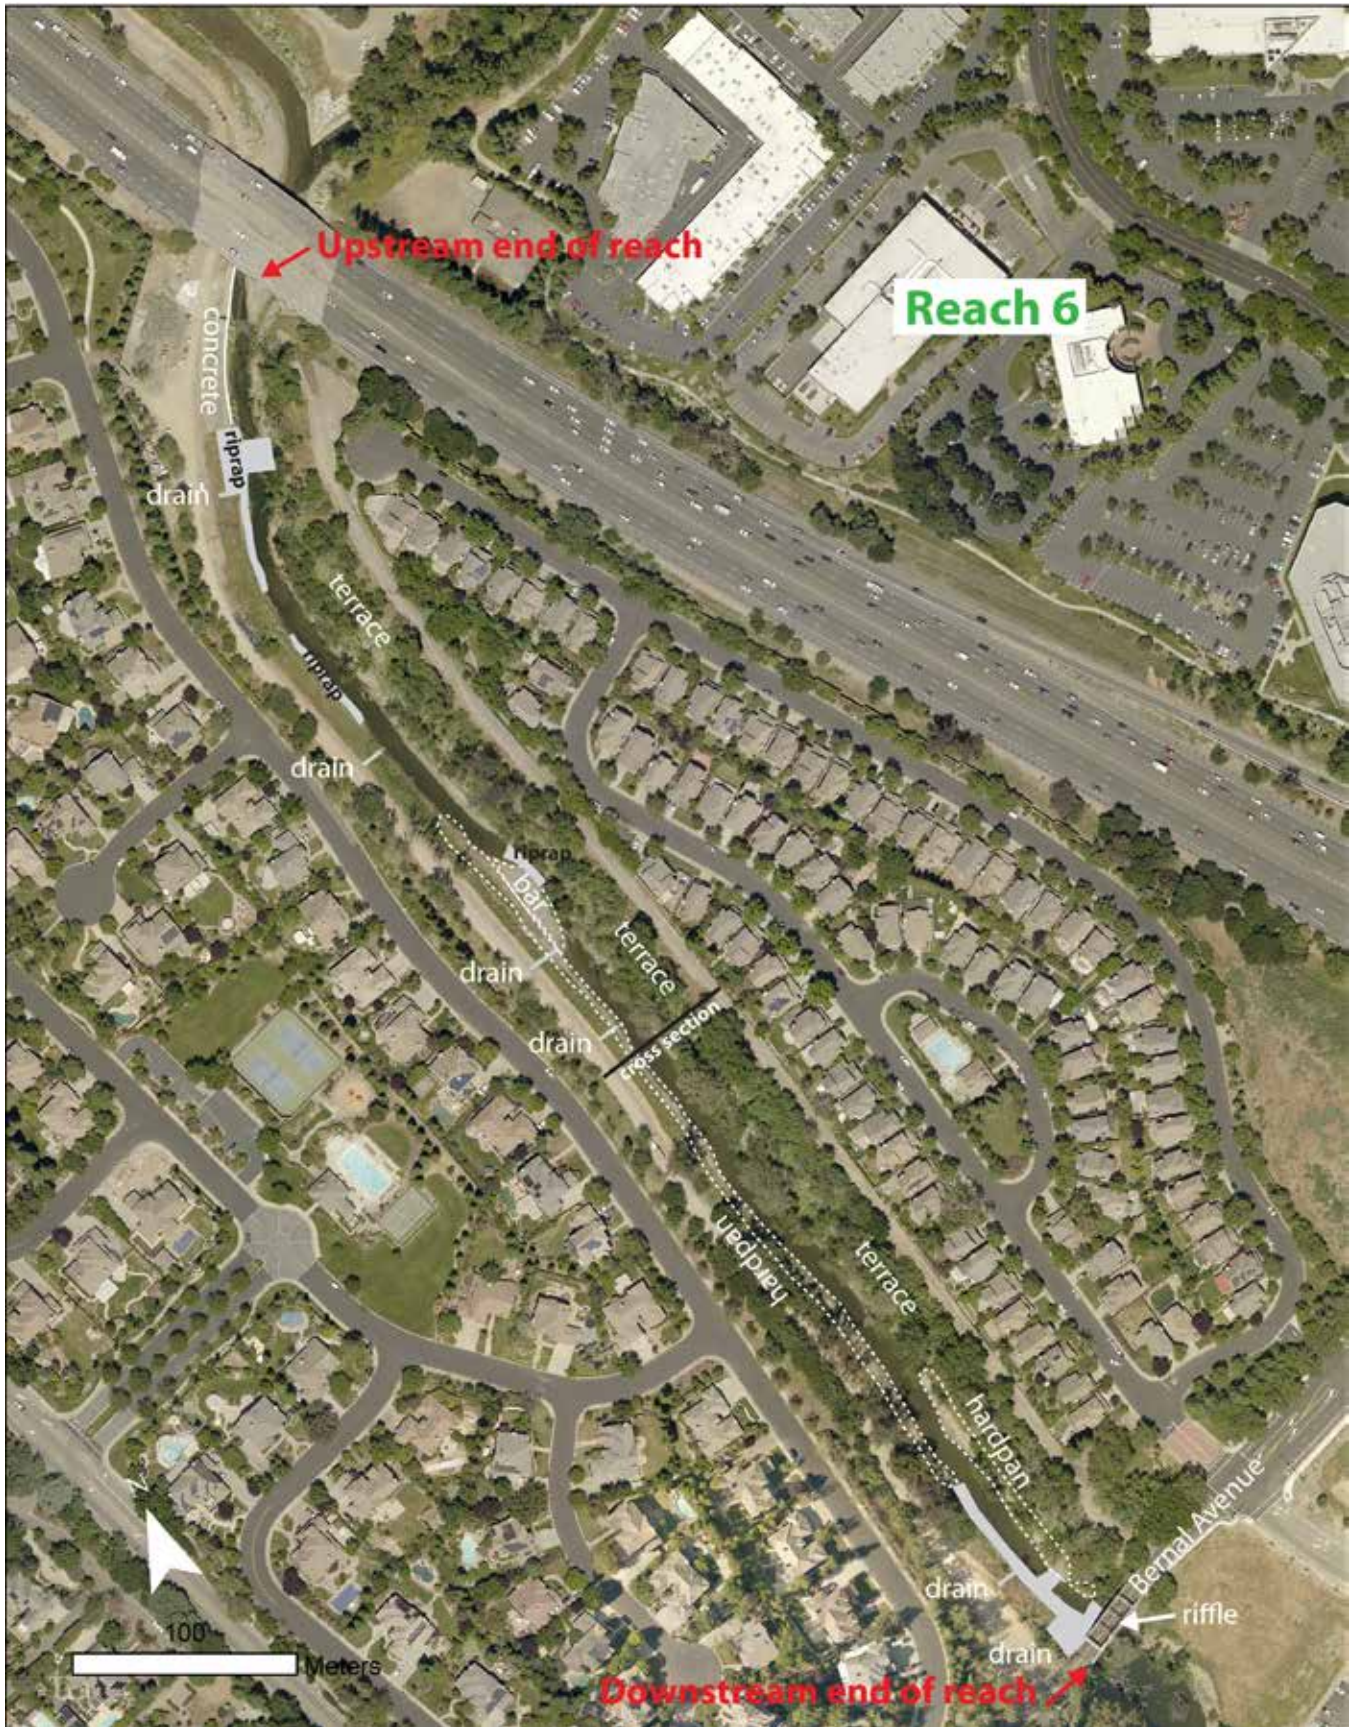
Reach 6 extends from Bernal Avenue upstream to the Interstate 680 crossing (Figure 47). The reach overall is very homogenous, and maintains a simple shape likely due to its history as a ditched reach through the historical Pleasanton Marsh. The reach is fairly straight, except for the curve at the upstream end where it flows underneath the 680 bridge.

Figure 47. Reach 6 channel map.

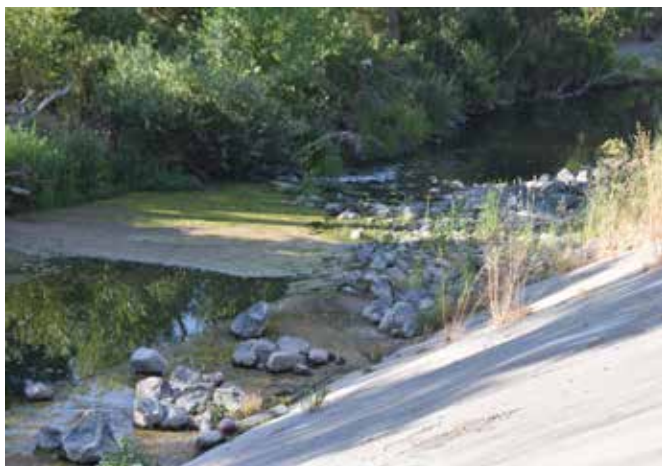
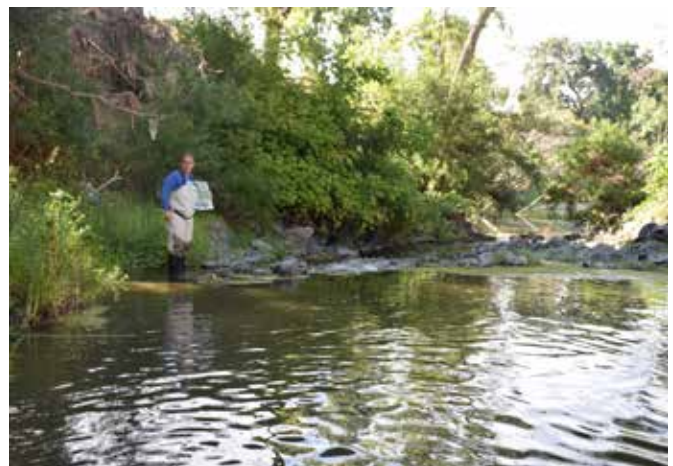
The channel pattern is mostly glide, with a riffle at the top (intentionally placed riprap that is forming a grade control), the middle as it flows over riprap (likely intentionally placed), and the bottom (intentionally placed riprap associated with the bridge footers) (Figure 49). Hardpan is exposed in the lower half of the channel reach, extending from Bernal Avenue upstream to the middle where a large low elevation bar has formed on the hardpan (Figure 50). There are no 1950s flood deposits or emerging floodplains in this reach.

Figure 49. Riprap forming riffle at top of reach; riffle at bottom of reach under Bernal Avenue bridge.

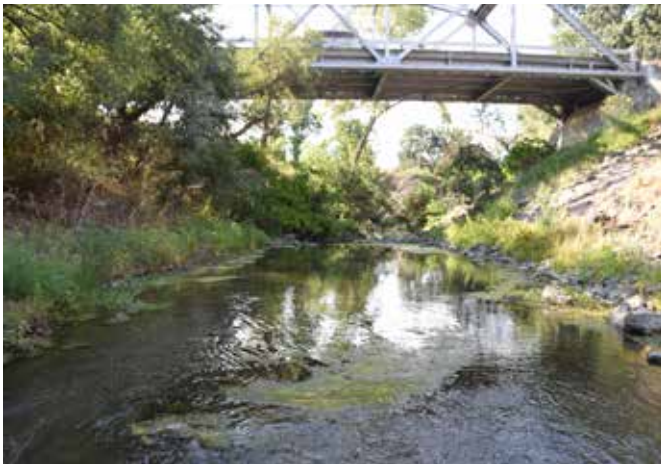
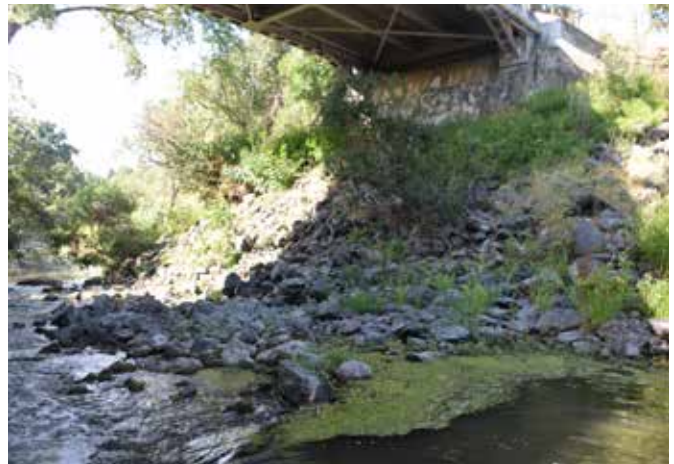
At the downstream end of the reach, the Bernal Avenue bridge deck is high above the bed, but the bridge earthen footers impinge upon the channel cross section (Figure 51). The width between footers is fairly narrow, and likely causes a hydraulic constriction during high flows. As the channel passes through the footer, a steep riffle has formed, with a gradient much higher than the channel up or downstream of the bridge. The riffle gradient is approximately 2.7%. Likely because of the constriction, downstream of the bridge the banks have blown out due to eddying, with significant failures of both the right and left vertical banks. Because these banks are 10-12 m tall, failures contribute a significant volume of sediment to the channel. In addition, a very deep pool (too deep to wade) and an arcuate bar on the downstream side of the pool have formed due to the scour and resultant deposition from the constriction (Figure 52) that are technically in Reach 5.

Figure 51. Bernal Avenue bridge footers.

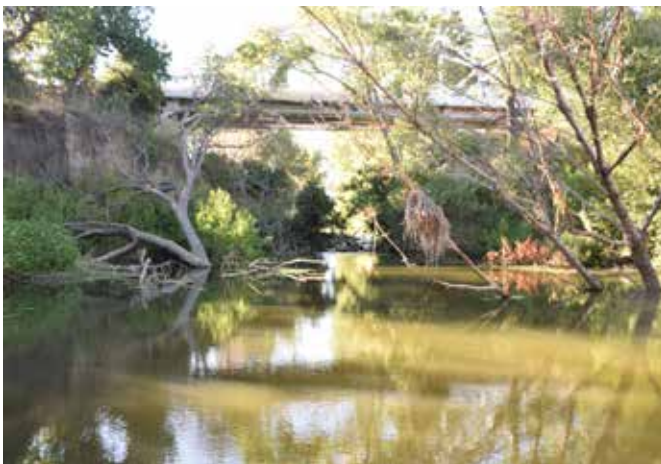
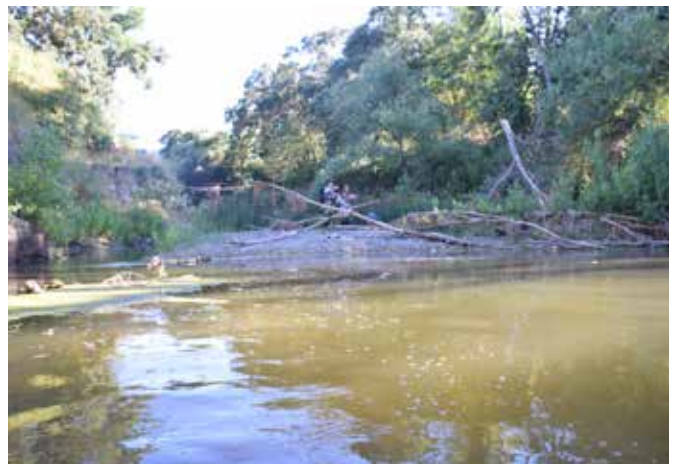
Figure 52. Looking upstream at the pool developed on the downstream side of Bernal Avenue; looking downstream at the arcuate bar deposited at the downstream end of pool.

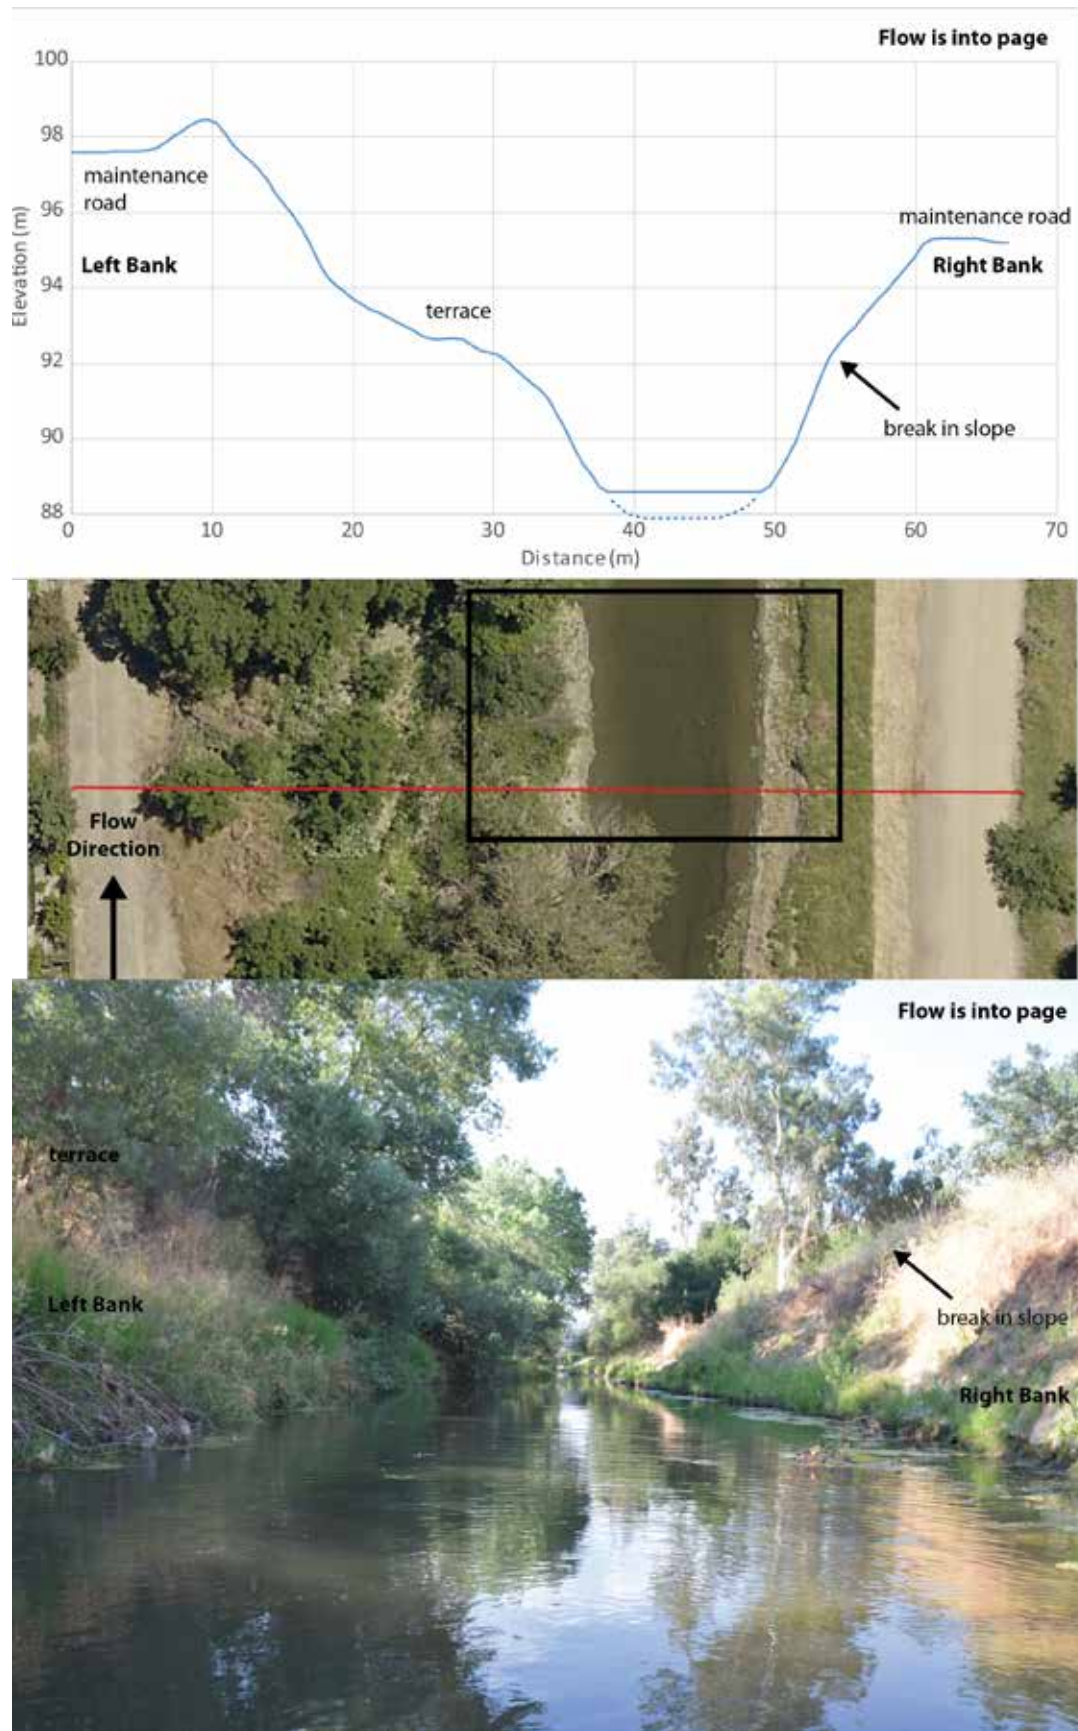
The representative cross section shows the constant constructed slope of the right bank, and the terrace on the left bank (Figure 53). It also shows the slight break in slope on the right bank that

Figure 53. Representative cross section for Reach 6. Solid line shows elevations directly from LiDAR, while the dashed line shows approximate elevations from field observation.

corresponds with the terrace elevation. It also shows the “V” shape of the lower banks, and the vertical slope of the lowest portion of the bank.
