ARROYO DE LA LAGUNA REACH-BASED GEOMORPHIC EVALUATION

NOVEMBER 2023

PREPARED BY
San Francisco Estuary Institute

IN PARTNERSHIP WITH
Alameda County Flood Control and
Water Conservation District, Zone 7

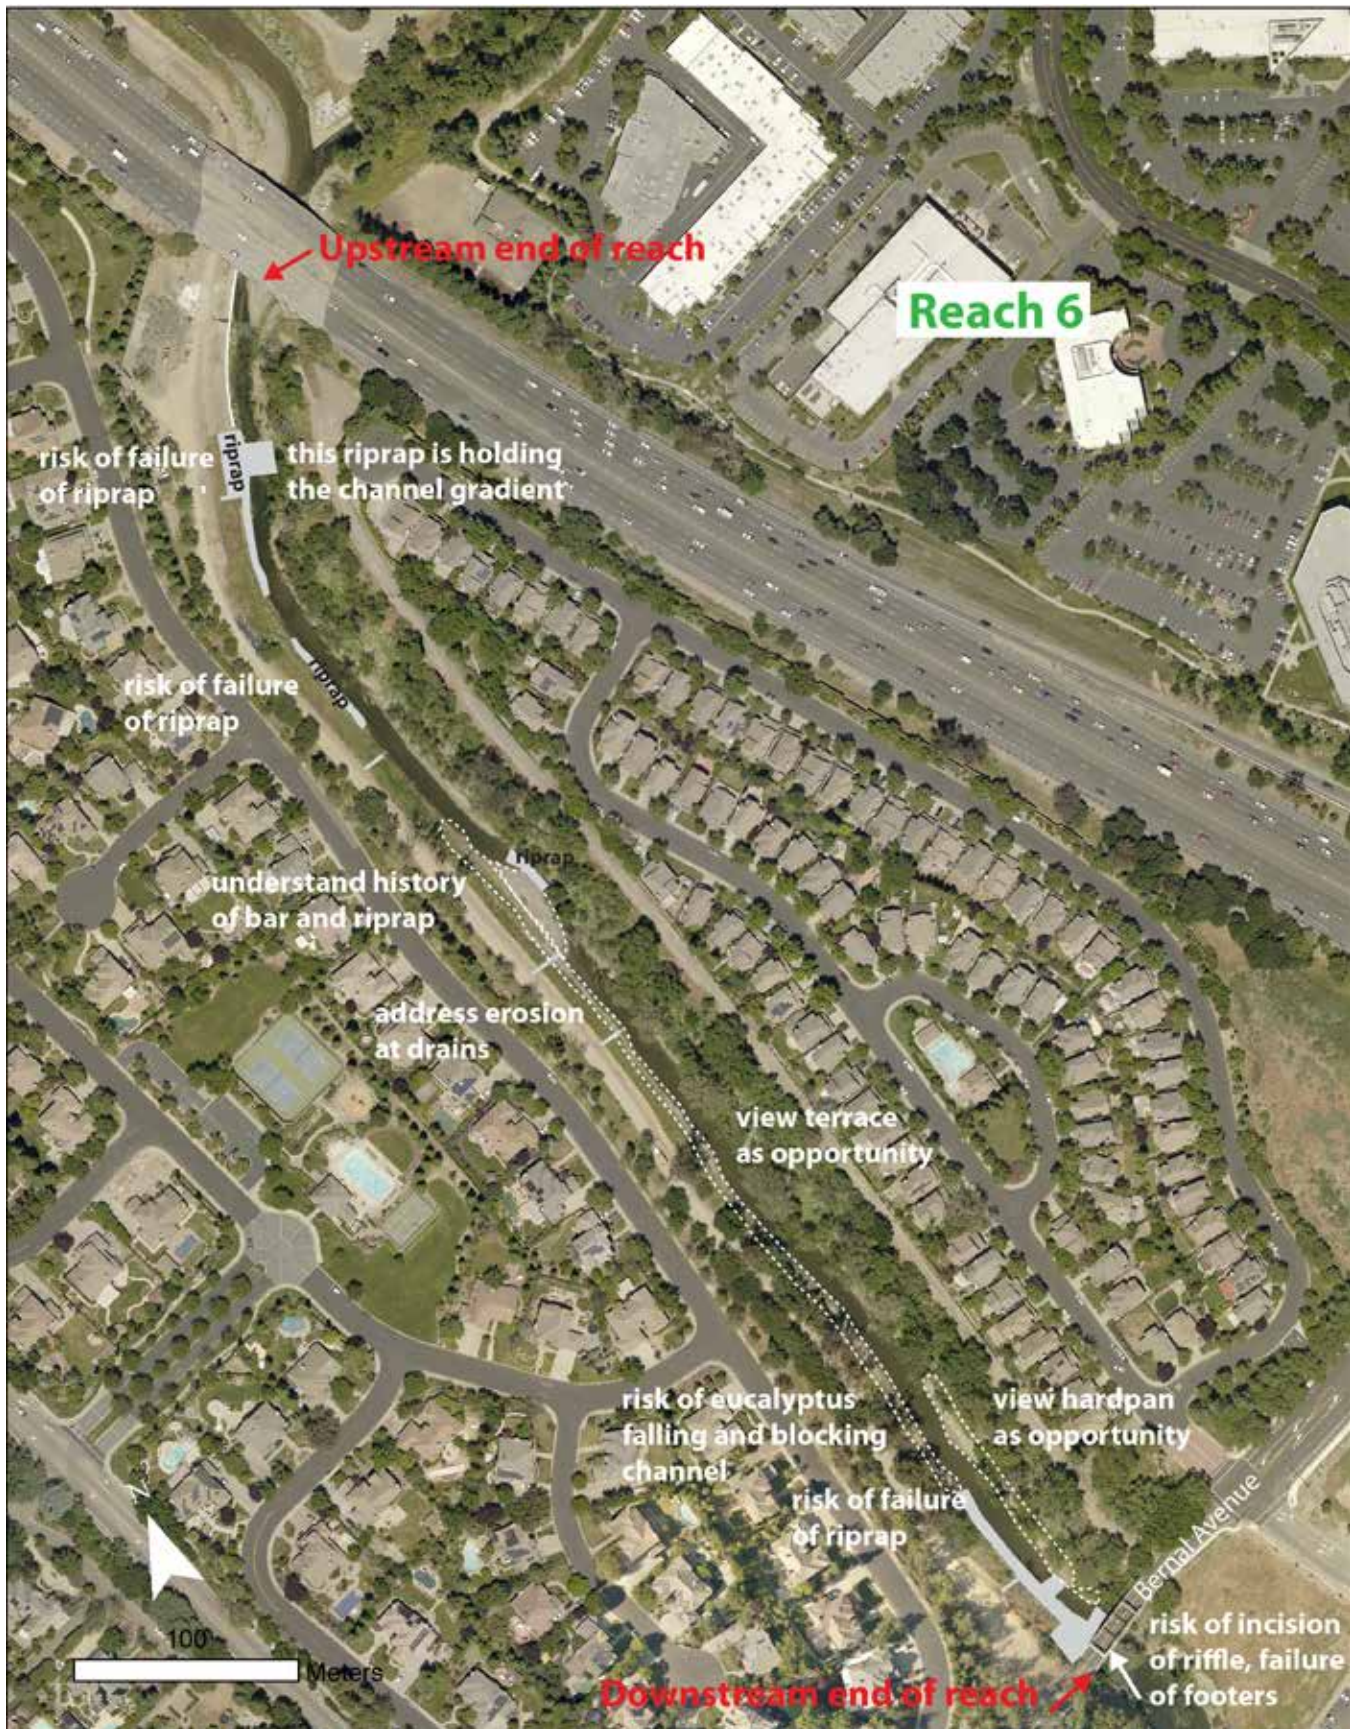
Risks in this reach are minimal, yet should be considered in a plan for the entire stream (Figure 54). It is possible, though unlikely that a knick point will move through this reach. More likely would include an undermining failure associated with the Bernal Avenue bridge footers, as well as rotational style failures of the right bank. If large enough, these failures could constrict part of the channel, which is fairly narrow in this reach. If one of the large trees (e.g. eucalyptus) were recruited or wind-blown and fell into the channel, it could block the narrow channel width at the Bernal Avenue bridge footer.

Figure 54. Reach 6 risks and opportunities.

- Reach 6 may begin to widen, as the incision is controlled by the elevation of the riffle underneath Bernal Avenue. This may cause failures that threaten the stability of the maintenance road.

However, the right bank might provide opportunity to set the bank back or to create an inset floodplain, given that it has some available distance between the creek and the property boundary. The maintenance road could be narrowed, although it would need to remain wide enough to allow maintenance and construction vehicles, or it could be moved to the west so that it is immediately adjacent to the property boundary. The hardpan in the lower half of the reach should also be viewed as an opportunity because it will likely help hold the channel gradient.
